Civic Building Reports

CHRISTCHURCH CIVIC BUILDING: STRUCTURAL PERFORMANCE AND REPAIRS FOLLOWING THE SEISMIC EVENTS OF 4TH SEPTEMBER, 22ND FEBRUARY AND 13TH JUNE 2011

This letter is an interim report in accordance with Beca proposal to the Christchurch Civic Building JV dated 28 January 2025, for a detailed seismic assessment of the Te Hononga (Christchurch Civic Building). You have requested that we provide an early initial report on our specific assessment of the seismic capacity of the annex floor connections to the original building.

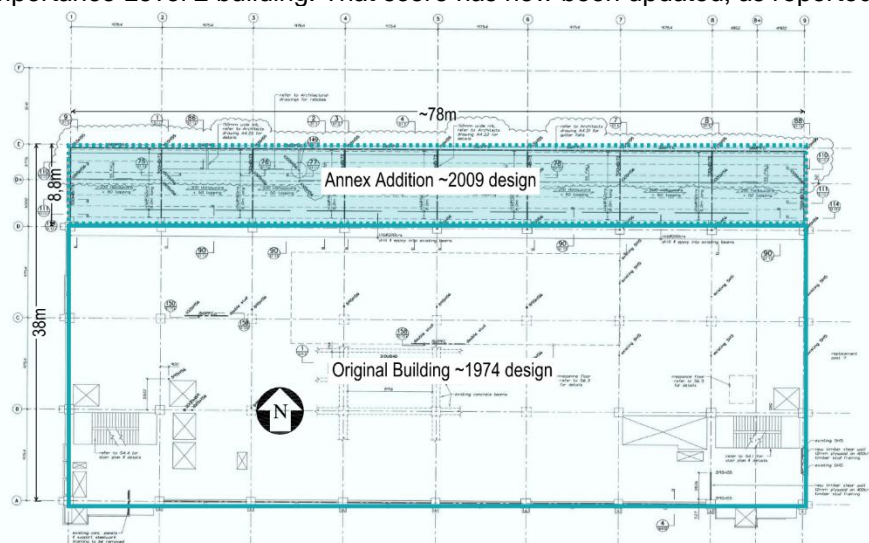
Figure 1: Plan view showing Annex addition shaded

The Christchurch Civic Building was converted for use as CCC offices including extensions to the floors on the north side of the building (refer Figure 1), these areas being referred to as the “annex”. The structure supporting the annex floors was constructed from steel beams and columns and precast concrete hollow-core floors. We understand that the overall seismic resistance was provided by the existing building frames and no additional seismic strengthening of the existing building frames was required to accommodate the annex addition.

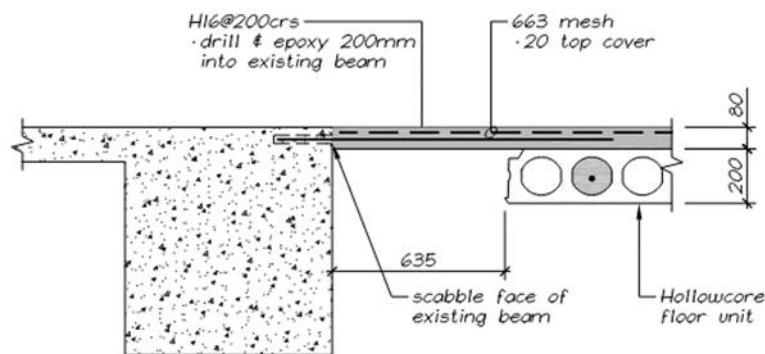
Figure 2: Detail of connection of 2009 annex floor to original concrete beam (Grid D)

The annex floors were added in 2009 using starter bars drilled into the concrete cover of edge beams. This method lacks the strength of deeper embedment, resulting in lower seismic performance.

We consider the annex floor connections are a SSW because the connections are expected to fail in a brittle manner, there could be a severe consequence of failure and there are limitations in the reliability of the assessment calculation. A large earthquake could (although unlikely based on events already sustained) result in detachment and collapse of annex floors.

The structural connection of the new floor extensions to the original building was completed by drilling and grouting reinforcing bars (“starter bars”) at close centres along the entire length (about 80 m), as shown in Figure 2. The starter bars were only drilled into the cover concrete of the edge beam. A more reliable and

robust detail would have been to drill and grout the starter bars well into the beam between the reinforcement.

Based on the assessed scores we do not consider that the building or annex connections should be regarded as earthquake prone, as neither score is less than 34%NBS. However, we recommend that options to strengthen the annex connection should be considered to increase its score to match or be greater than the %NBS score for the main building structure.
