CHRISTCHURCH CITY COUNCIL
PRK_1108_BLDG_001 EQ2
Addington Park – Pavilion and Toilets
77 & 83 Jerrold St, Addington

QUALITATIVE ASSESSMENT REPORT

FINAL

- Rev B
- 23 May 2013

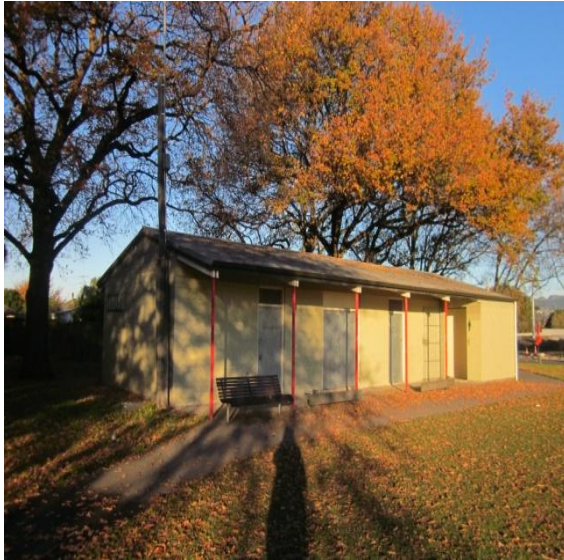
Photo 1: The north and west elevations of the building

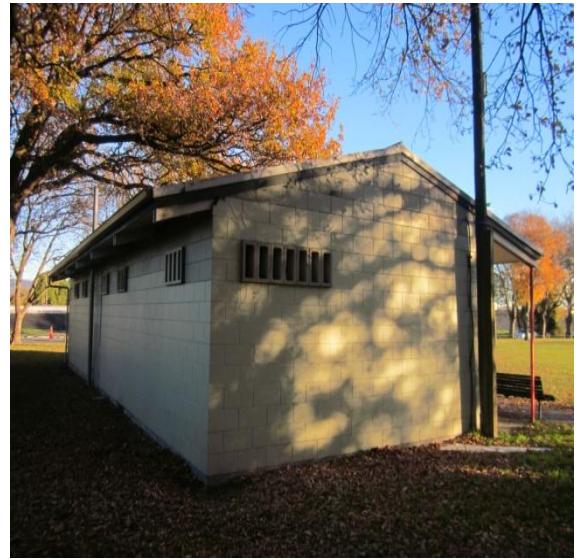
Photo 2: The east and north elevations of the building

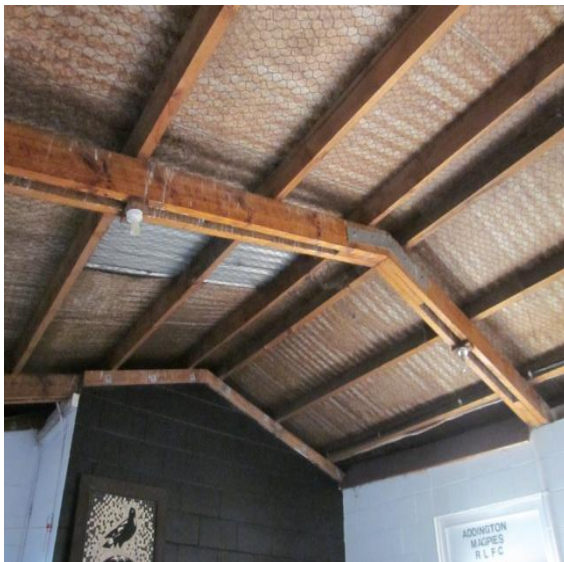
Photo 3: Interior of the roof showing typical roof framing

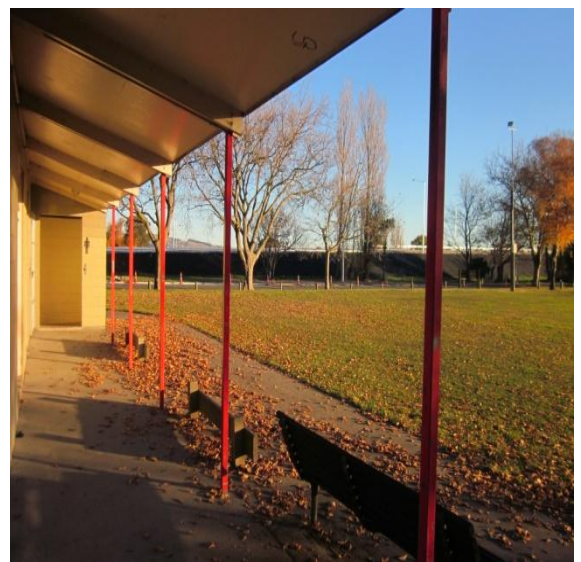
Photo 4: Verandah on the west side of the building where the roof is supported by steel posts

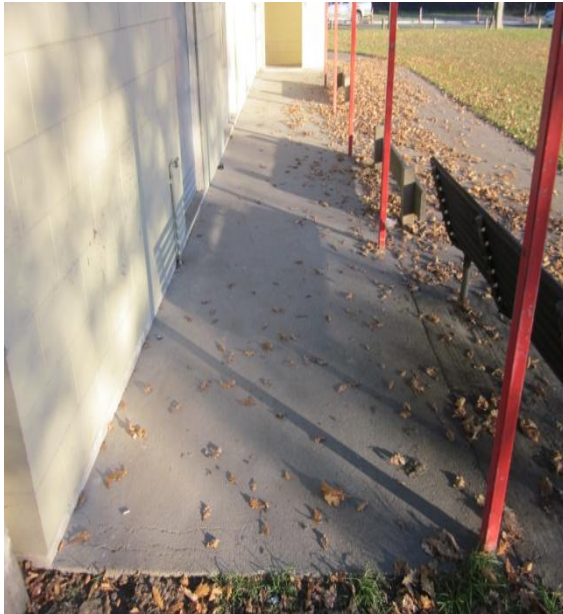
Photo 5: External concrete slab on the west side of the building

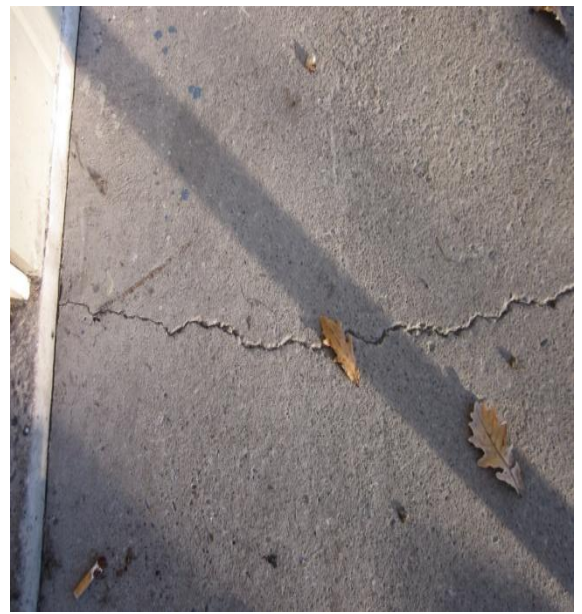
Exacerbation of existing damage to the external concrete slab was observed.

Photo 6: Detail of existing cracking in the external concrete slab which has been exacerbated by the recent earthquakes

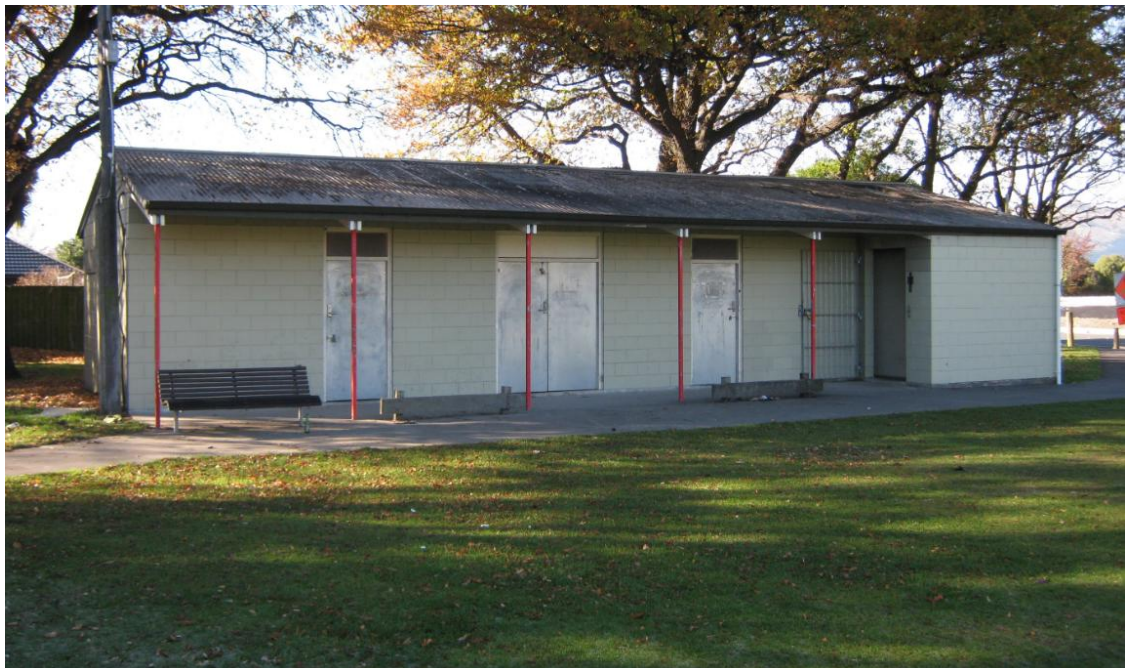
The toilet/pavilion block is a masonry block building with corrugated iron roof and a concrete slab on grade foundation. Very little indication of damage could be observed of the toilet buildings on site, with minor hairline oscillation cracks between the building and the paving slabs.

■ **Figure 7 Toilet / Pavilion block at Addington Park**

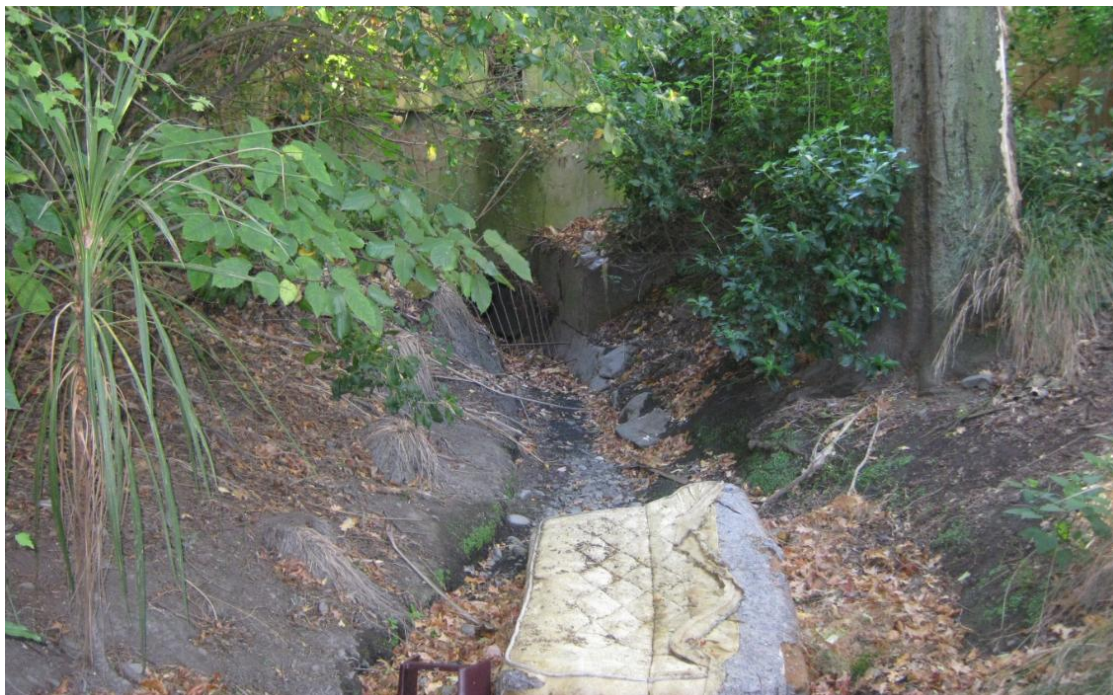
The dry creek bed lies close to the building is slopes down to approximately 2m below the field level. There was no evidence of liquefaction on the surface of the river bed or any bank slope failure.

■ **Figure 8 Dry bed of Jacksons Creek**
