# **Customs House PRO 3640-002**

**Detailed Engineering Evaluation  
Quantitative Assessment Report**

**1 Rue Balguerie, Akaroa**

Date: March 2014  
Reference: 6-QUCCC.98  
Status: Final

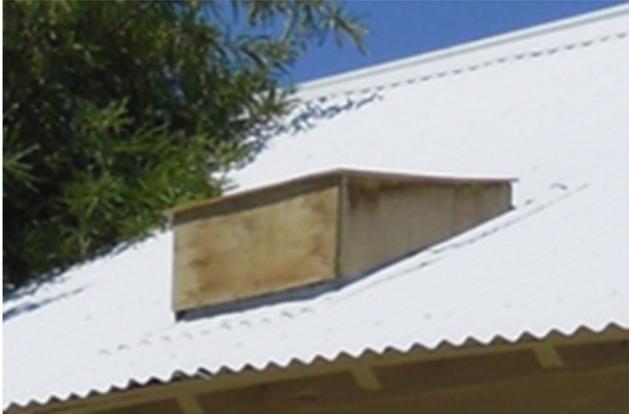
Cracking to brick chimney was noted during post-earthquake inspections in May and June 2011. The chimney was deconstructed down to roof level in August 2011 and therefore eliminating the fall hazard. See Photo 2 in Appendix 1. Any future reinstatement of the chimney would need to consider the strengthening of the entire chimney structure, down to the ground floor.

<p>Photo after chimney removed and temporarily water proofed.</p>

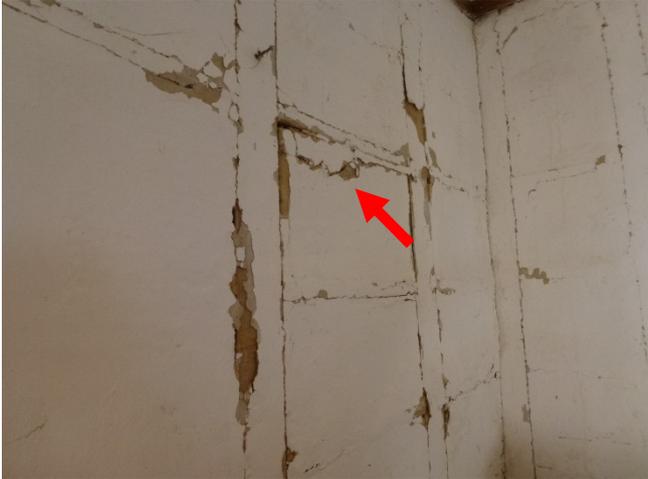
Spalling of limewash and cracking to earth infill at stud and batten edges, which was due to the movement of the timber framing caused by earthquake shaking. See Photo 3 in Appendix 1.

<p>3.</p>	<p>Spalling of limewash and cracking in infill earth</p>

- a. Repair gaps/cracks within earth infill of the timber framed mud infilled walls with suitable structural filler based on consultation between engineer and conservation expert. This repair would also improve the seismic capacity of the wall albeit marginally.
- b. Strengthen the building's seismic performance to as near as practicable to 100%NBS, and at least 67%.
- c. During the strengthening works as recommended above, conduct intrusive investigate to check if the building is connected to the foundation. Carry out remedial works if it is not connected,

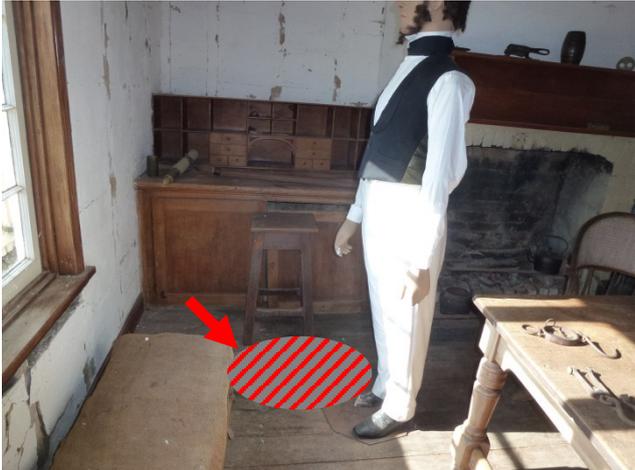
No observed earthquake related damage. There is an area of dipping in the timber flooring near the northwest corner of the building. This is likely to be due to deterioration over time of the timber subfloor. See Photo 4 in Appendix 1.

<p>4.</p>	<p>Localised dipping of timber flooring</p>

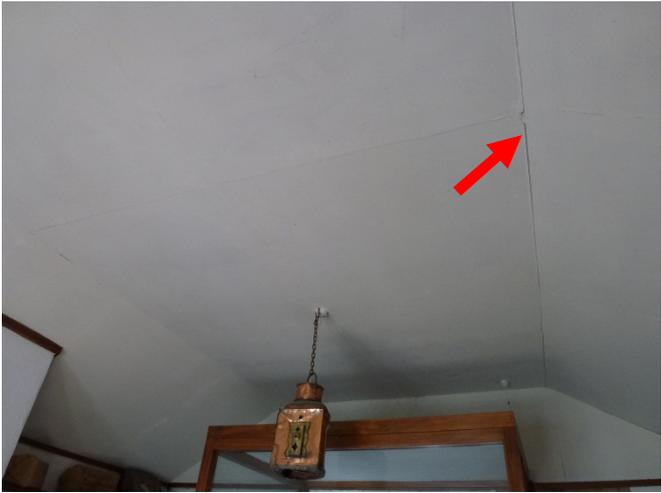
Minor cracking to joints between ceiling plasterboards. See Photo 5 in Appendix 1.

<p>5.</p>	<p>Minor cracking to joints between ceiling plasterboards.</p>
