**Christchurch City Council**  
PRK\_3739\_BLDG\_006 EQ2  
Akaroa Recreation Ground - Pavilion  
28C Rue Lavaud, Akaroa

QUANTITATIVE ASSESSMENT REPORT  
DRAFT

- Rev A
- 30 January 2013

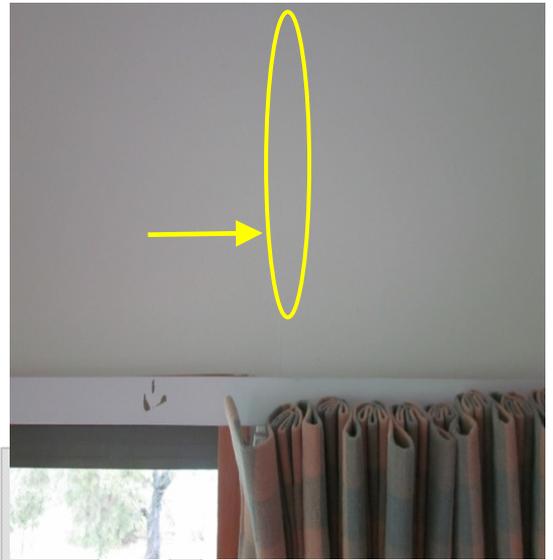
- Cracking of internal walls and ceiling linings including junctions between linings and different materials. Note that the internal linings appear to be hard board. Refer to photos 2 to 13.

Photo 2: Lining Damage

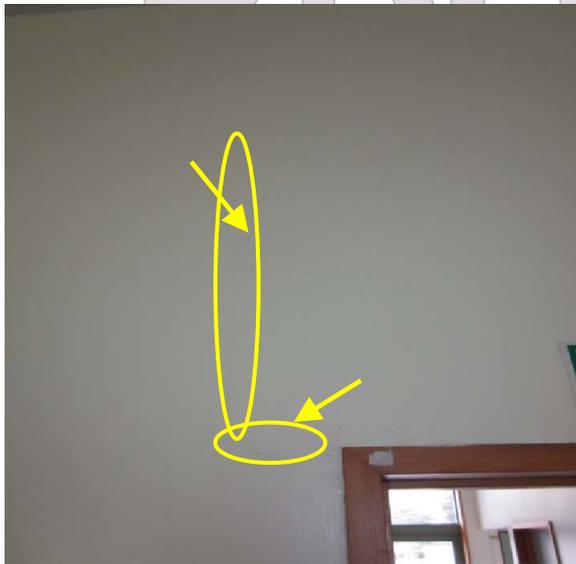
Photo 3: Lining damage

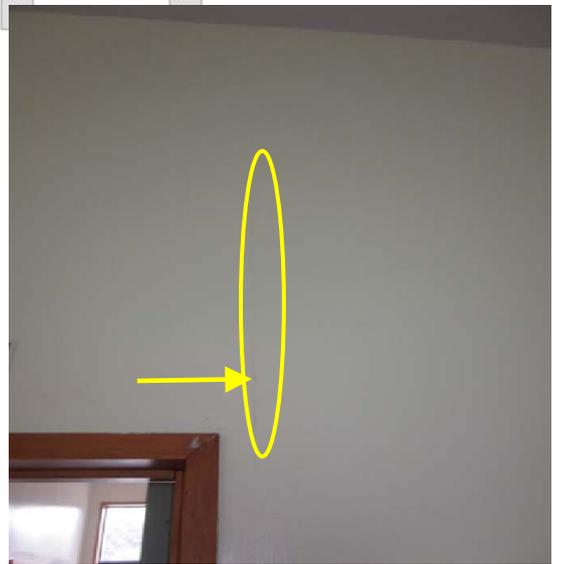
Photo 4: Lining damage

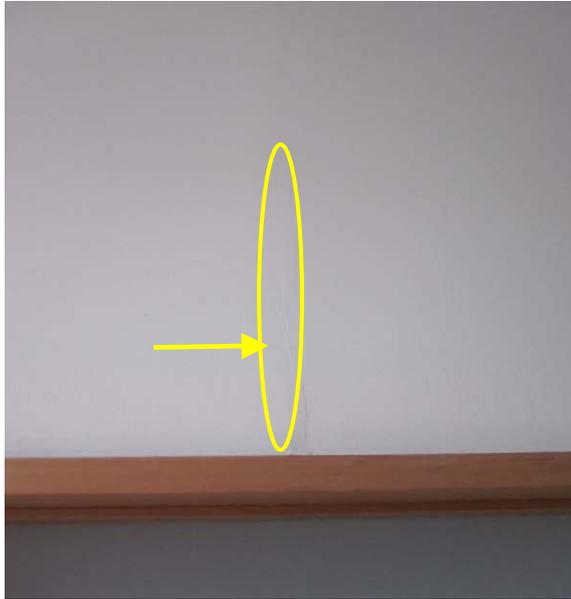
Photo 5: Lining damage

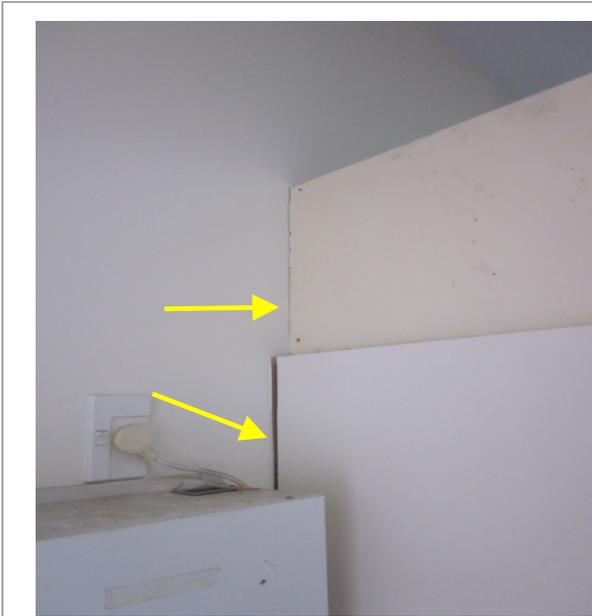
Photo 9: Movement between kitchen timber enclosure and adjacent wall.

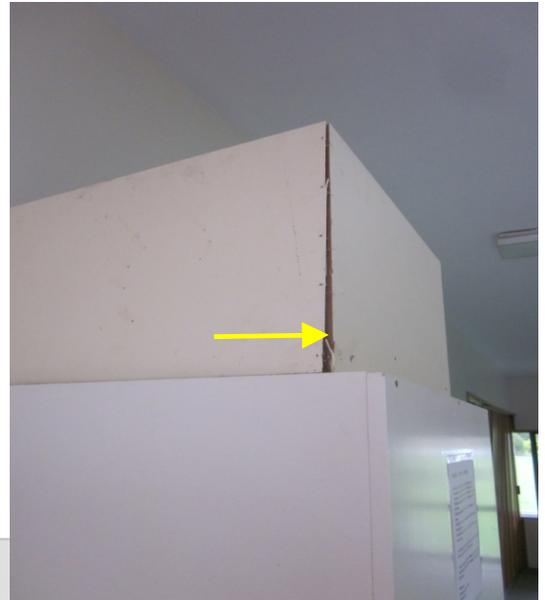
Photo 10: Damage to timber enclosure in kitchen.

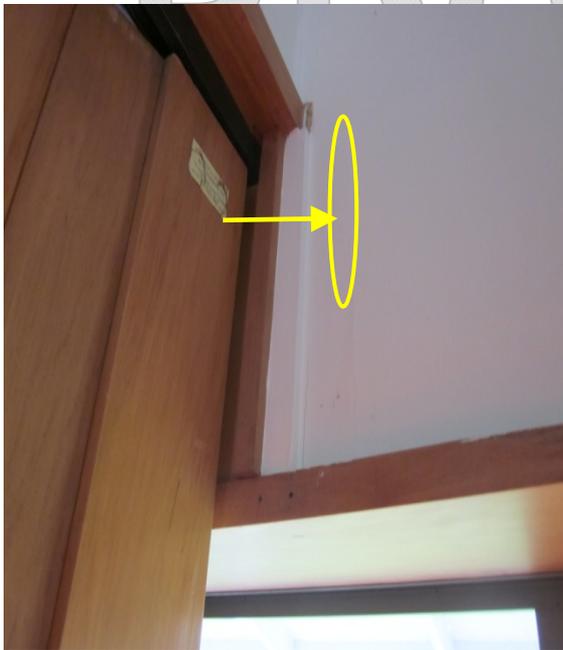
Photo 11: Lining damage

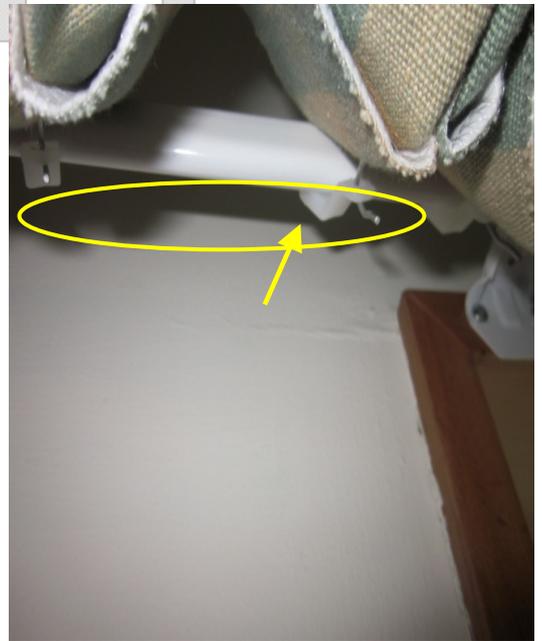
Photo 12: Lining damage

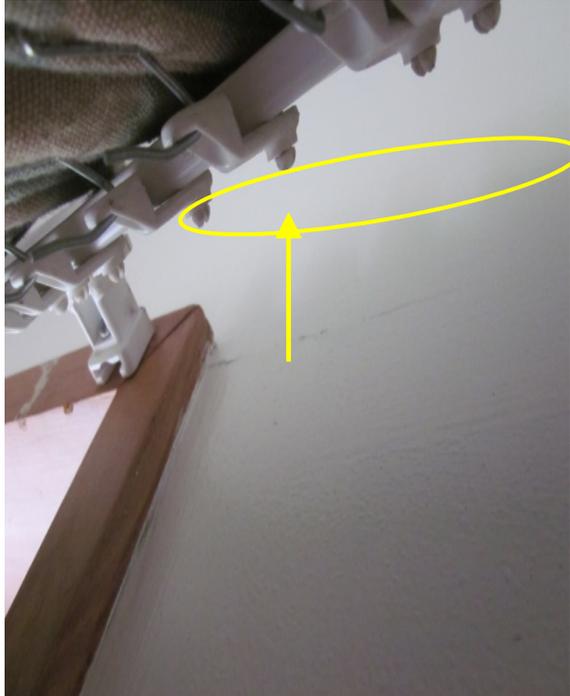
Photo 13: Lining damage
