Allison Courts  
Quantative Engineering Evaluation

Functional Location ID: BU 1113 EQ2  
Address: 40 Brougham Street

**Reference:** 233414  
**Prepared for:**  
Christchurch City Council  
**Revision:** 1  
**Date:** 27 November 2015

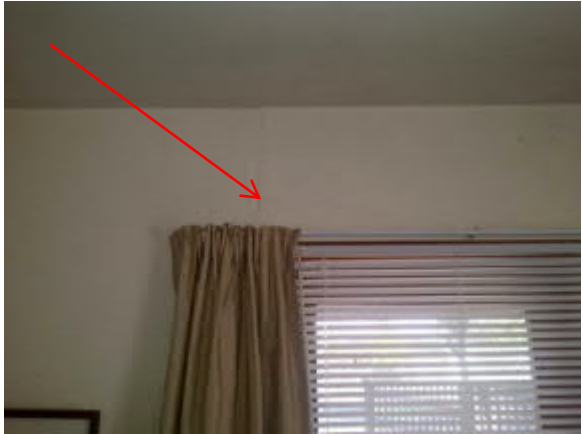
- A floor level survey using the zip level was carried out on the slab-on-grade and at the first floor when applicable. It has shown that the levels do not exceed MBIE guidelines limits – refer Appendix A for details.
- Minor damage to internal wall linings, mainly around doors and windows - refer pictures 1 and 2 – Appendix A).
- The roof structure was inspected locally by accessing a trap tile and appeared to be in good condition in the area inspected (picture 4).

Ref	Description	Photograph
1.	Typical minor damage cracking to interior wall lining around windows.

We recommend any damaged linings be repaired.

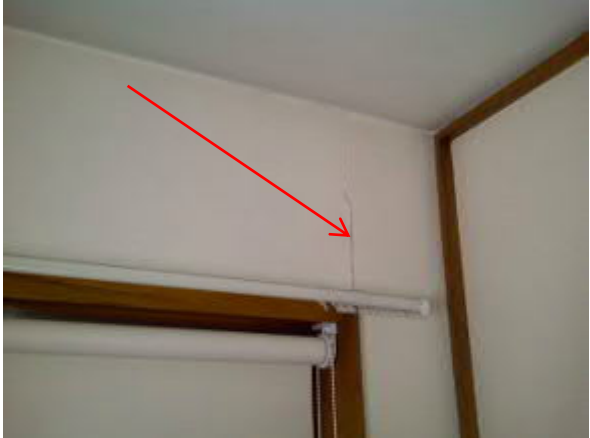
2.	Typical minor damage cracking to interior wall lining around windows.

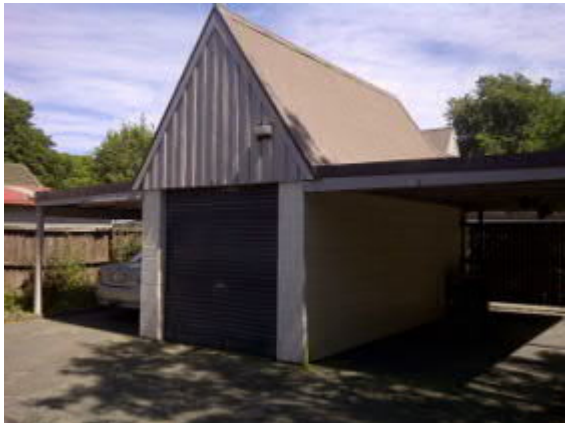
3.	Typical garage at Allison Courts.

In our opinion no repair works are required for the garages.

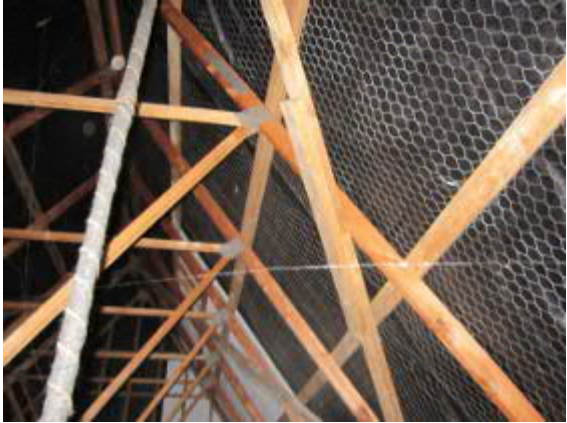
4.	Locally inspected roof structure

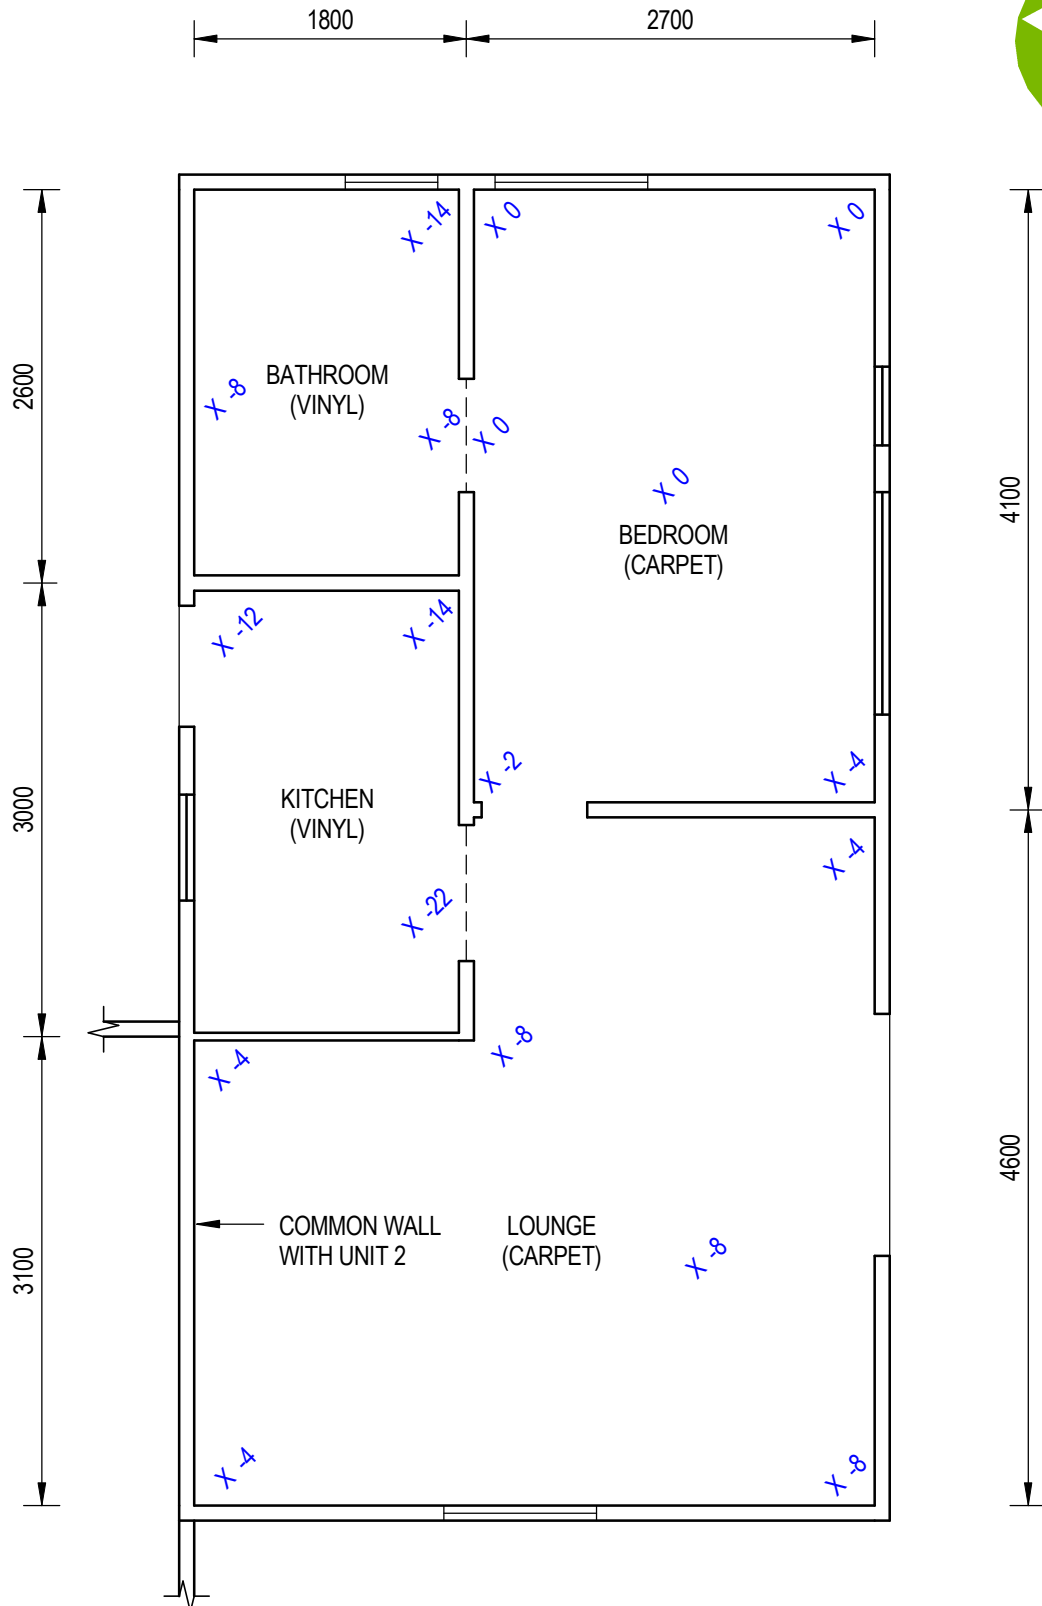
PROJECT
ALLISON COURTS 40 BROUGHAM STREET
TITLE
LEVEL SURVEY UNIT 1

The floor levels for the Allison Courts are considered to be acceptable and there is no evidence of strain induced damage to the superstructure as a result of differential foundation settlement.
