Christchurch City Council
BE 0574 EQ2 (excluding BU 0574-003)
Aorangi Elderly Persons Home
110 Aorangi Road

QUANTITATIVE REPORT
FINAL

QUANTITATIVE ASSESSMENT REPORT

- Rev C
- 30 April 2013

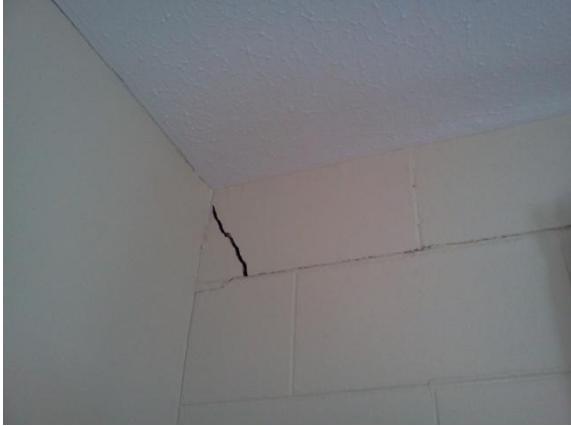
- 1) Crack through masonry block (8mm wide) (refer to Photo 5 in Appendix 1).
- 2) Step cracking along masonry joints (up to 2mm wide) (refer to Photo 6 in Appendix 1).
- 3) Tearing of wall and ceiling lining/bracing along joints.
- 4) Cracking between masonry wall and aluminium window frame (refer to Photo 7 in Appendix 1).
- 5) Hairline crack in the concrete topping slab of the first floor (refer to Photo 9 in Appendix 1).
- 6) Indication of repaired earthquake damage. Stepped cracks looks to have been repaired and repainted with a different colour (refer to Photo 8 in Appendix 1).

Photo 5: 8mm wide crack through masonry block. Visible from the exterior. (refer to Photo 7 for external view).	Photo 6: Up to 2mm wide step cracking along masonry joints

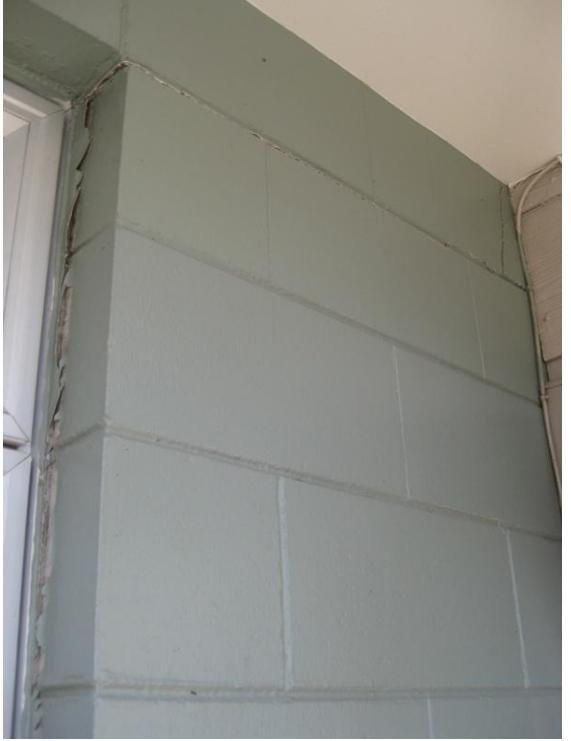
Photo 7: Crack formed between masonry wall and aluminium window frame	Photo 8: Re-pointed masonry joint

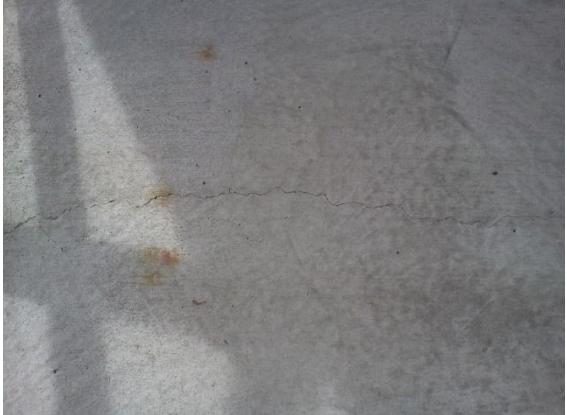
Photo 9: Hairline crack in concrete deck slab	Photo 10: Gap opening up between ceiling cladding panels

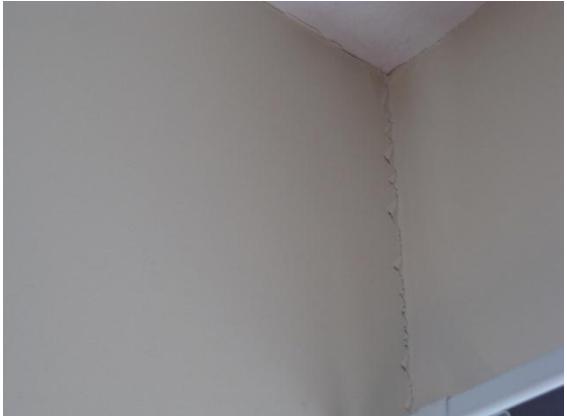
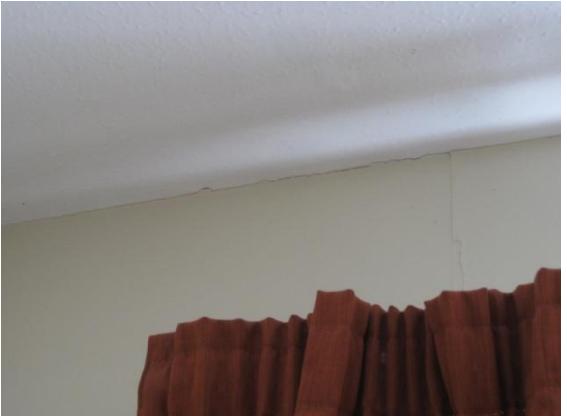
Photo 11: Tearing of wall lining at joints	Photo 12: Tearing of wall lining at joints

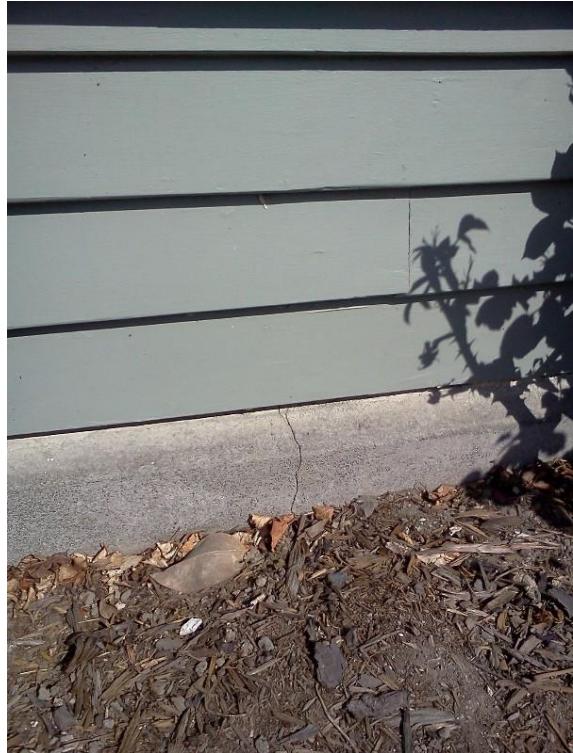
Photo 6: Crack in concrete footing

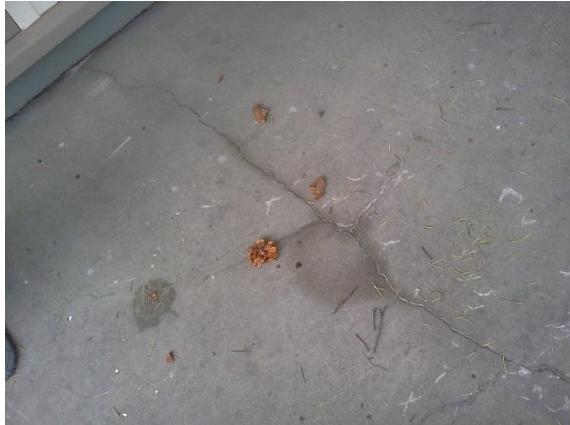
Photo 7: Cracking in external concrete ground slab

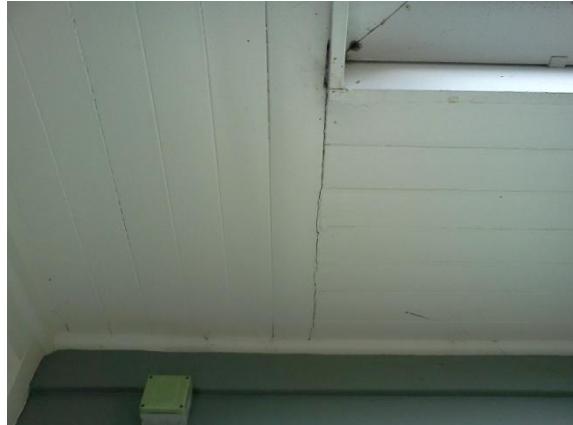
Photo 8: Gap opening up between timber roof cladding elements

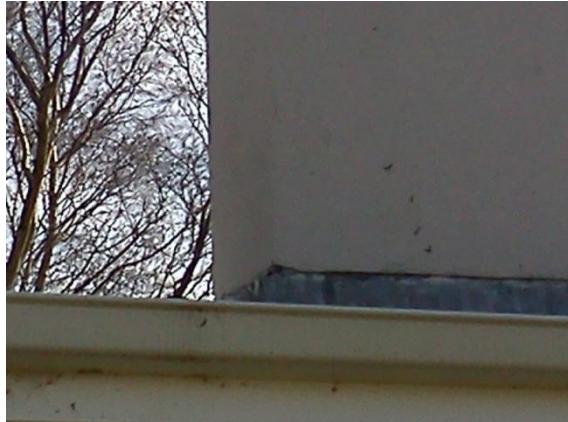
Photo 9: Suspected opening between cladding elements on the west side of the chimney on the south side of the building that is causing water damage inside

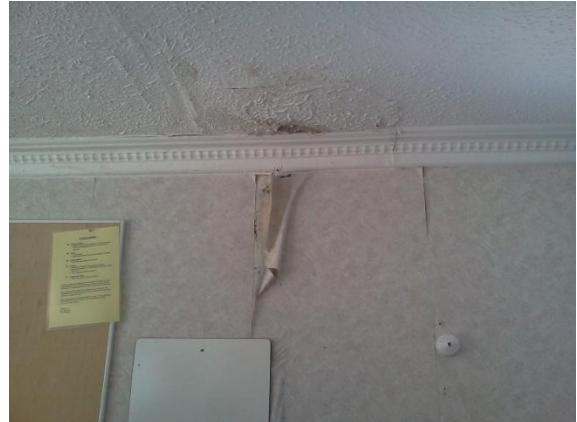
- 1) Cracking in concrete footing and external ground slab.
- 2) Cracking between timber cladding elements.
- 3) Tearing of wall and ceiling lining/bracing along joints.
- 4) Water damage was noted in the ceiling and along the south wall. Non earthquake related (refer to Photo 10 in Appendix 2).

Photo 10: Suspected water damage

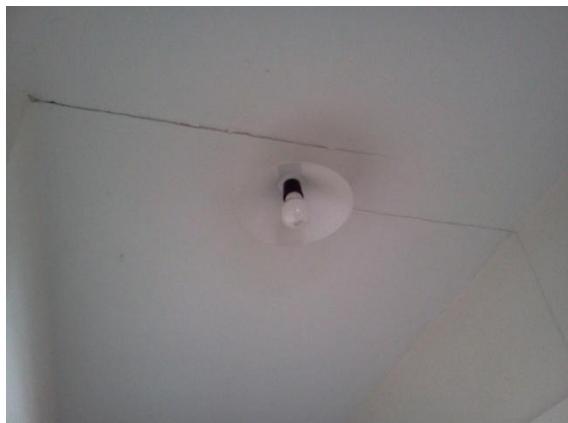
Photo 11: Tearing of ceiling lining at joints

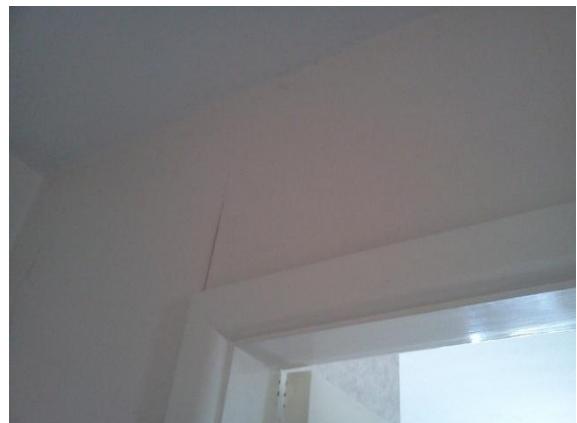
Photo 12: Tearing of wall lining at joints

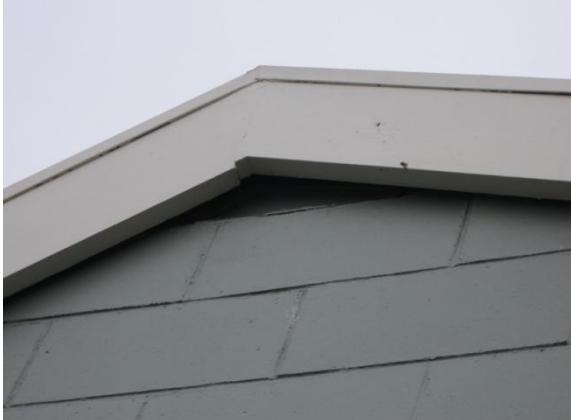
Photo 5: Dislodged or missing block near the apex.	Photo 6: Plywood sheeting near apex appears to be a temporary weather tightness repair.

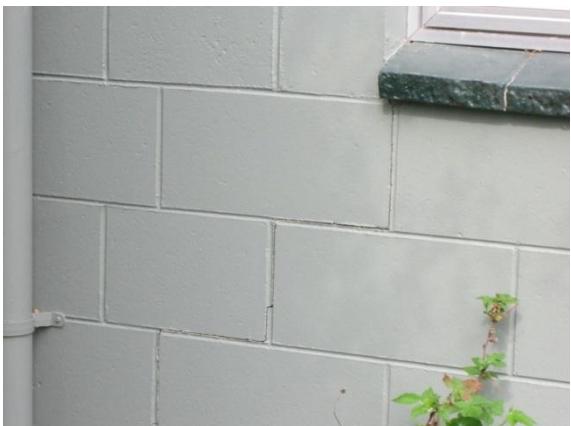
Photo 7: Step cracking along masonry joints	Photo 8: Gap opening up between ceiling cladding panels

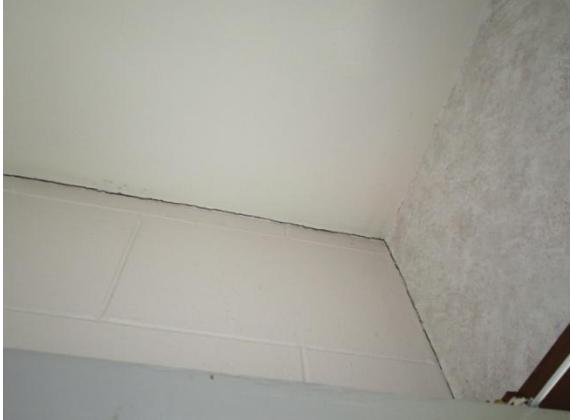
Photo 9: Gap opening up between wall lining, masonry wall and ceiling cladding	Photo 10: Steel flashing present between offset units

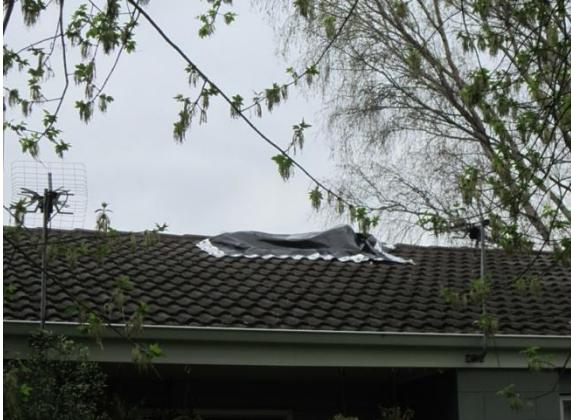
Photo 11: Suspected roof damage related to waterproofing	Photo 12: Damaged connection between masonry wall and downpipe. Not structural damage.

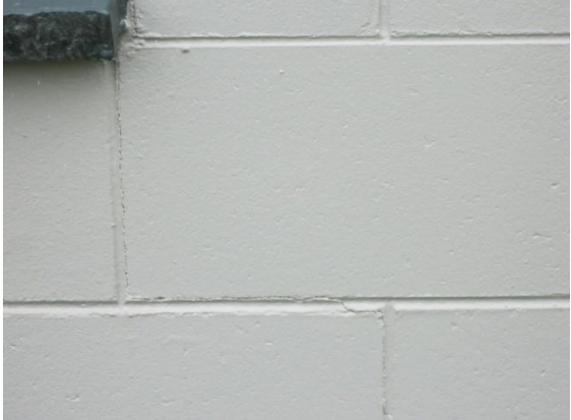
Photo 5: Step cracking along masonry joints	Photo 6: Gap opening up between masonry wall and ceiling cladding

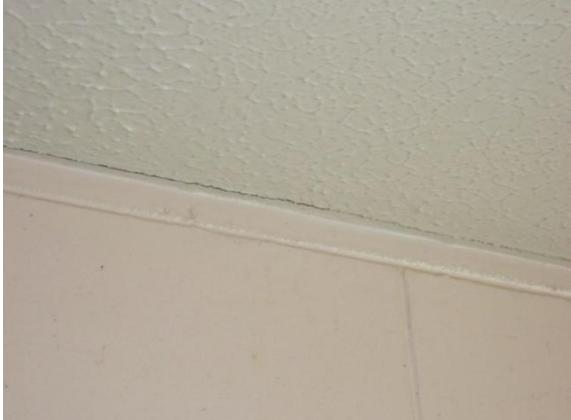
Photo 7: Gap opening up between masonry wall and ceiling cladding	Photo 8: Tearing of wall lining at joints

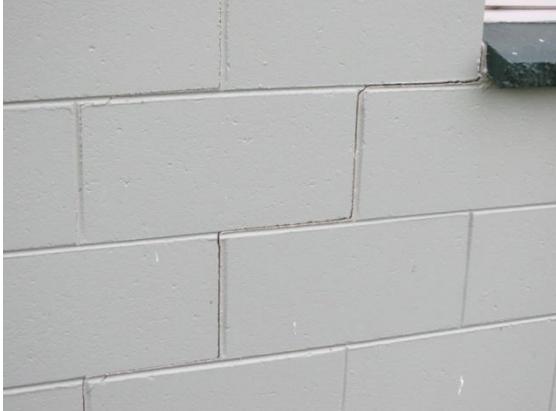
Photo 5: Step cracking along masonry joints.	Photo 6: 5mm horizontal gap opening up along masonry joint on 800mm long wall

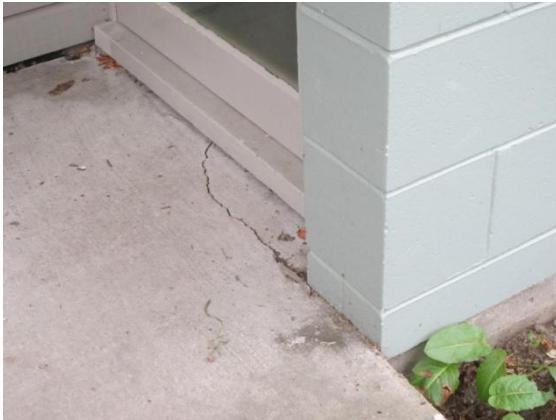
Photo 7: Crack in external concrete ground slab	Photo 8: Masonry block at apex cut at a different angle to the timber roof edge beam, reducing weather tightness.

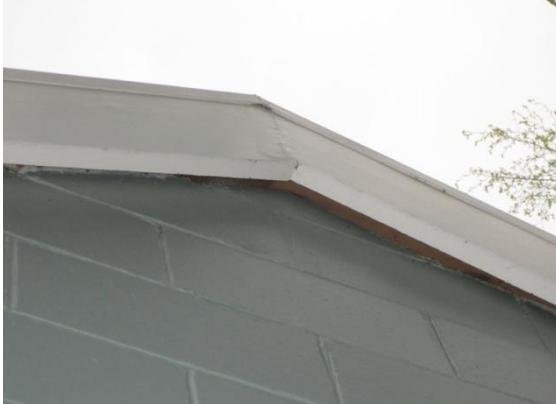
Photo 9: Gap between masonry wall and timber roof edge beam.	Photo 10: Tearing of wall lining at joints

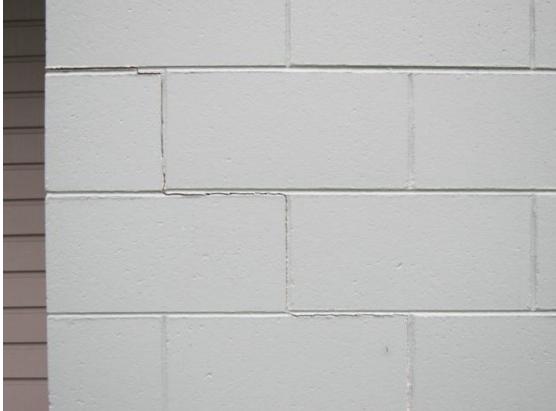
Photo 5: Step cracking along masonry joints	Photo 6: Gap between masonry wall and timber roof edge beam.

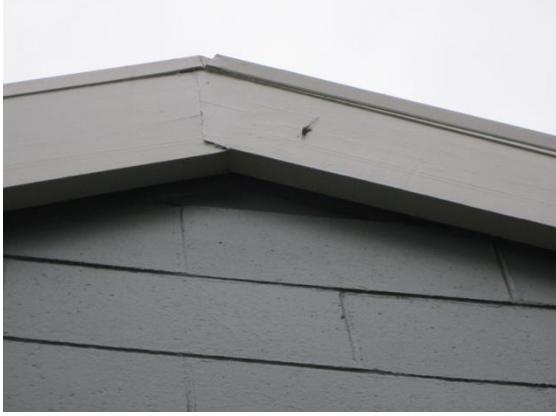
Photo 7: Dislodged or missing block near the apex.	Photo 8: Gap opening up between timber roof cladding elements

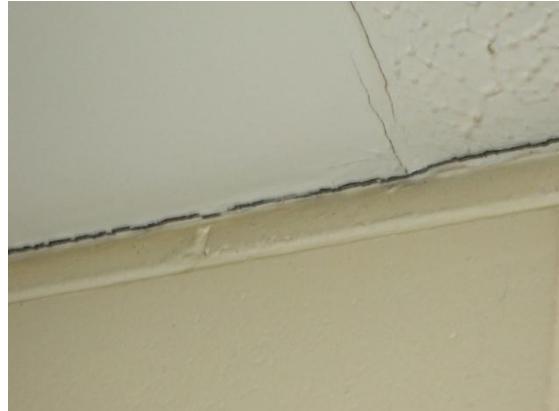
Photo 9: Gap opening up between masonry wall and ceiling cladding

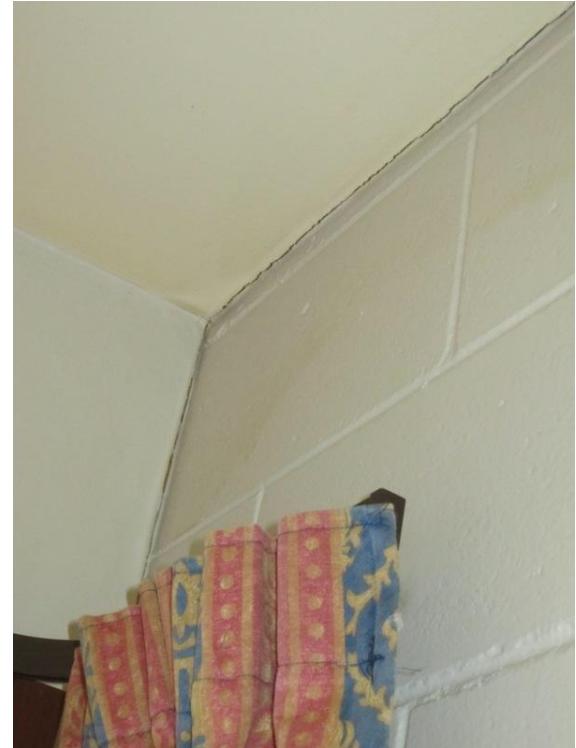
Photo 10: Gap opening up between masonry wall and ceiling cladding

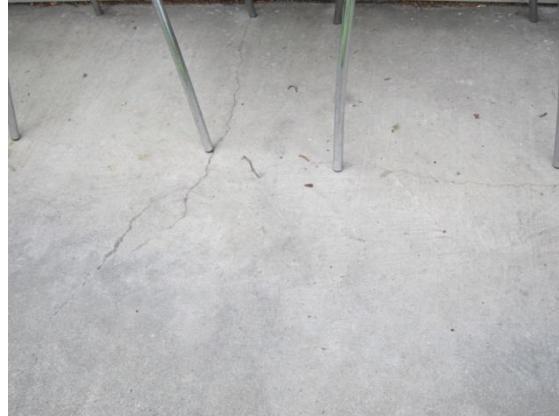
Photo 11: Hairline cracking in external concrete ground slab

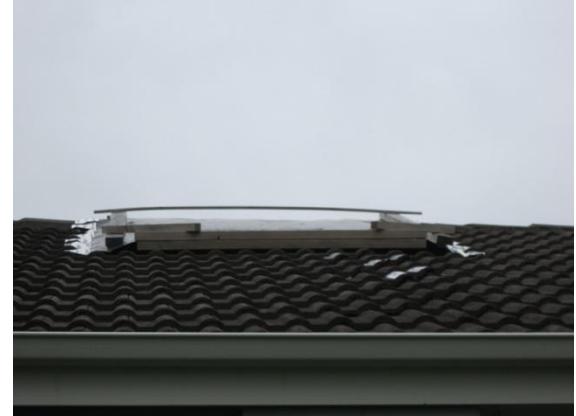
Photo 12: Suspected roof damage related to waterproofing

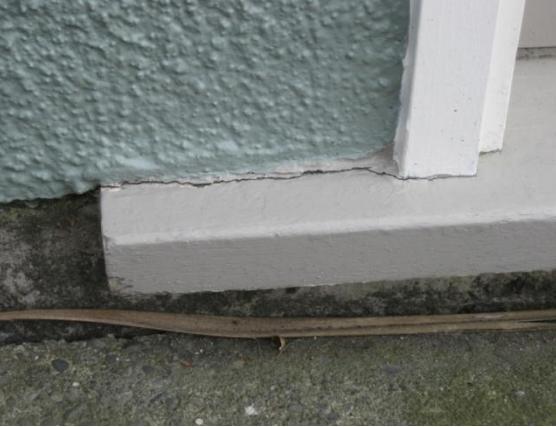
Photo 11: Cracking between timber doorstep and external masonry wall cladding	Photo 12: Damaged connection between masonry wall and downpipe. Not structural damage.

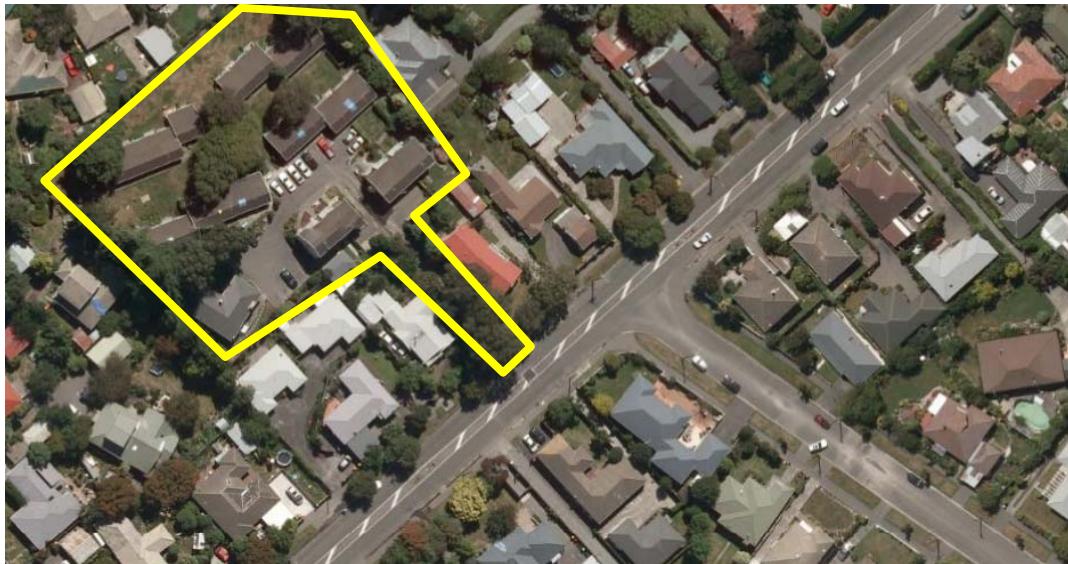
- **Figure 5 – Aerial photography from 24 Feb 2011 (courtesy of LINZ <http://maps.cera.govt.nz/advanced-viewer>) (site shown in yellow)**

It should be noted there is evidence of water on the driveway of Aorangi Court shown in the aerial photo. It is unclear if this material is liquefaction ejecta or water from a burst pipe. This was present between blocks A and G. Minor liquefied ejecta can be seen on Colwyn Street as seen in Figure 5.

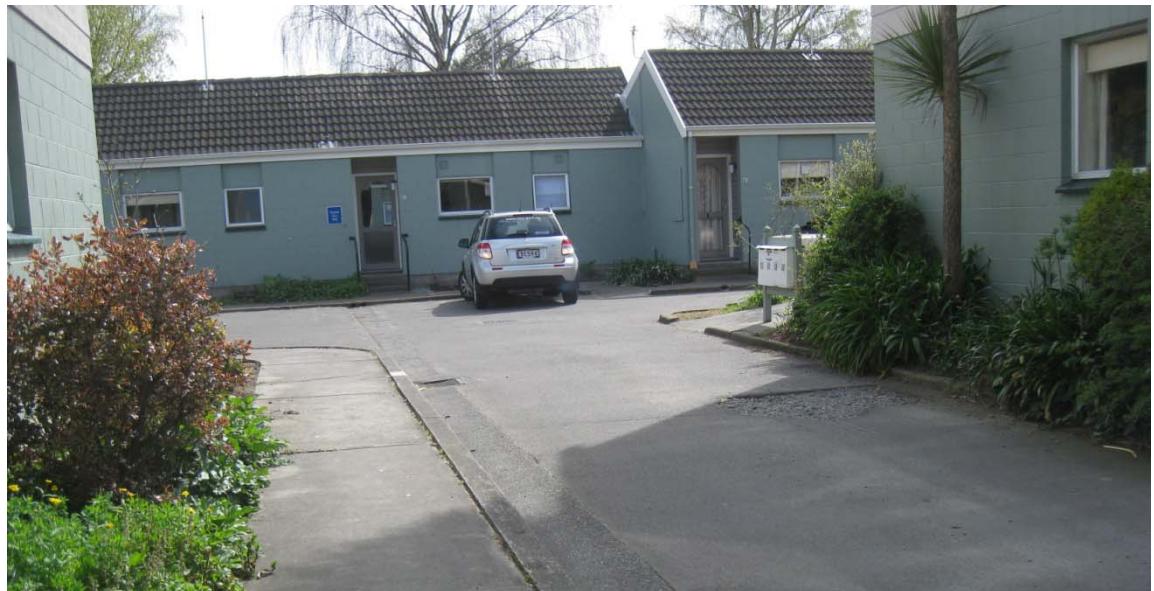
No significant land evidence of land damage was noted during the site walkover, while it is expected that ejecta would have been removed the ground appeared to be level with no notable undulations. There were two areas of the asphalt in the driveway that had been cut and gravel exposed, the holes are in the same location as where evidence of liquefaction was noted on the aerial photos. It is likely the holes have been cut to repair damaged underground utilities.

▪ **Figure 8 - Overview of the block units on site, cut in asphalt to right of picture**
