Ataahua Domain Garage
Quantitative Engineering
Evaluation

Functional Location ID: PRK 3672 BLDG 002

Prepared for:
Christchurch City Council

Date: 10 April 2014

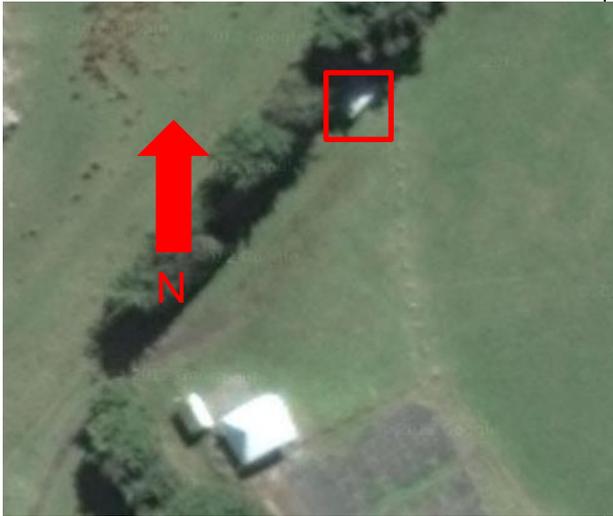
<p>Aerial photograph of the Ataahua Domain Garage.</p>

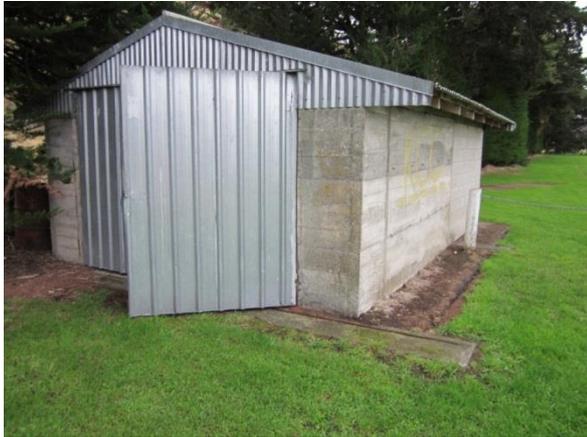
<p>Building south elevation.</p>

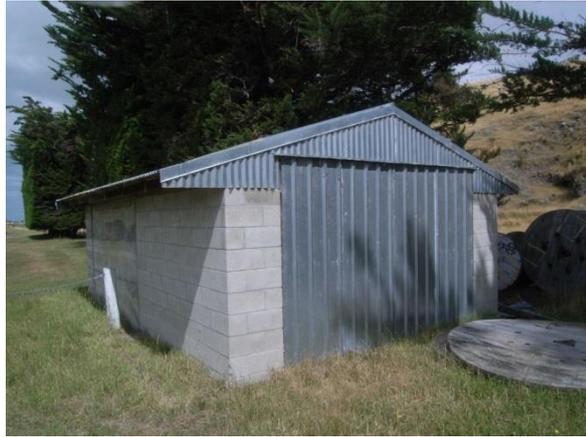
Building southern elevation.

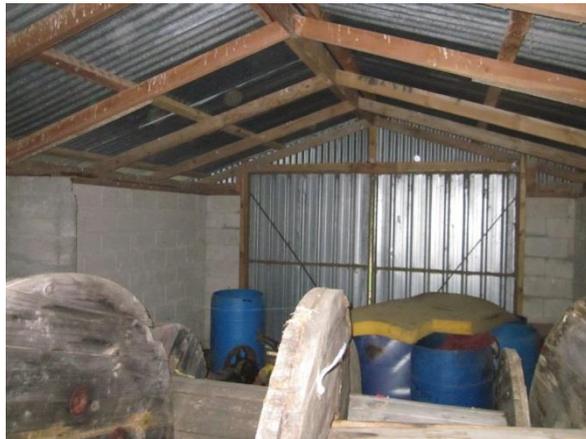
Inside building

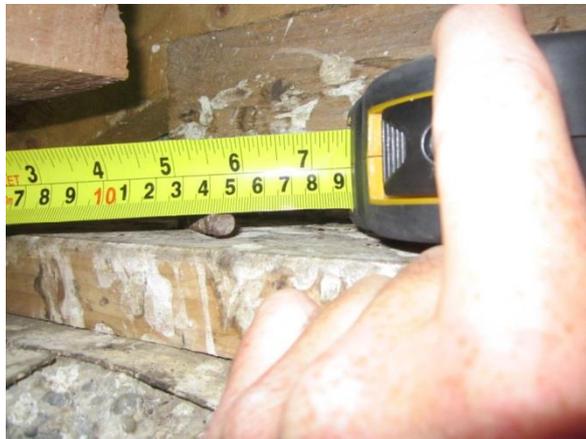
Typical connection from top plate to walls.
