Pump Shed  
Qualitative Engineering Evaluation

**Reference:** 231559  
**Prepared for:**  
Christchurch City Council

Functional Location ID: PRK 2653 BLDG 001

Address: 31 Wairoa Street

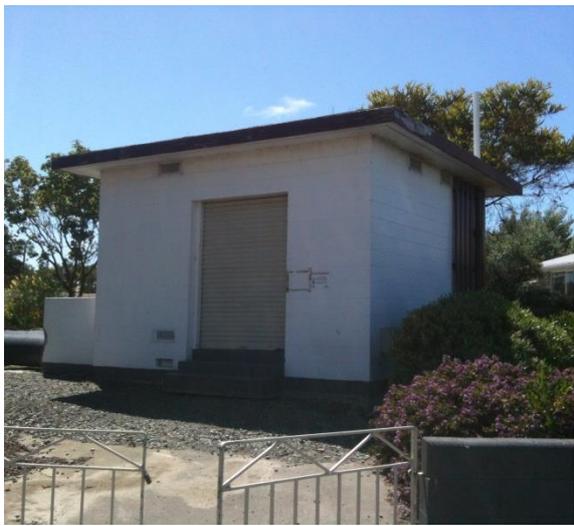
<p>Front elevation of building (western view)</p>

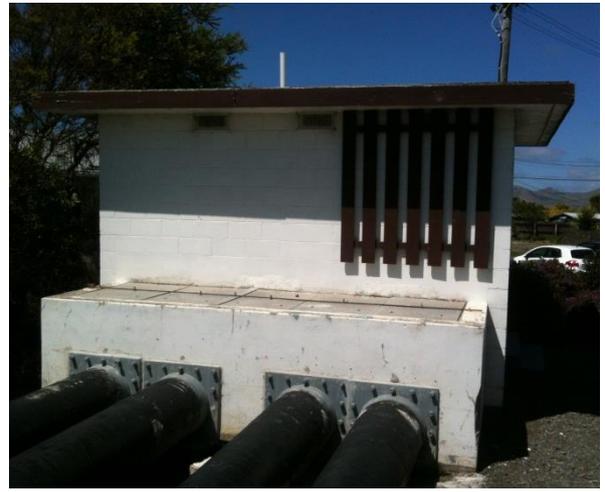
Side elevation of building (northern view)

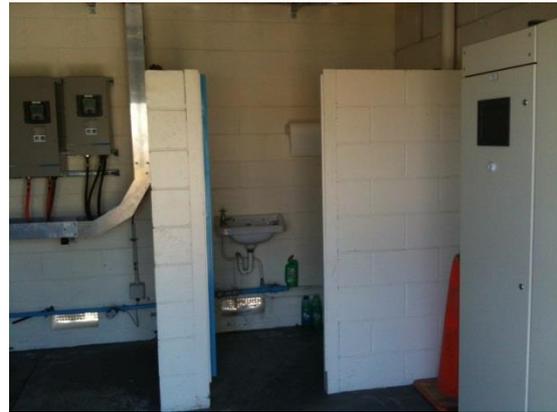
Inside view of Pump Station

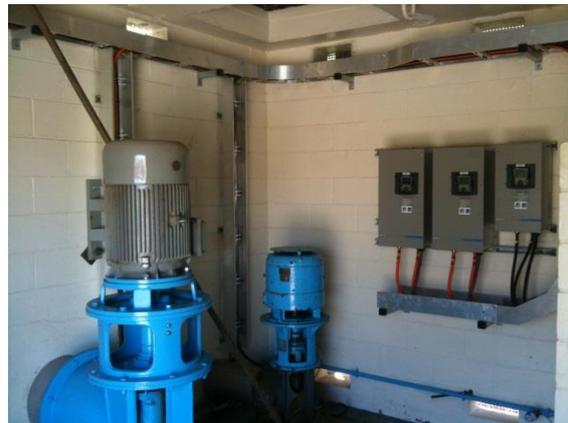
Inside view of Pump Station

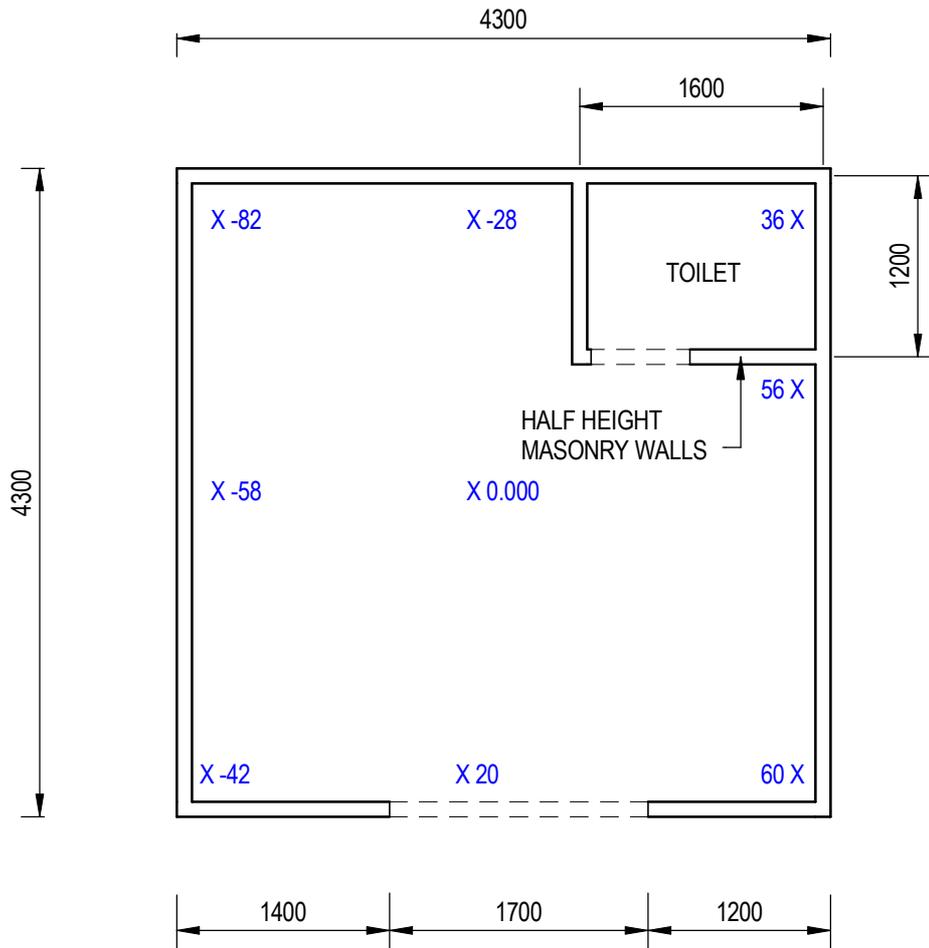
PROJECT
AVON RIVERBANK TRUE RIGHT PUMP SHED
TITLE
LEVEL SURVEY

After completing a levels survey of the building it was found that the Pump Shed was sloping downwards from the south end to the north end (towards the Avon River). The maximum slope was found to be 2.74% which is outside of the recommended tolerances.

The building itself has performed very well during the Canterbury earthquake sequence as shown by the lack of structural damage observed. The only area of concern is the slope of the building which exceeds DHB guidelines. As the building is located in the Red Zone, **a geotechnical investigation is currently not considered necessary** as the land is known to be prone to earthquake damage.
