Women's Toilet Avonhead Cemetery
PRK 0217 BLDG 004
Detailed Engineering Evaluation
Qualitative Report
Version Final

140 Hawthornden Road

Christchurch City Council

Date
20th May 2013

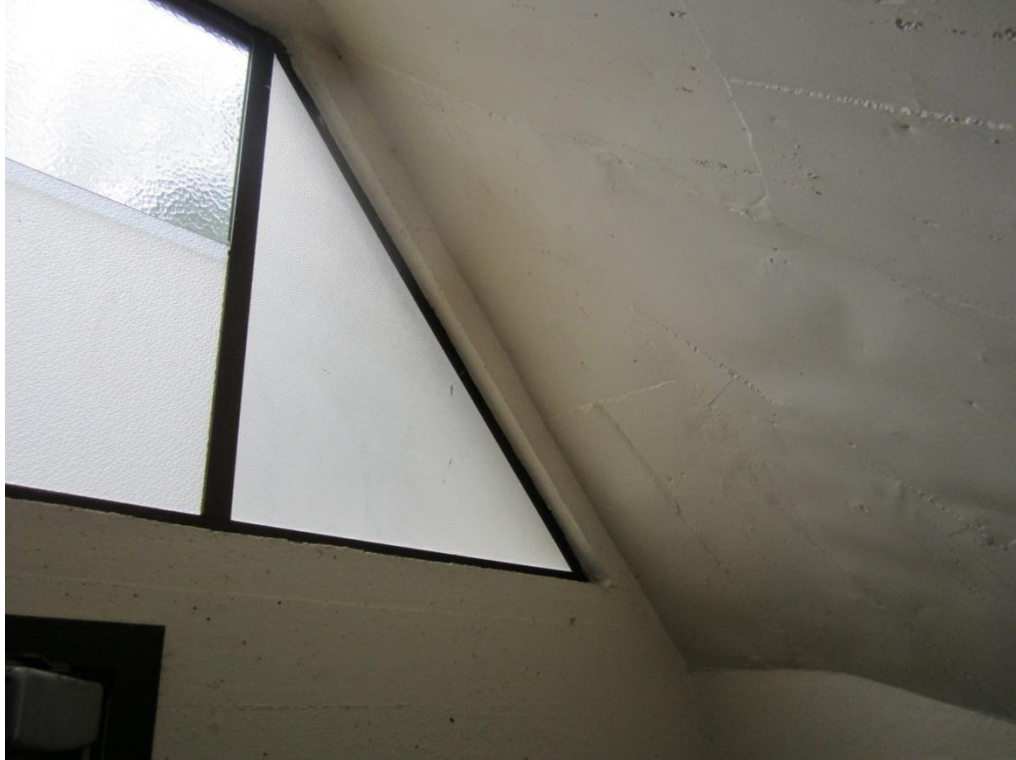
Photograph 5 View of window and roof slab soffit.
