Ex Memorial Room Avonhead Park Cemetery

**Detailed Engineering Evaluation
Quantitative Assessment Report**

Ex Memorial Room
Avonhead Park Cemetery
PRK 0217 BLDG 005 EQ2

Detailed Engineering Evaluation
Quantitative Report - Summary
Final

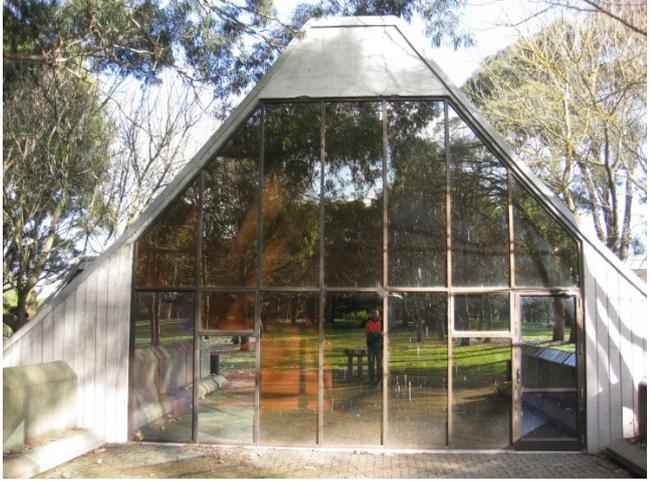
Ex Memorial Room, Avonhead Park Cemetery		
No.	Item description	Photo
1.	Front Elevation

No damage to the above-ground, exterior structure was noted. Other parts of the structure were unable to be investigated.
