**Avonhead Park Cemetery
Sextons Buildings
PRK 0217 BLDG 001 EQ2**

Detailed Engineering Evaluation

Quantitative Assessment Report

Avonhead Park Cemetery Sextons Buildings Quantitative Assessment Report

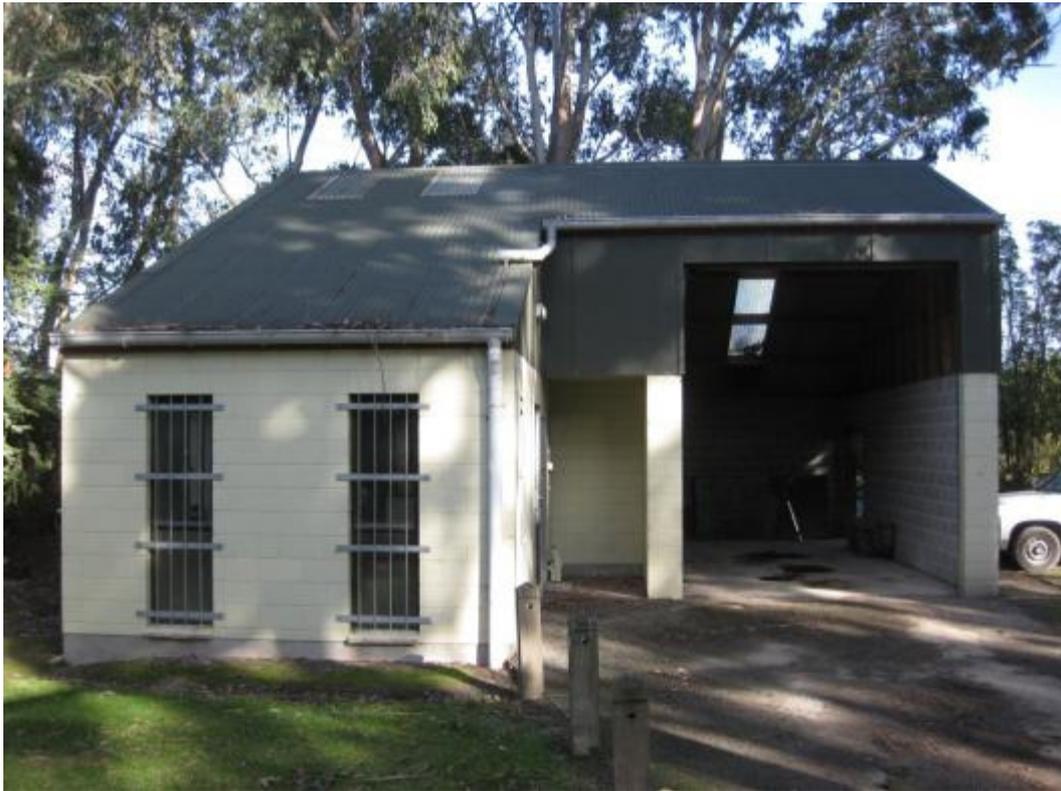
Photo 1: View of the building from north

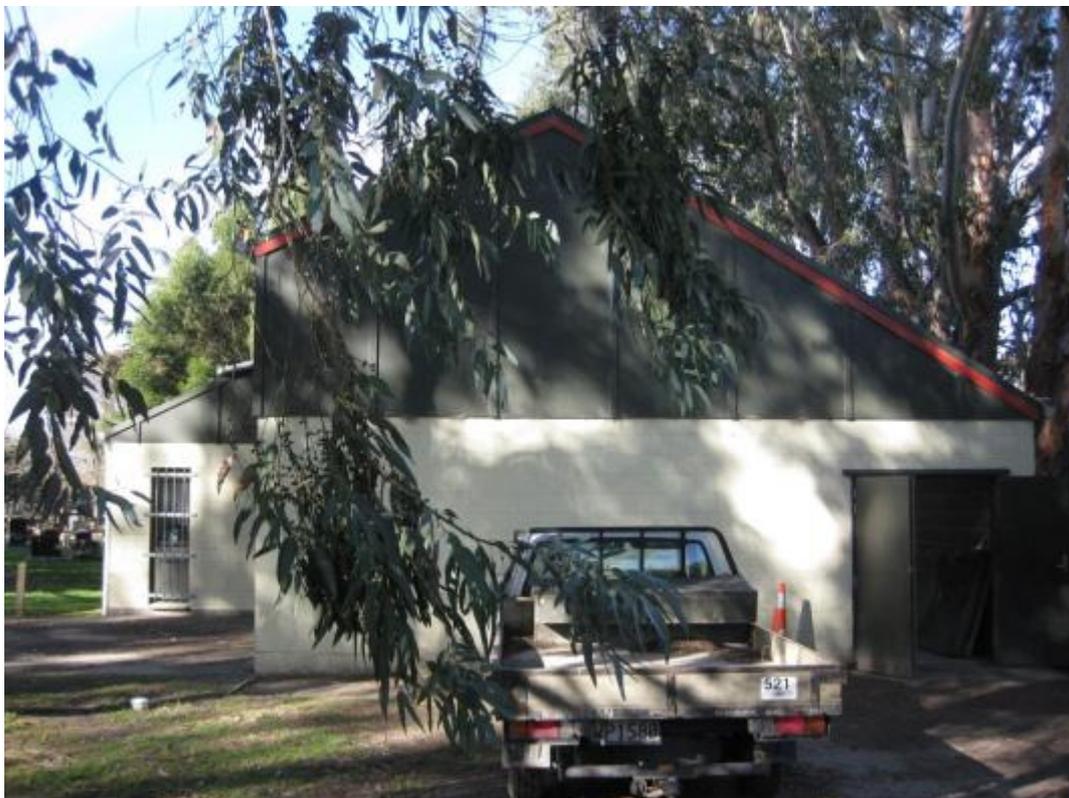
Photo 2: View of the building from west

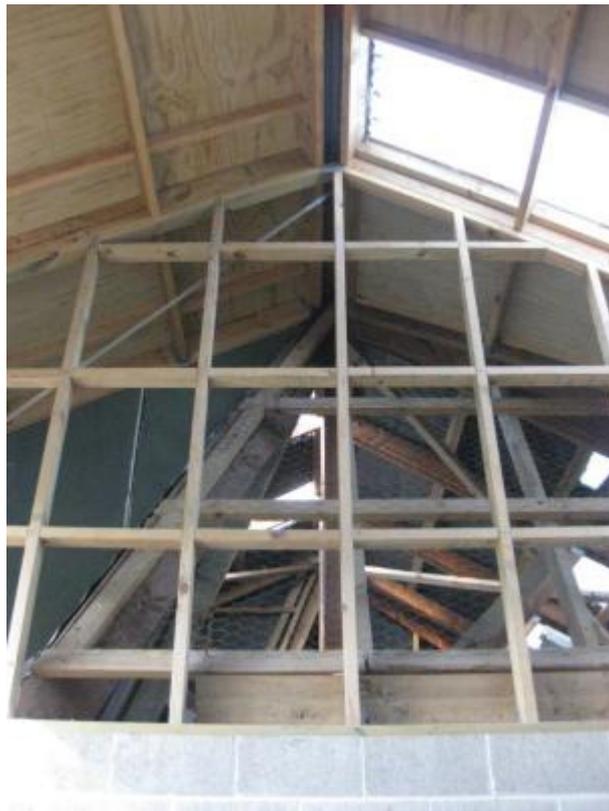
Photo 3: Ceiling diaphragm in extension

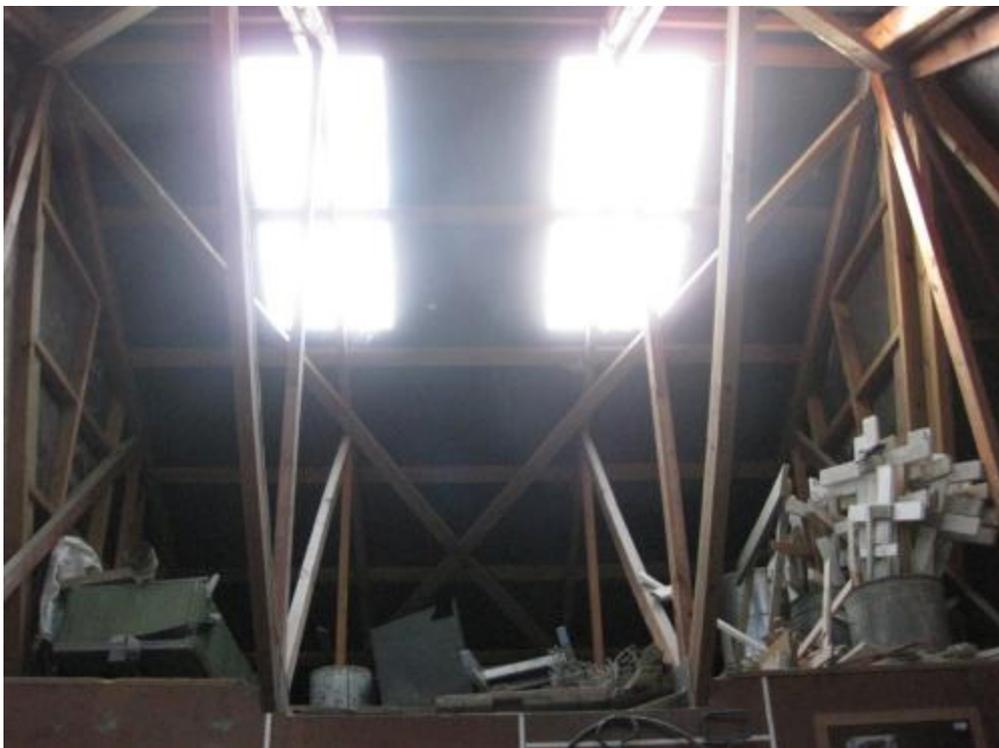
Photo 4: Roof frames and cross bracing of original building

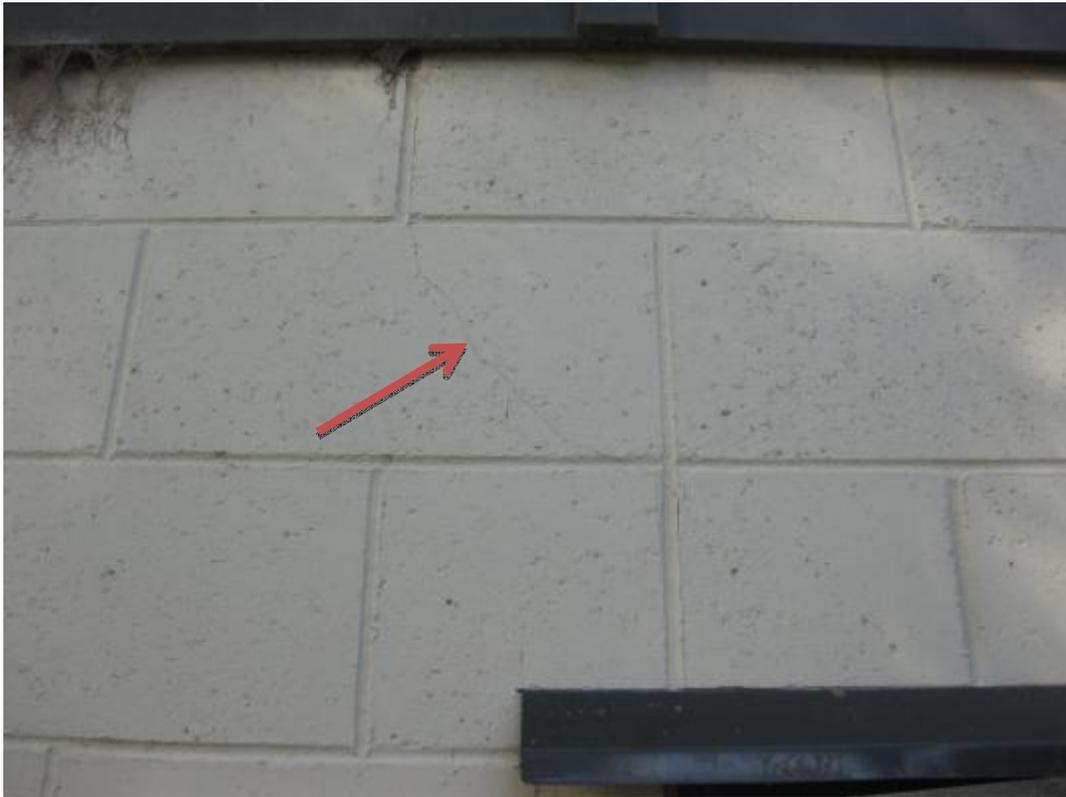
No major damage was identified. There is a minor crack in south side external wall above the door opening.

There is a minor crack at the door opening in the south side external wall.

Photo 5: Crack in the south side wall above the door opening

We recommend that only minor cracks in the masonry wall need be repaired.
