**Barrington Park Cricket Club Shed
PRK 1125 BLDG 003**

Detailed Engineering Evaluation
Quantitative Report
Version FINAL

270 Barrington Street, Spreydon,
Christchurch

Christchurch City Council

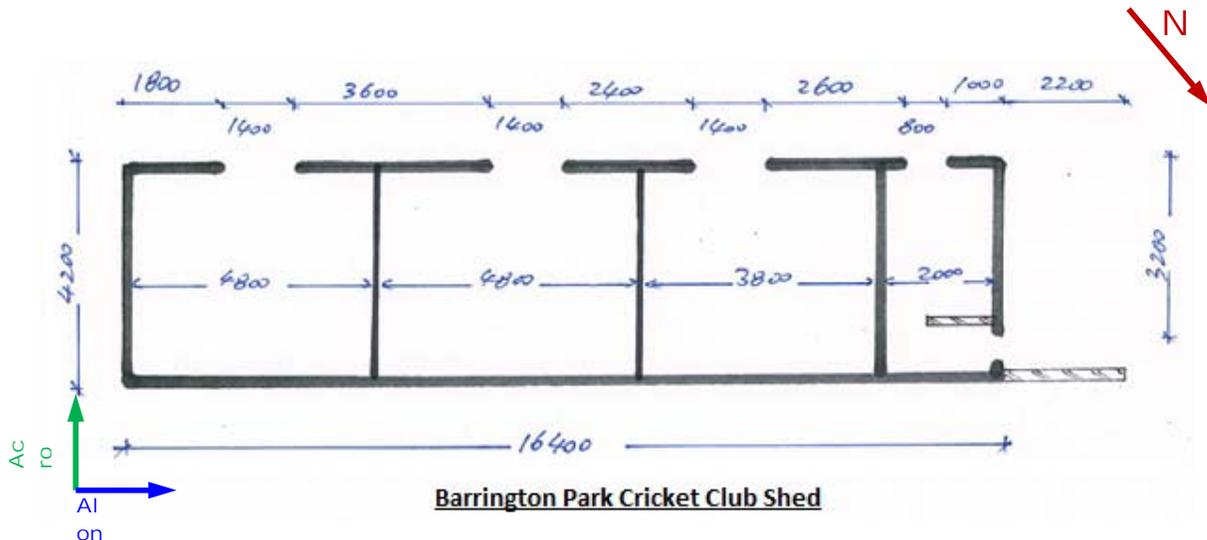
Figure 2: Plan Sketch Showing Key Structural Elements

The building measures approximately 16.4 m long by 4.2 m wide by average 3.0 m high. It is rectangular in plan, with a gross floor area of approximately 69 m², as shown in Figure 2.

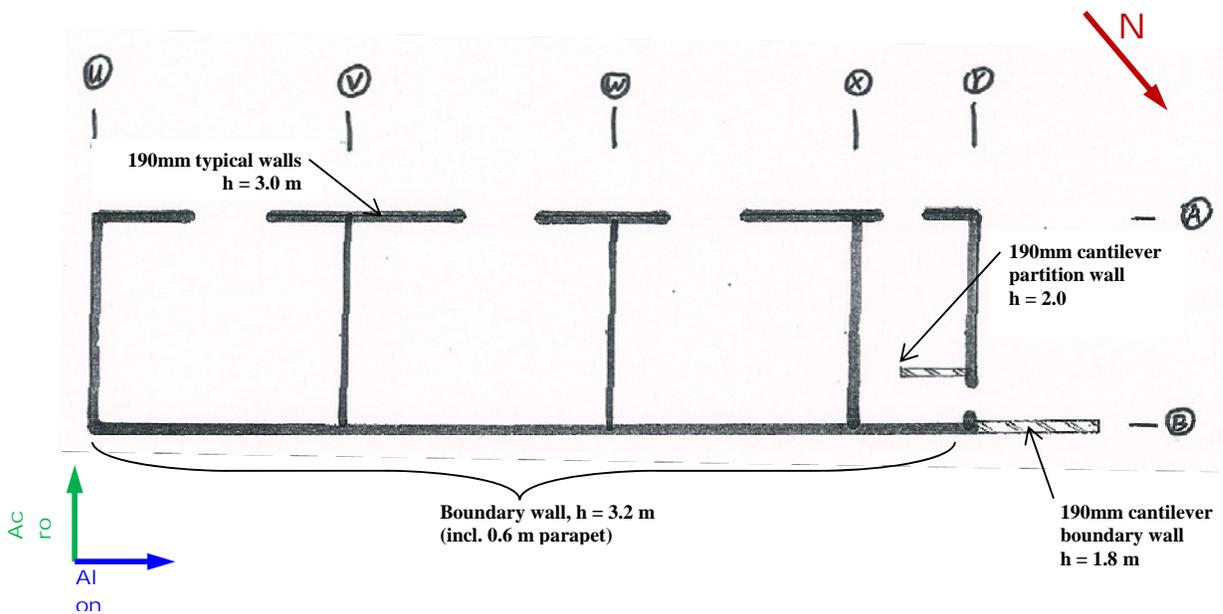
Figure 4: Building Plan

The overall seismic capacity for the Barrington Park Cricket Club Shed building assessed in accordance with NZSEE guidelines is 20% NBS. The 20% NBS represents the out-of-plane seismic capacity of the cantilevered partition walls (as shown in Figure 4). The in-plane seismic capacity of the building has been assessed as over 100% NBS in the along direction and 58% NBS in the across direction. The out-of-plane seismic capacity of the simply supported walls has been assessed as 60% NBS and 42% NBS for the parapet on the eastern wall.

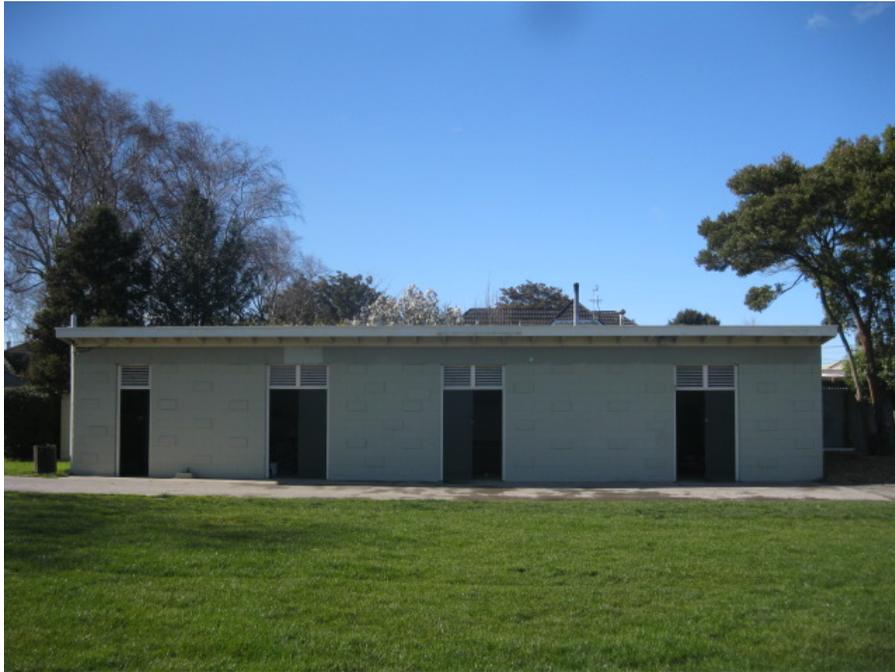
Photograph 1: West elevation (front)

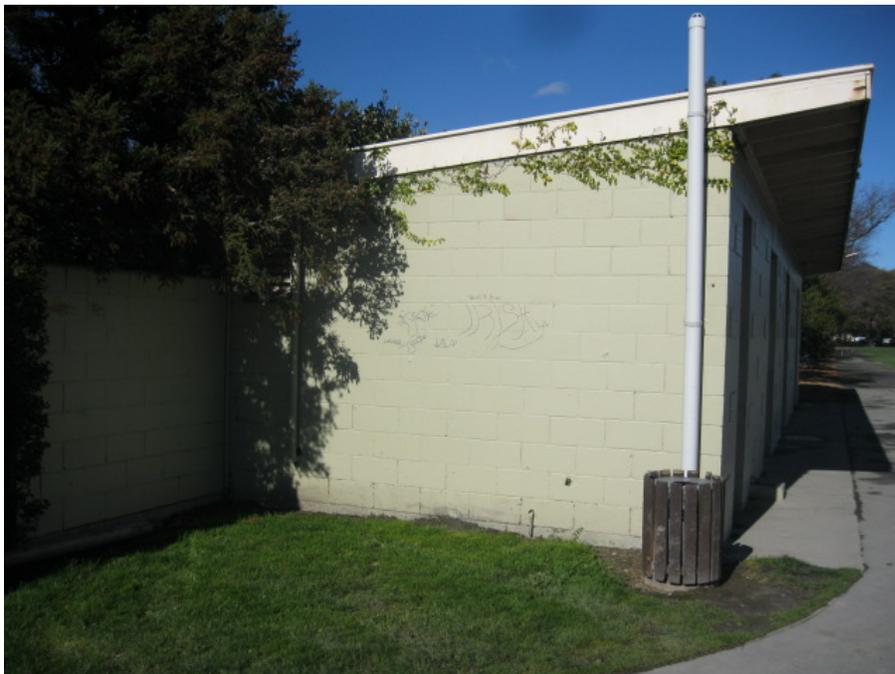
Photograph 2: North elevation

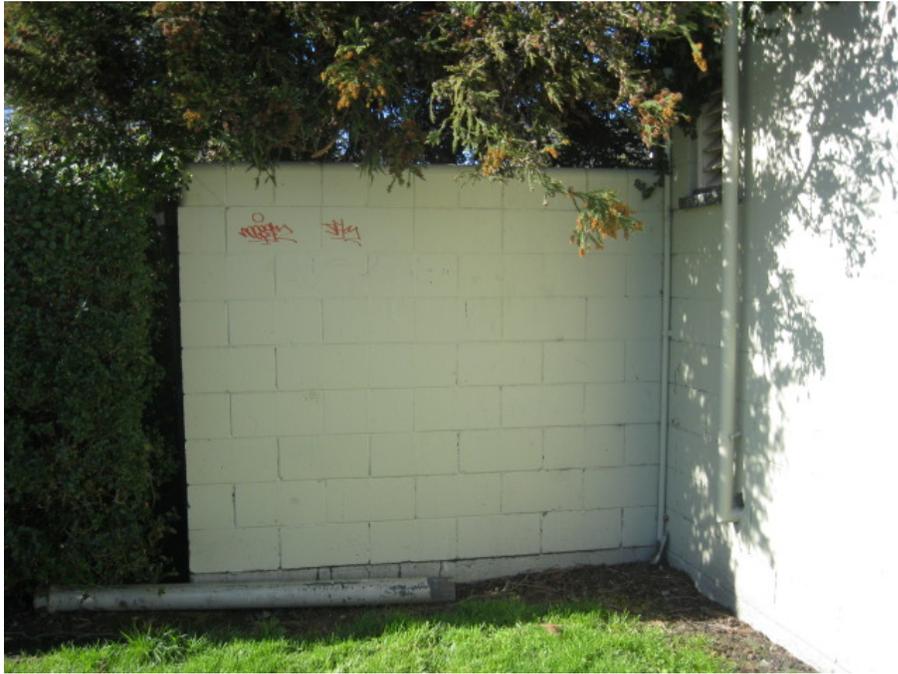
- ▶ Stepped cracking to the boundary wall on the northeast side;
- ▶ Cracking to concrete floor outside the front of the building;

Photograph 3: Boundary wall

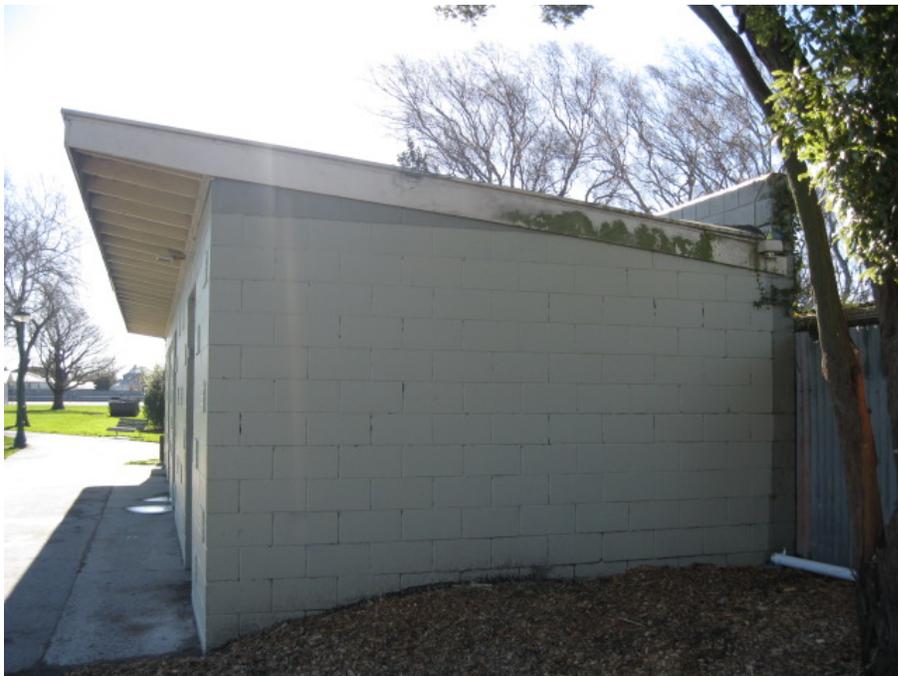
Photograph 4: South elevation

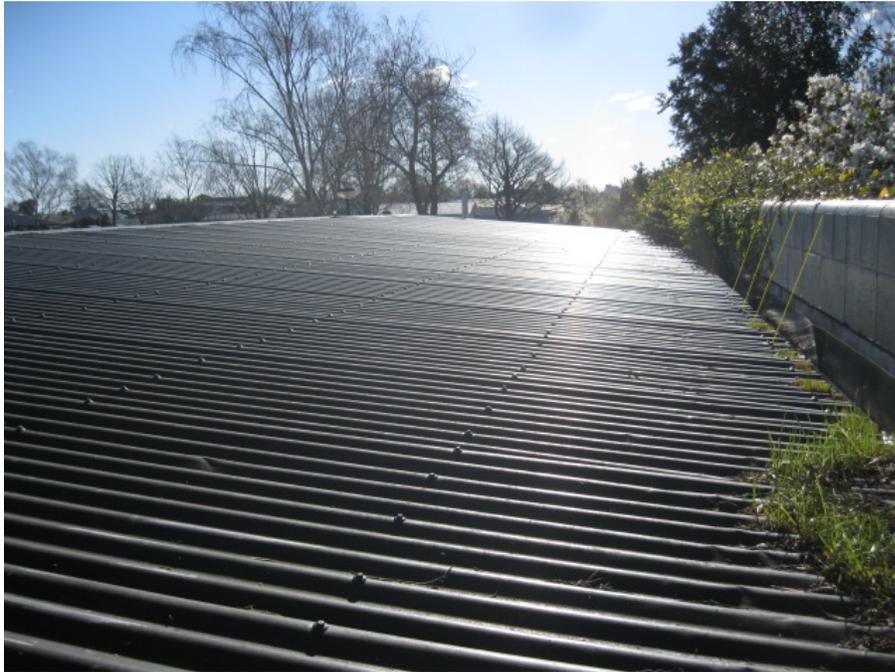
Photograph 5: Corrugated metal roofing

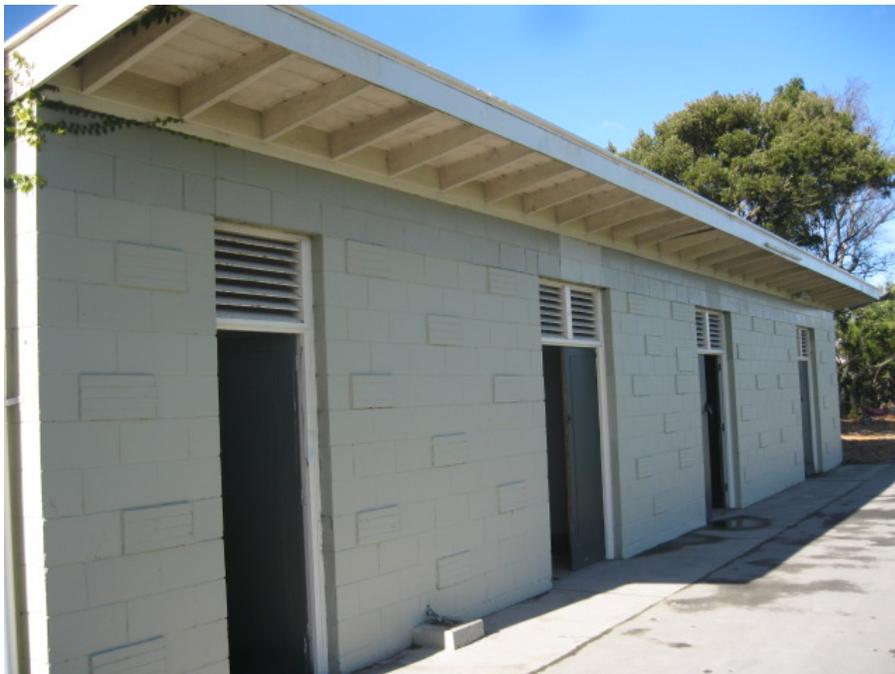
Photograph 6: Mono pitched roof and the front elevation

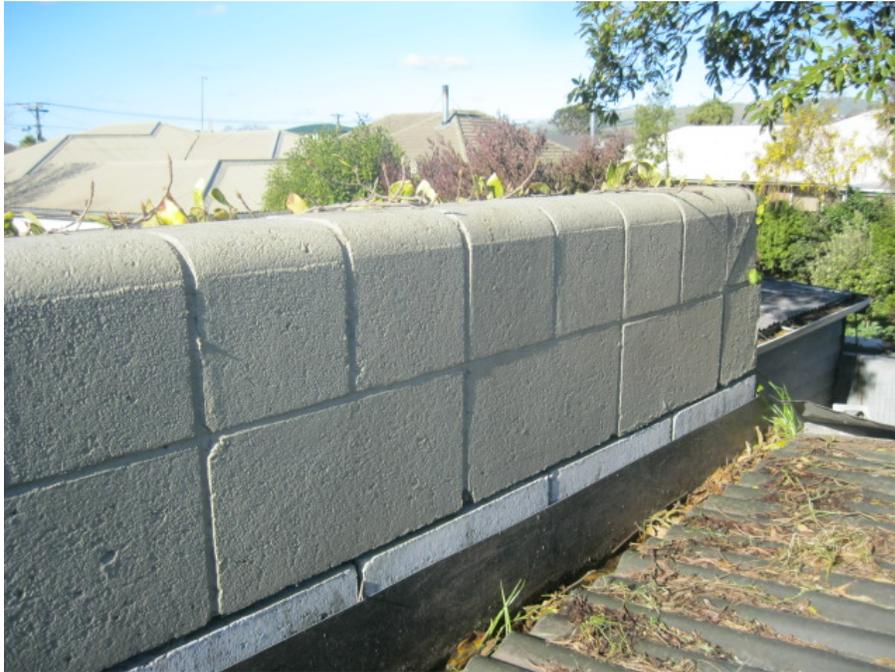
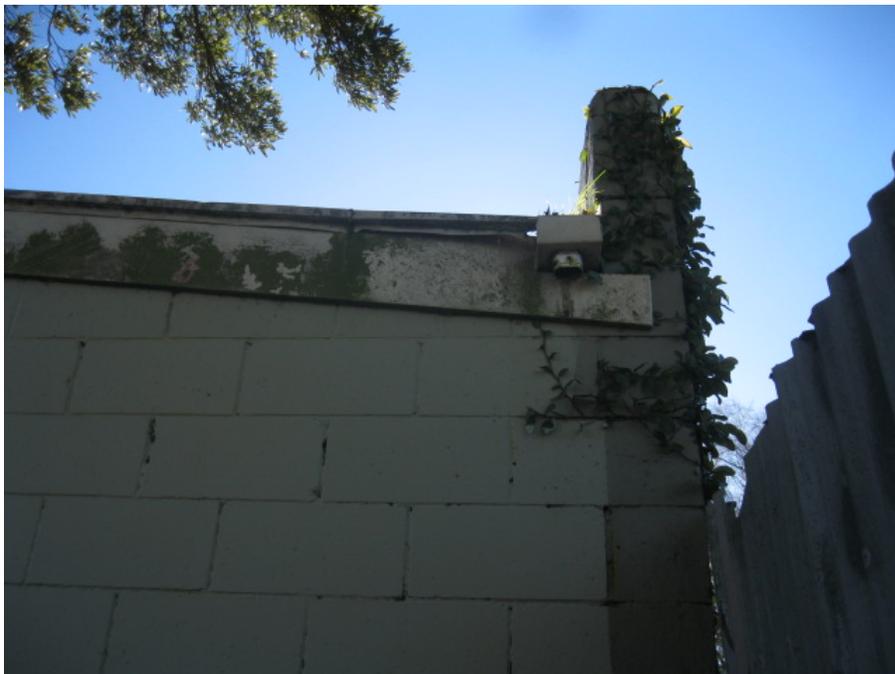
Photograph 7: Blockwork Parapet on the eastern boundary wall

Photograph 8: As above

The recent seismic activity in Christchurch has only caused minor damage to the building, with minor cracking in the concrete blockwork masonry walls the only damage noted. However the building has been assessed as having a seismic capacity of less than 34% NBS following a Quantitative Detailed Engineering Evaluation, therefore the building should be strengthened to minimum of 34% NBS to comply with Christchurch City Council's "Earthquake Prone, Dangerous and Insanitary Buildings Policy (2010)". However, GHD recommends strengthening options to the blockwork walls should be explored and implemented to bring the %NBS of the building to a minimum of 67% as recommended by the NZSEE guidelines.

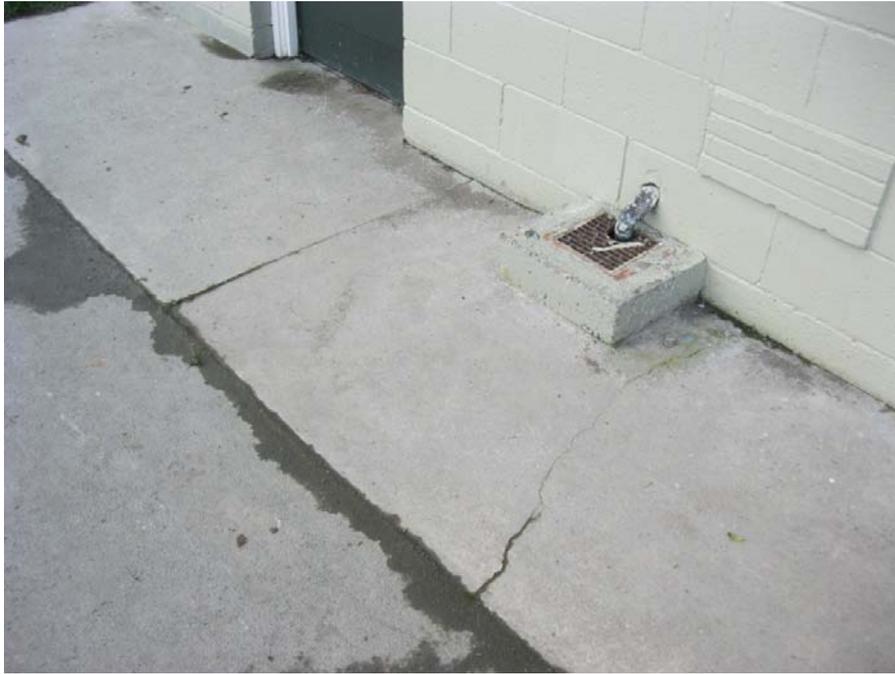
This damage observed is not considered to have an impact on the seismic capacity of the building. Refer photographs of the damage in Appendix A.

Photograph 9: Minor cracking to the exterior concrete floor slab

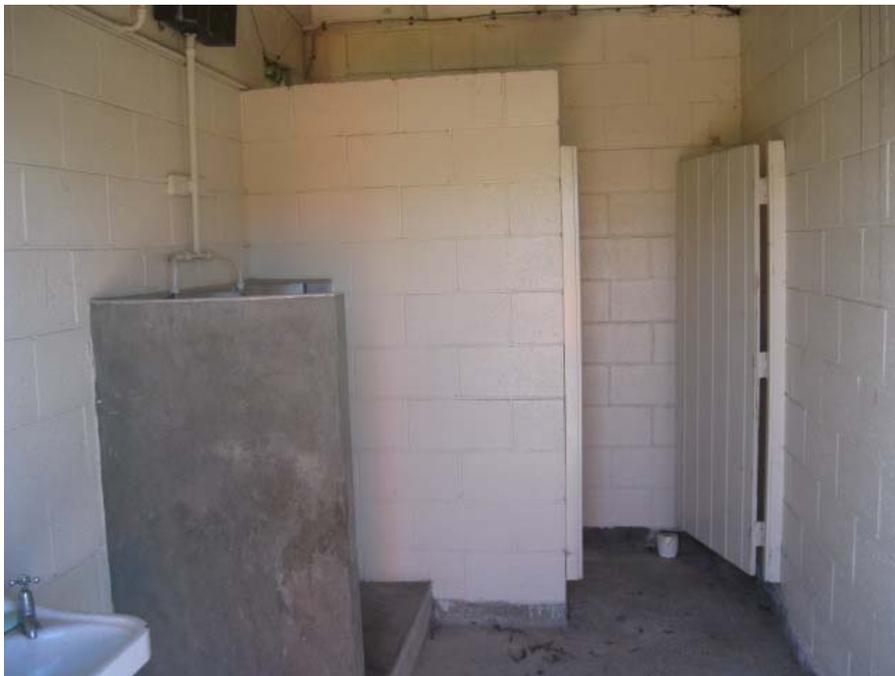
Photograph 10: Cantilever partition wall in the toilet area

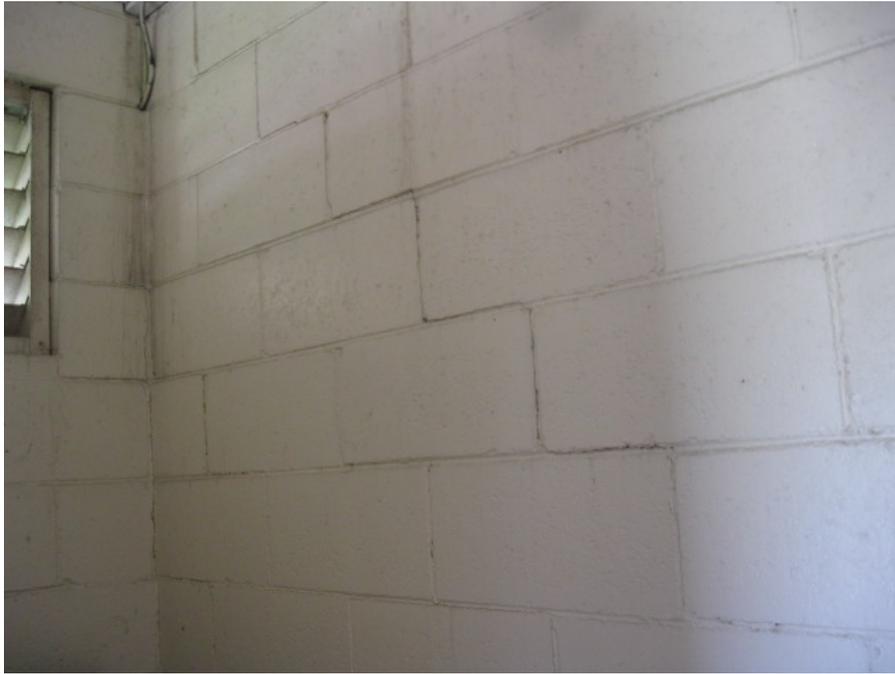
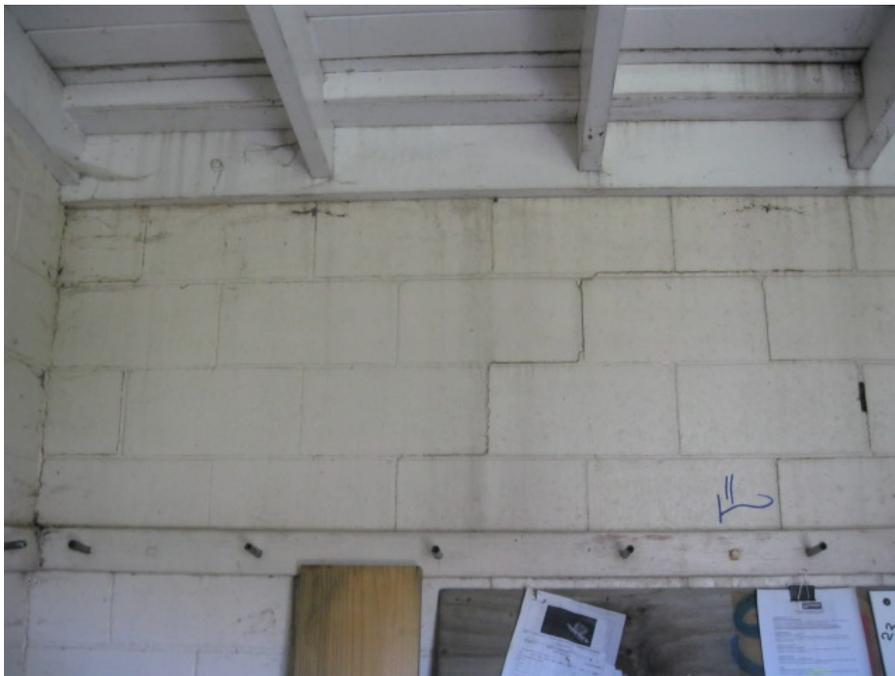
Photograph 11: Typical stepped cracking on the eastern wall

Photograph 12: As above

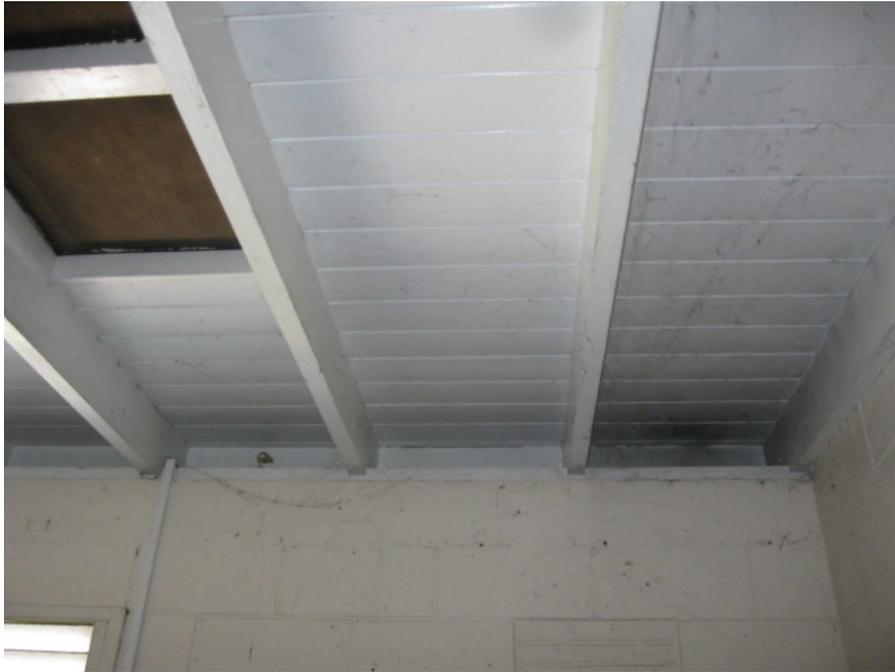
Photograph 13: Timber sarking

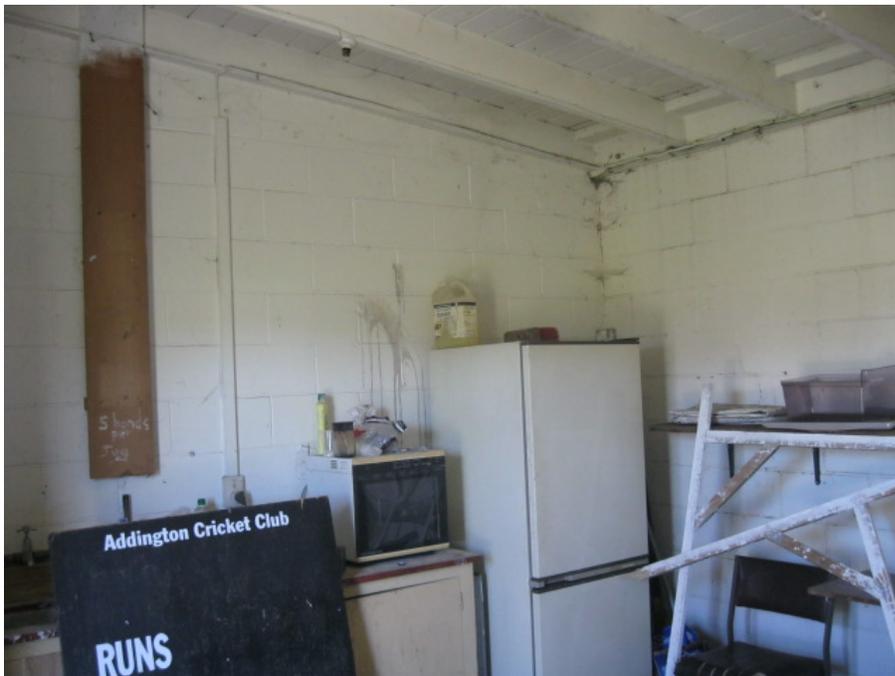
Photograph 14: Typical interior view
