**Birdlings Flat  
Reserve Toilets  
PRK 3655 BLDG 002 EQ2**

**Detailed Engineering Evaluation**

**Quantitative Assessment Report**

Date: November 2012  
Reference: 6-QUCC1.43  
Status: Final

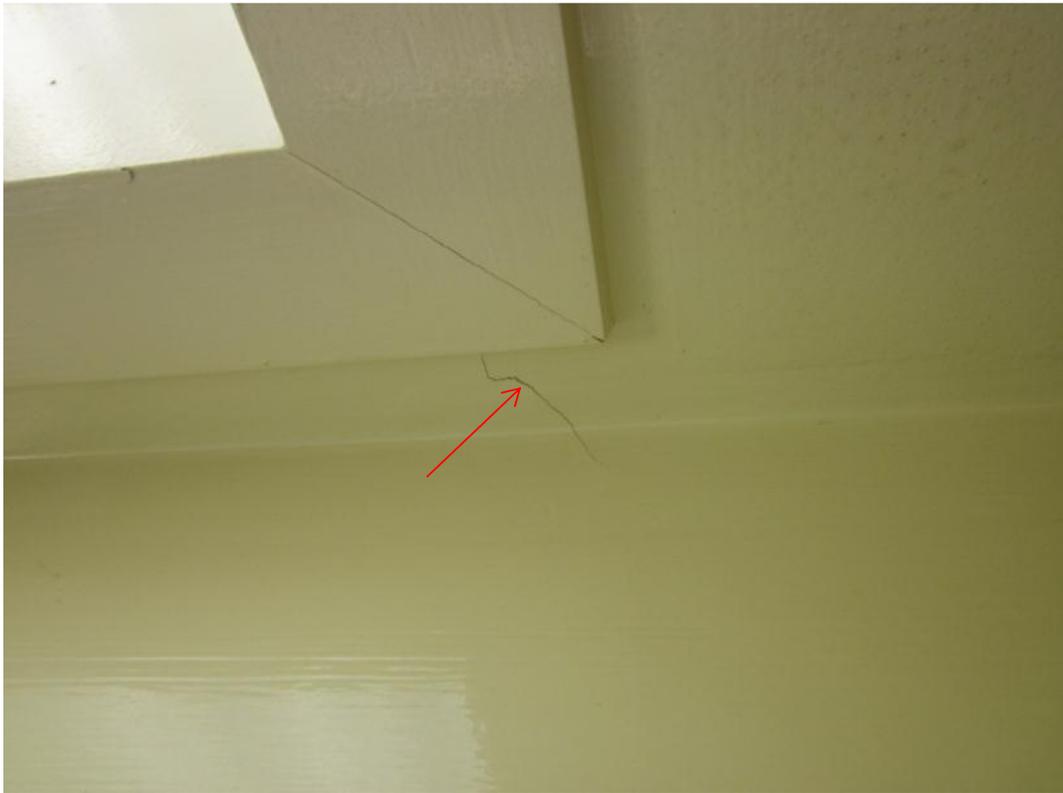
No major damage was identified. Minor wall lining cracks were observed at internal door openings, a crack in the corner of a wall and a crack in the ceiling adjacent to the roof light.

**Photo 3: Crack in the roof ceiling**

We recommend that the minor cracks in the wall linings are repaired.

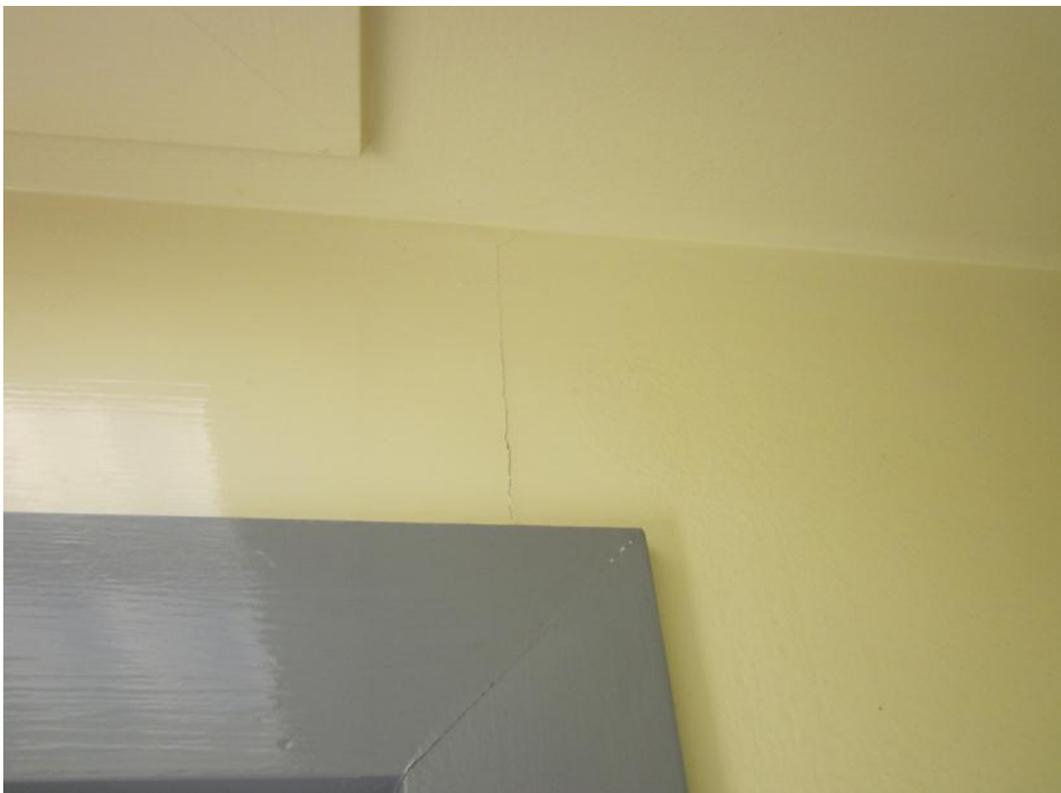
**Photo 4: Crack above the door frame**

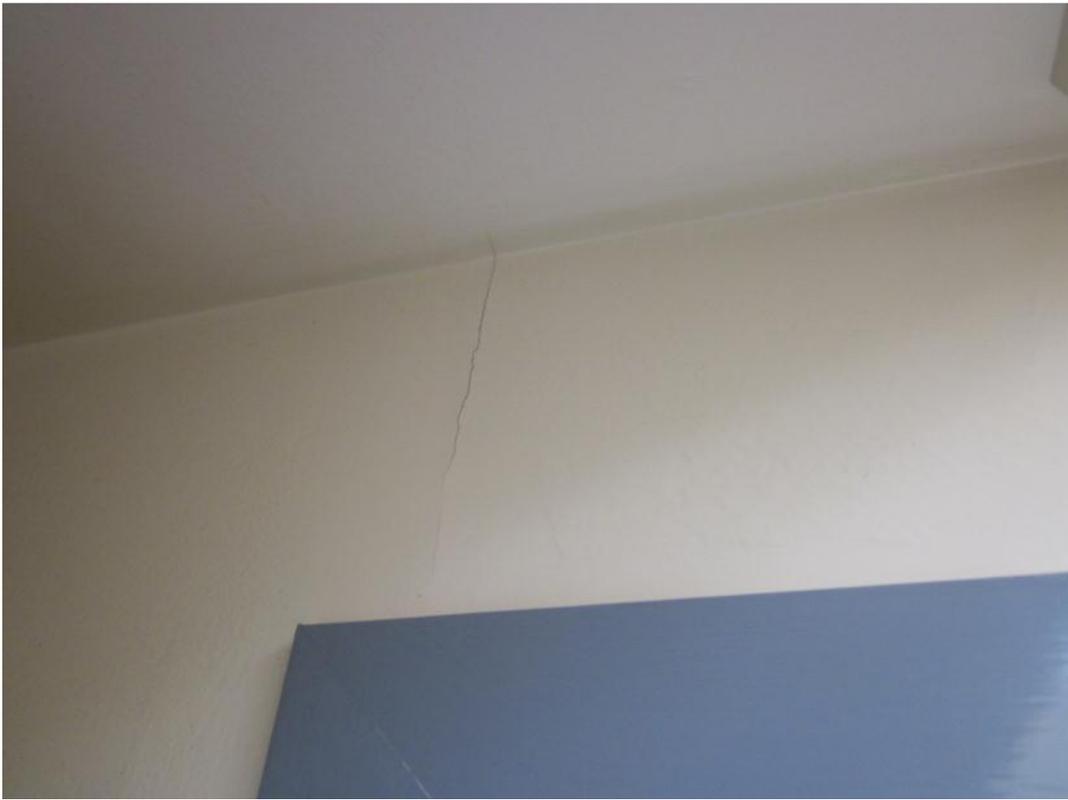
**Photo 5: Crack in the wall above the door frame**

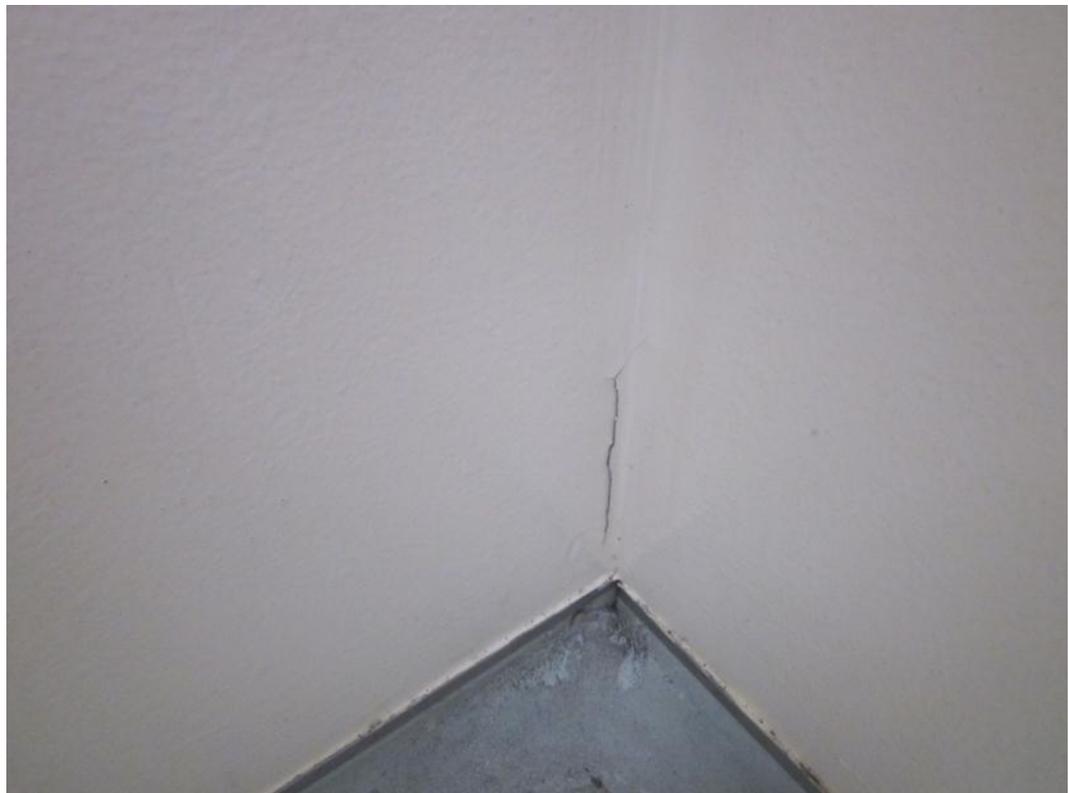
**Photo 6: Crack in the corner wall at floor level**

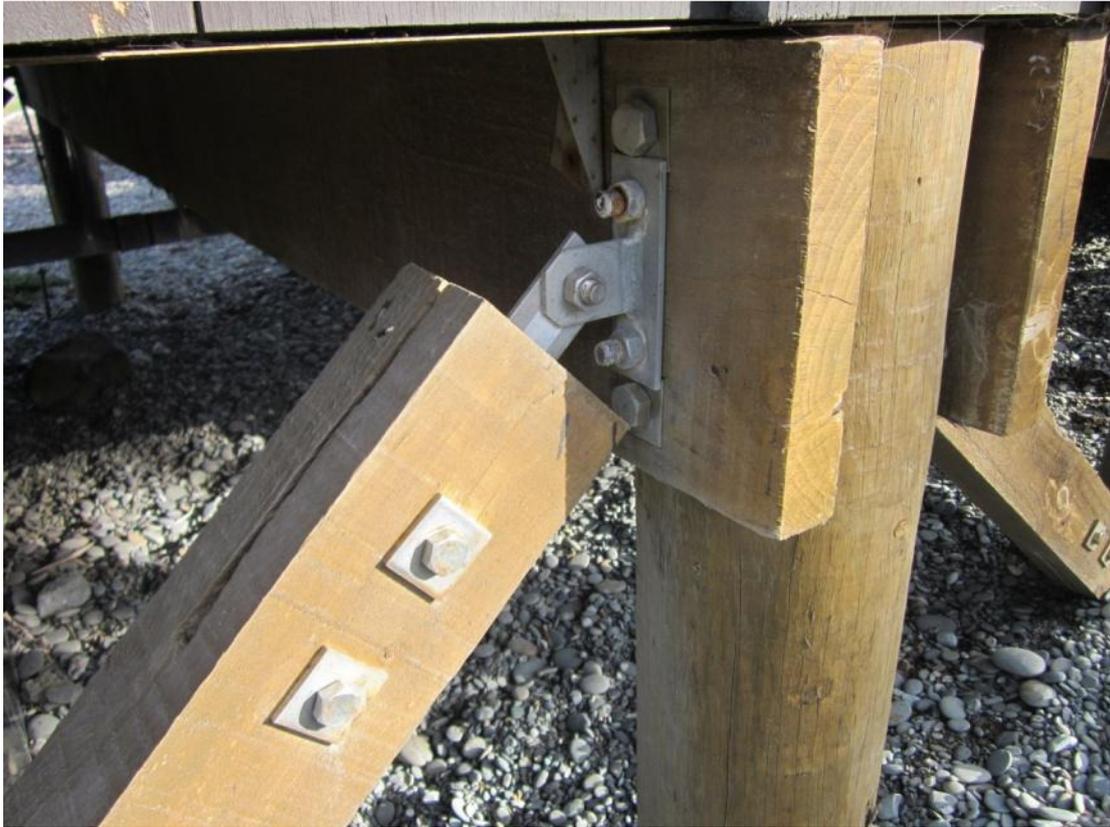
The subfloor has been braced in one direction by diagonal timber bracing bolted to proprietary steel pole cleats, and in the other direction by embedded timber piles and timber portal action.

**Photo 7: Subfloor bracing**
