Birdsey Reserve Lockup Shed
PRK 1742 BLDG 003 EQ2
Detailed Engineering Evaluation
Quantitative Report
Version FINAL

40 Bridle Path Road, Heathcote Valley,
Christchurch

Christchurch City Council

Date
05 April 2013

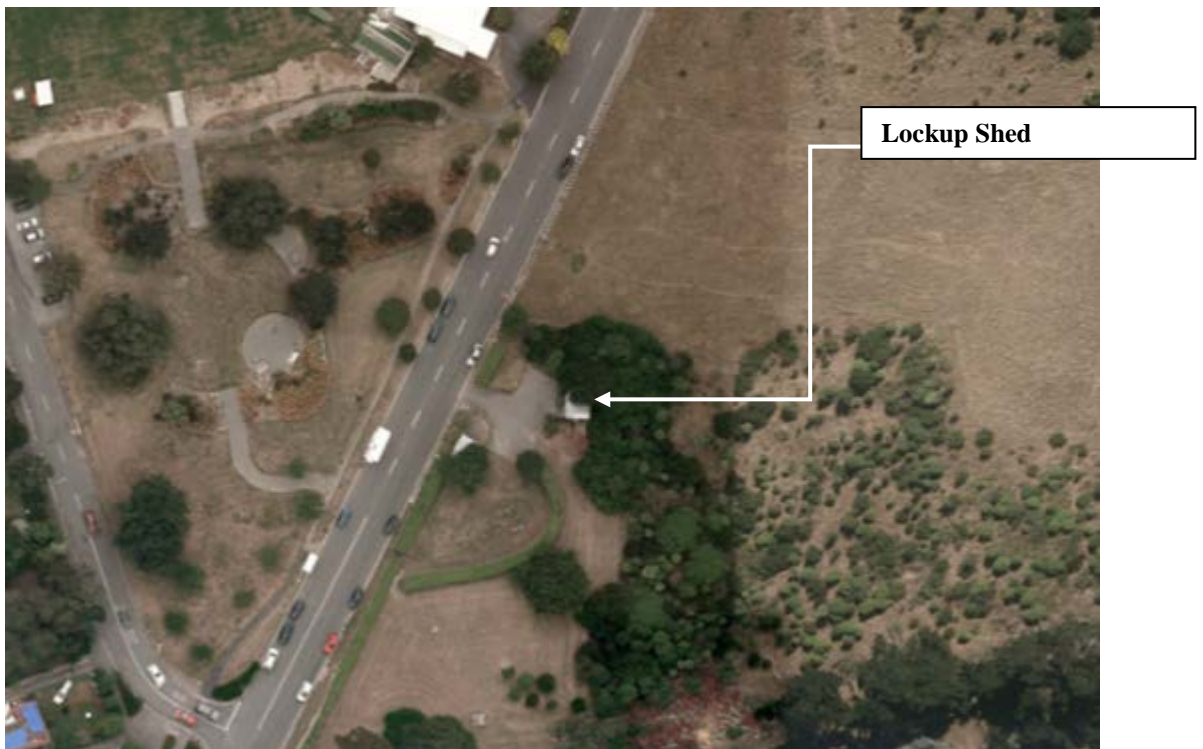
Figure 3 Post February 2011 Earthquake Aerial Photography ²

Aerial photography taken following the 22 February 2011 earthquake shows no signs of liquefaction outside the building footprint or adjacent to the site, as shown in Figure 3.

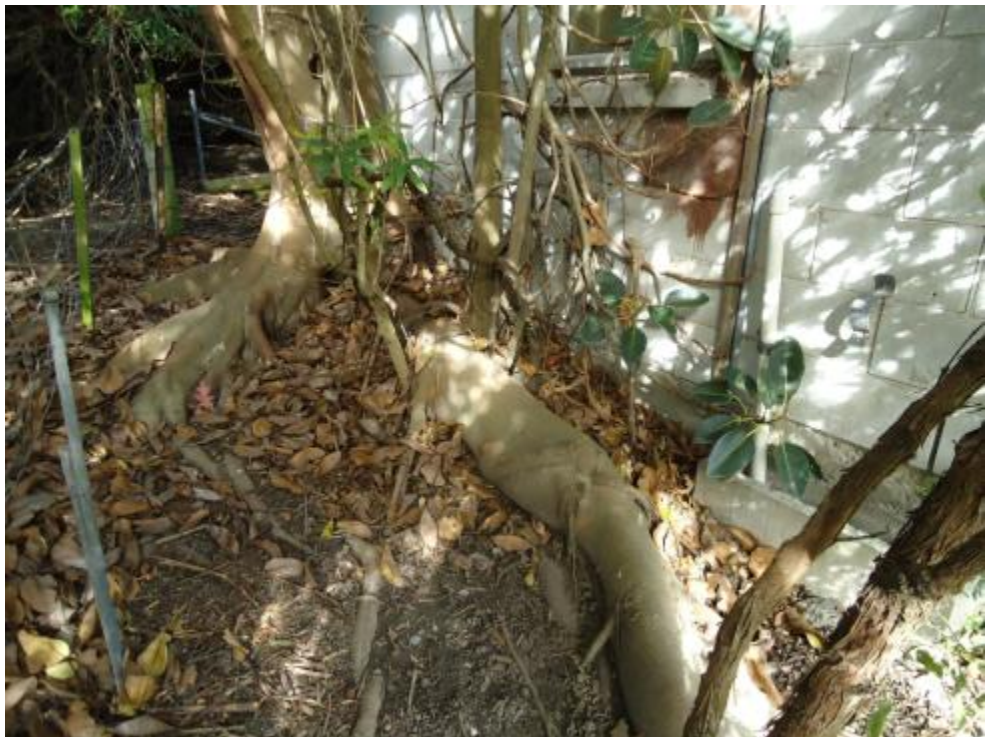
Photograph 4: Northern wall damaged by tree roots.

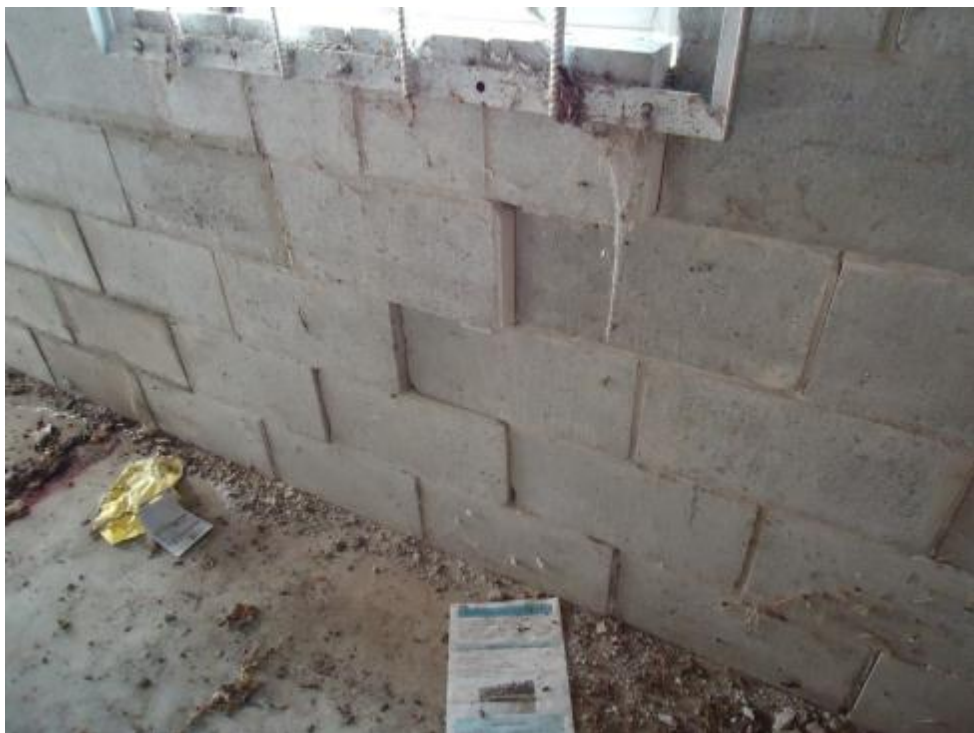
Significant structural damage has occurred to the western and northern walls of the building. Displacement of the walls around the windows has occurred which constitutes a failure of these structural elements (Refer to photographs 12 and 13).

Following a detailed assessment, the Lockup Shed has been assessed as achieving 43 %NBS excluding any structural damage. Significant damage to the walls of the north-west corner is considered to constitute a failure of these structural elements and as such they have achieved 0% NBS. Under the New Zealand Society for Earthquake Engineering (NZSEE) guidelines the lockup shed is considered to be an Earthquake Prone building.

Photograph 12: Interior view of displacement to western wall by window adjacent to the north western corner of the building.

As the Lockup Shed has been assessed to have a %NBS less than 33% NBS, it is deemed to be Earthquake Prone. It is recommended that wall strengthening or replacement options be explored and implemented to bring the %NBS of the building up to a minimum of 67% NBS.

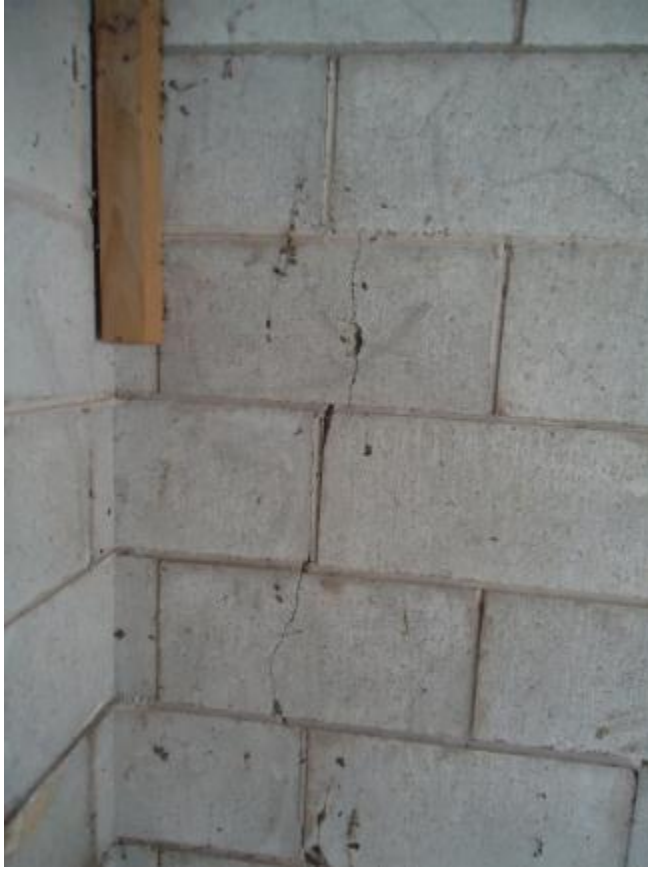
Photograph 13: Interior view of damage to north eastern wall.
