**Botanic Gardens Chemical Store**  
**PRK 1566 BLDG 037**  
Detailed Engineering Evaluation  
Qualitative Report  
Version FINAL

7 Rolleston Avenue, Christchurch

**Date**  
13 February 2014

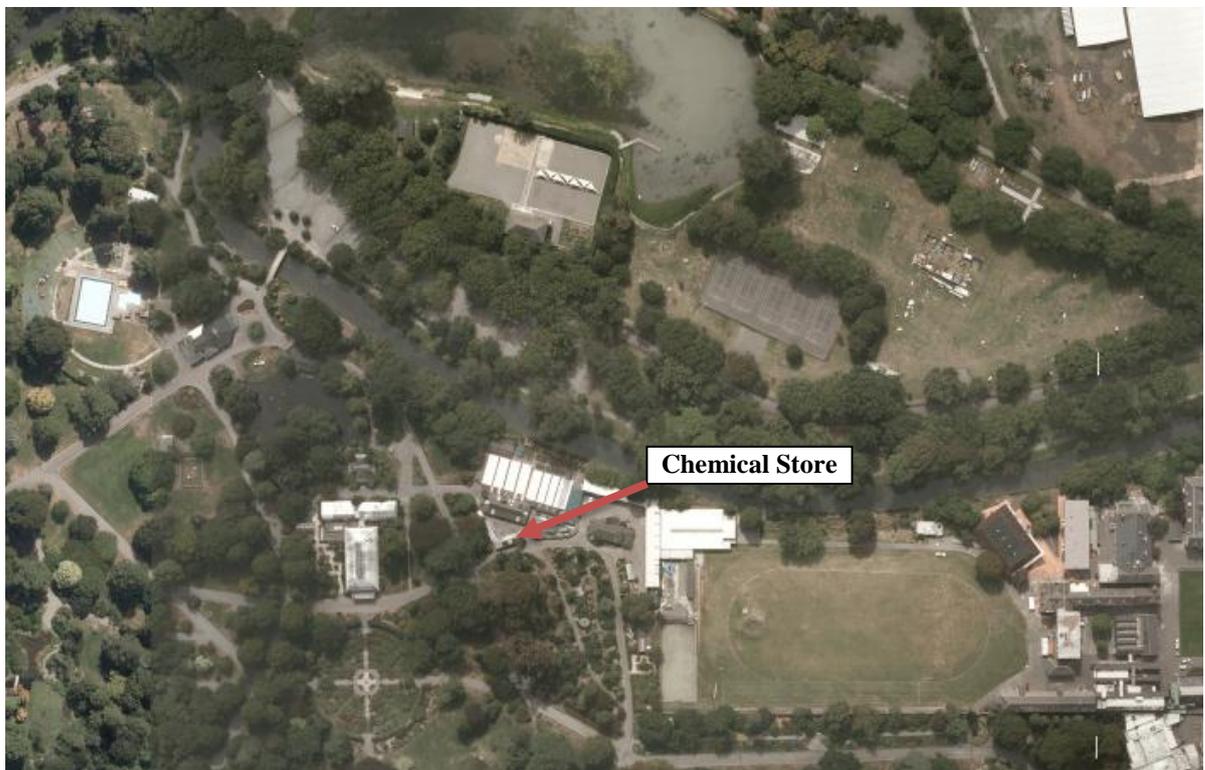
**Figure 3 Post February 2011 Earthquake Aerial Photography<sup>2</sup>**

Aerial photography taken following the 22 February 2011 earthquake shows moderate amounts of liquefaction on the northern side of the Avon and in Victoria Lake, in the top-left and top-right corners of Figure 3. However, there is no evidence of liquefaction at the surface within the botanic gardens themselves.

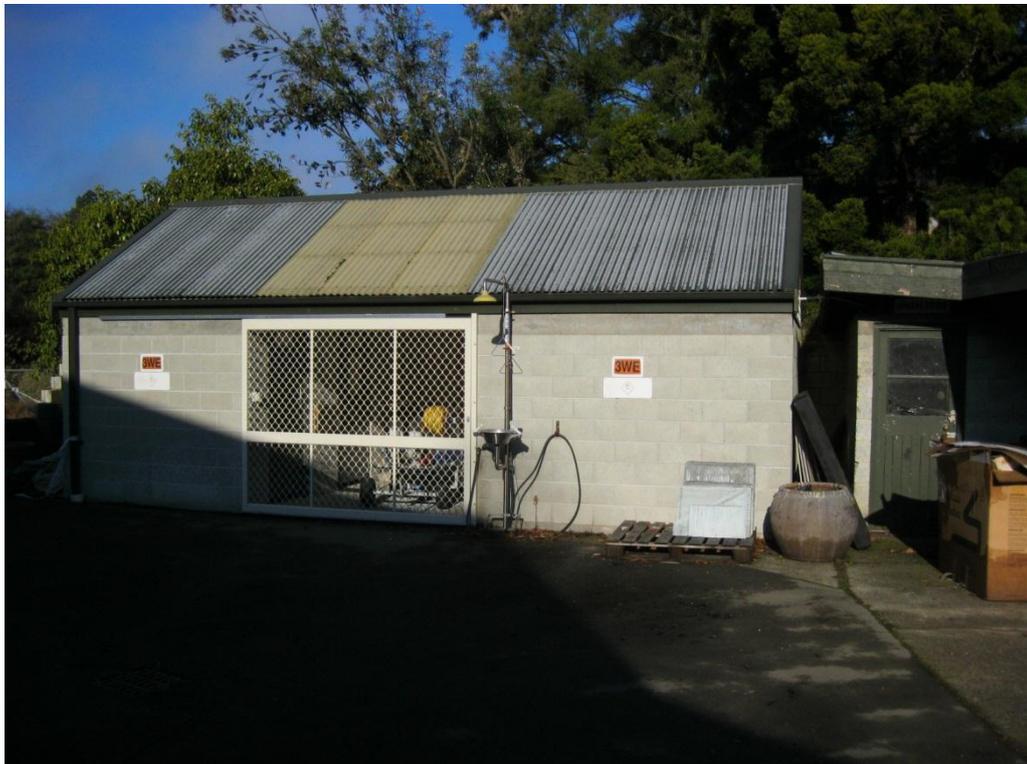
**Photograph 2 Northern face of building (Front).**

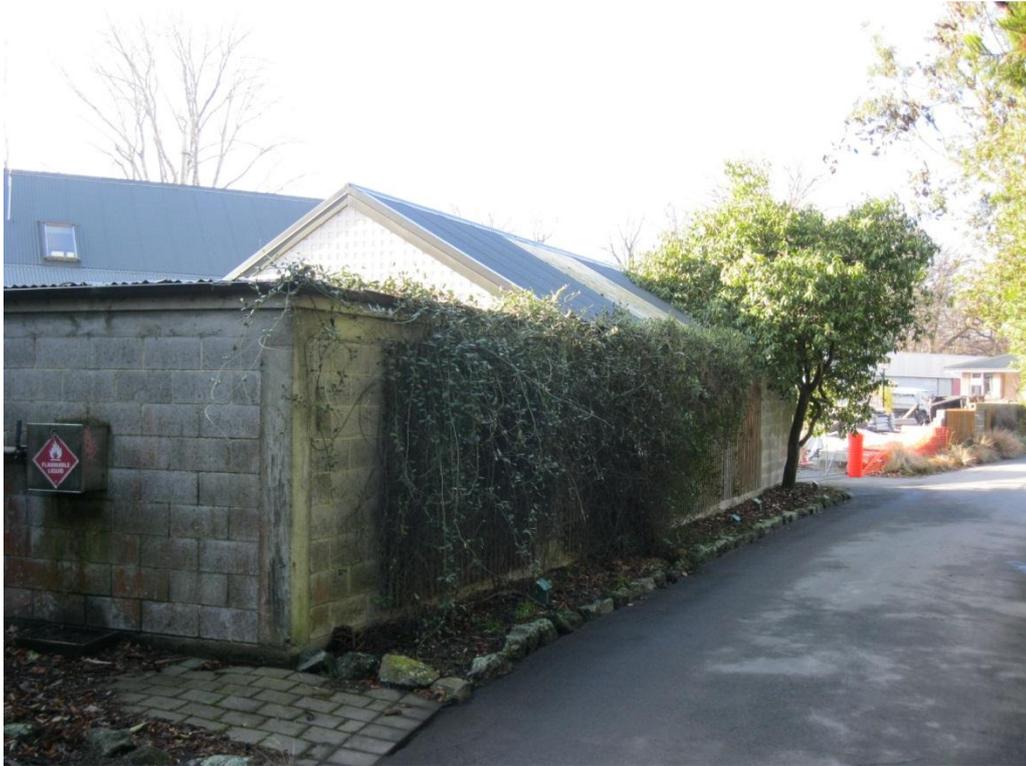
**Photograph 3 The original southern wall of the building (Rear wall).**

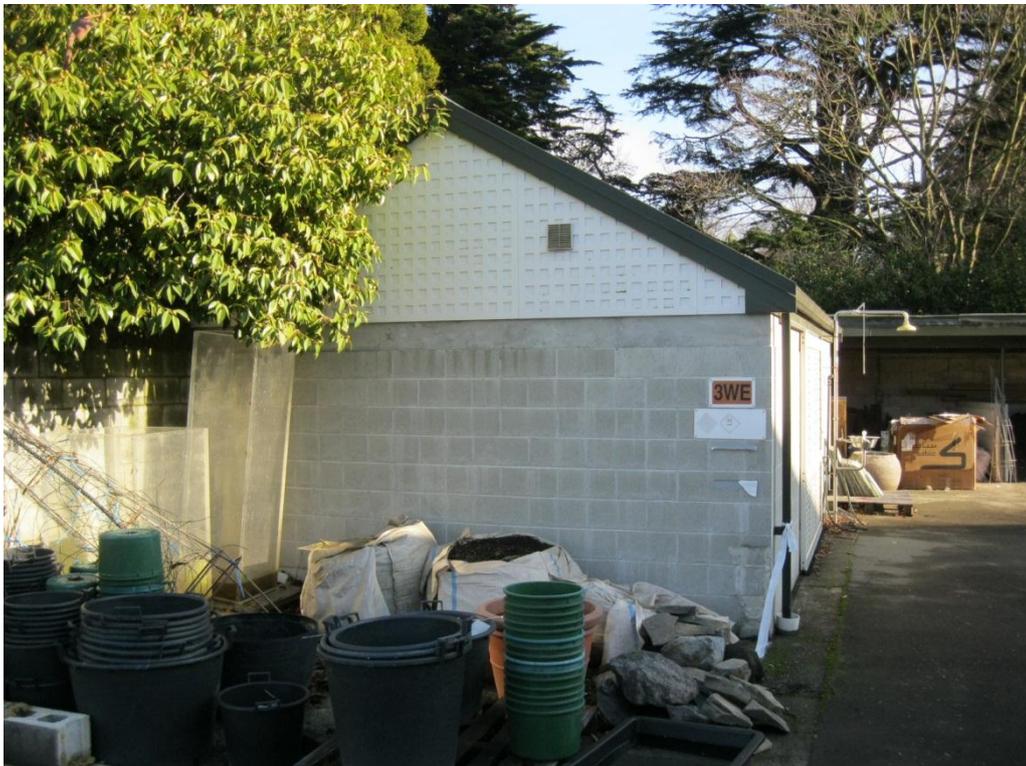
**Photograph 4 The eastern face of the building.**

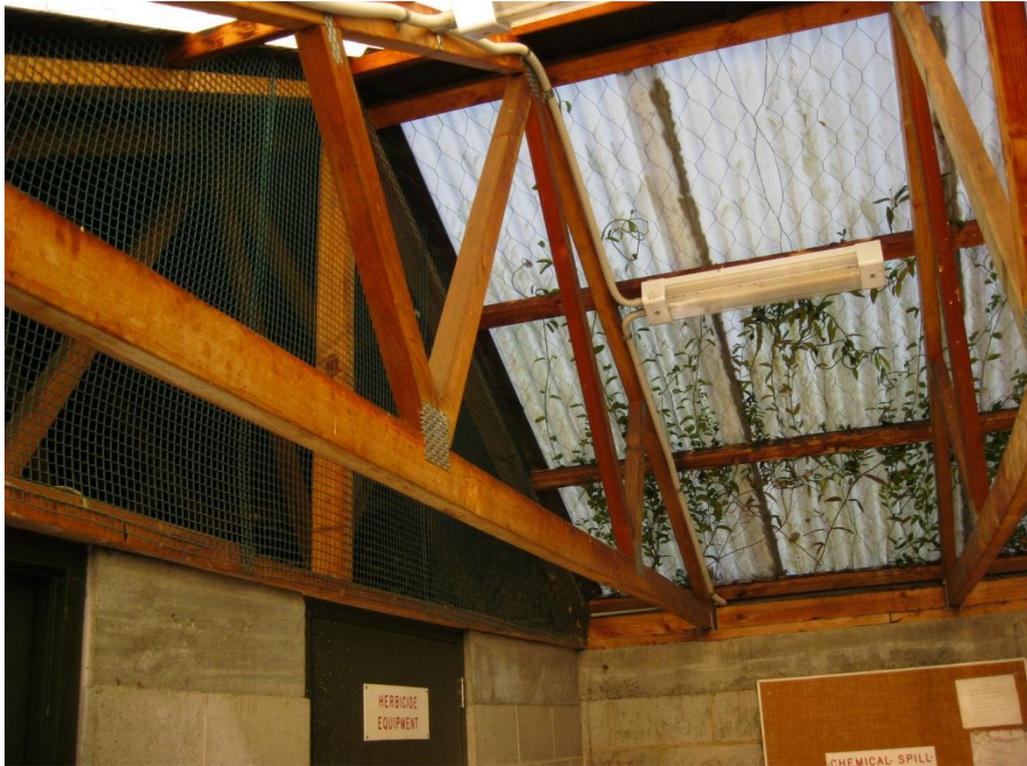
**Photograph 5 Timber roof trusses and purlins visible. No roof cross-bracing present.**

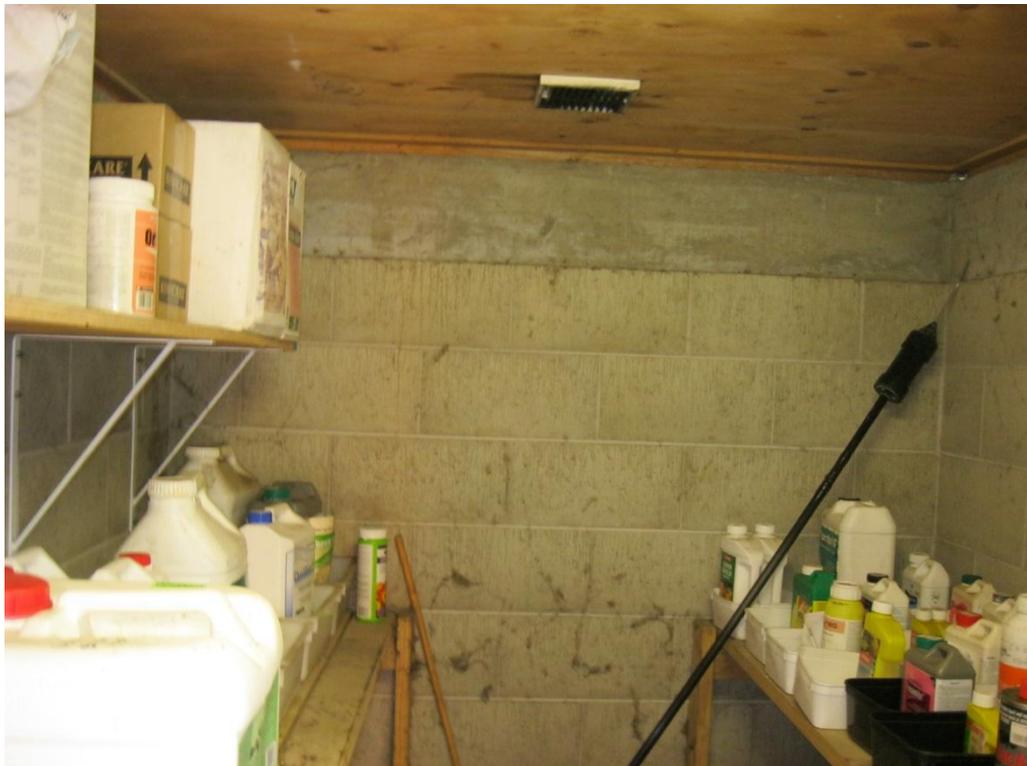
**Photograph 6 Plywood ceiling lining to the underside of one of the rooms. A reinforced concrete ring beam is clearly visible.**

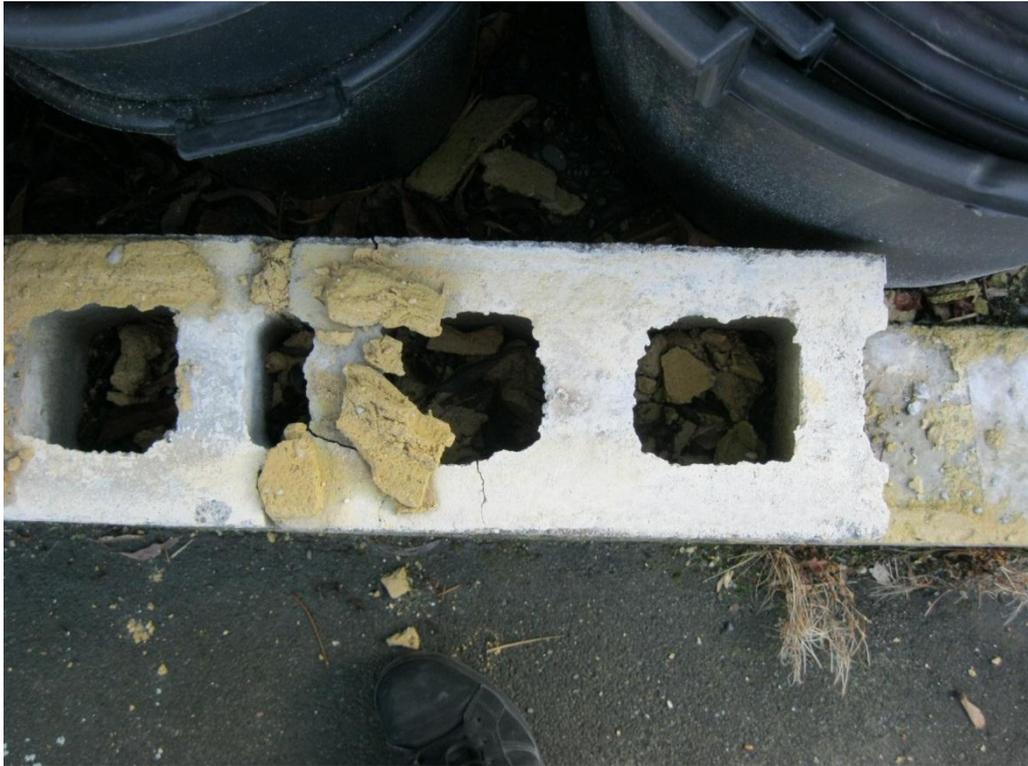
- ▶ No damage was observed to the building during inspection.
- ▶ A portion of the original boundary wall, not directly connected to the Chemical Store building, has collapsed as a result of seismic actions.

**Photograph 7 Unfilled concrete masonry units of the collapsed portion of the original wall.**

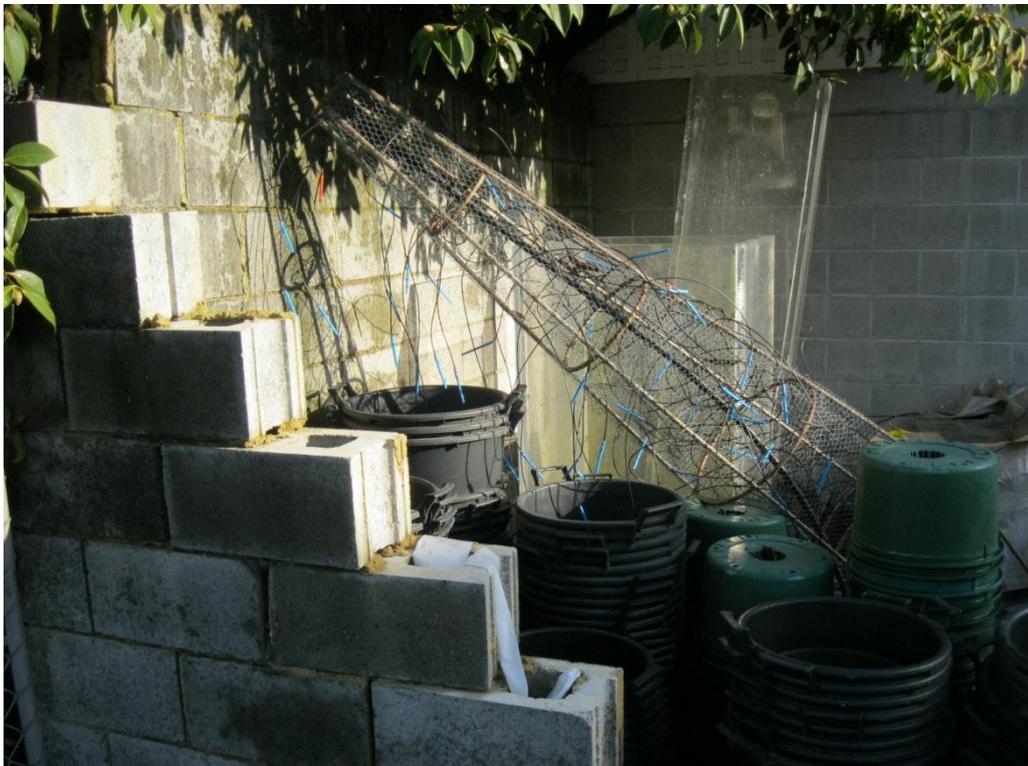
**Photograph 8 Collapsed portion of the original wall.**

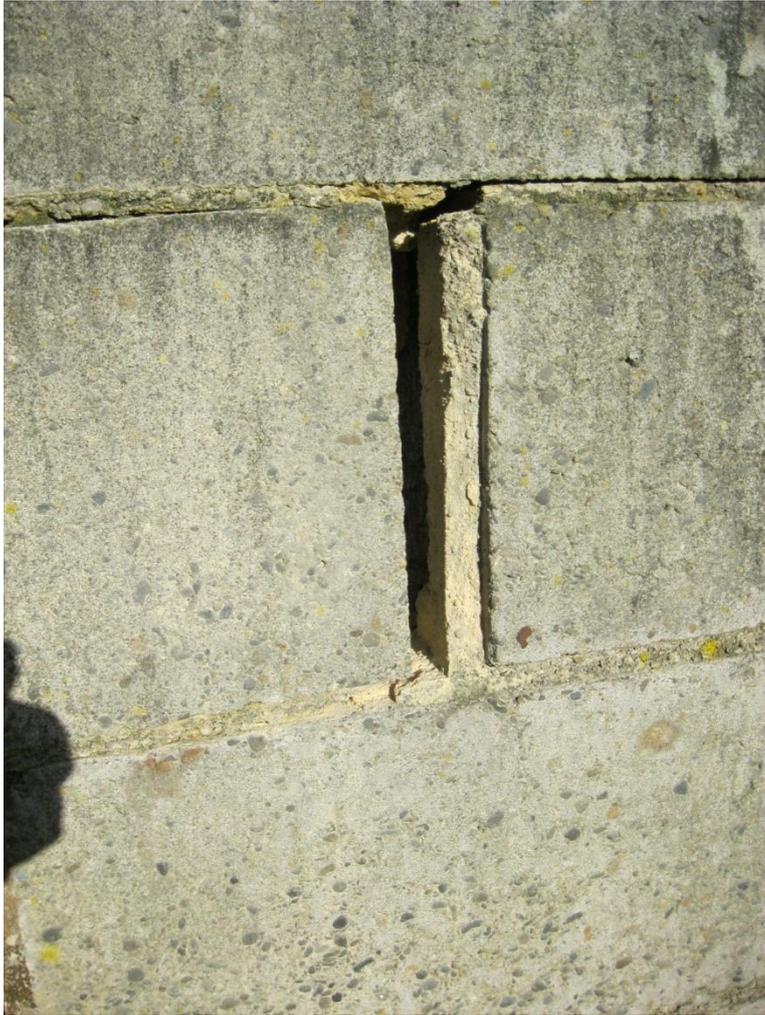
**Photograph 9 Cracking to original wall away from the chemical store.**
