**Botanic Gardens Information Kiosk**  
**PRK 1566 BLDG 002 EQ2**  
Detailed Engineering Evaluation  
Quantitative Report  
Version FINAL

7 Rolleston Avenue, Christchurch  
Central

Christchurch City Council

**Date**  
27/2/13

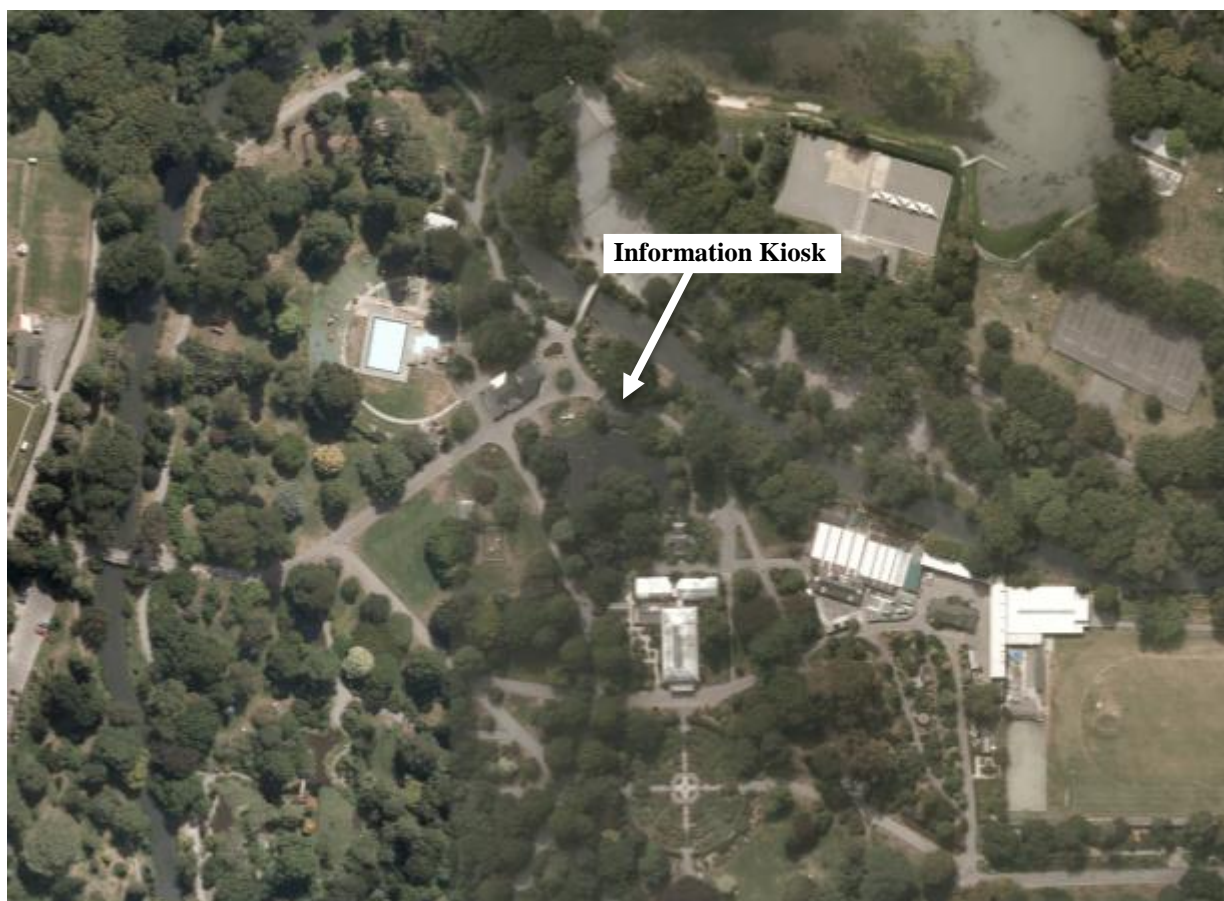
**Figure 3 Post February 2011 Earthquake Aerial Photography<sup>3</sup>**

Aerial photography taken following the 22 February 2011 earthquake shows moderate amounts of liquefaction on the northern side of the Avon River and in Victoria Lake. There is no evidence of liquefaction within the Botanic Gardens themselves.

The Canterbury Geotechnical Database<sup>2</sup> shows several observed ground cracks <10mm within 100m of the café and information kiosk structures and 280m from the office block.

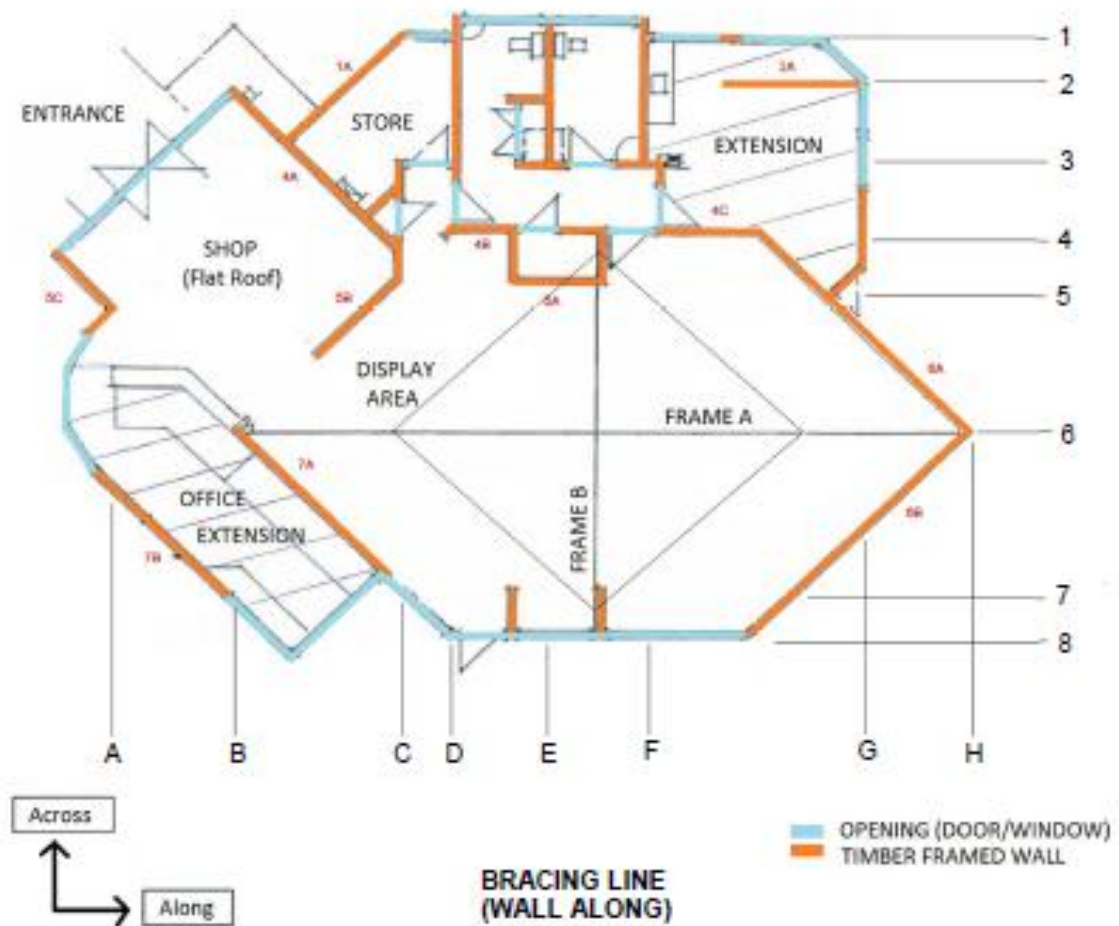
**Figure 5 Plan Sketches Showing Numbering Sequence for Bracing Elements (Along)**

The overall bracing system of the wall structure achieved a score of over 100% NBS in both directions.

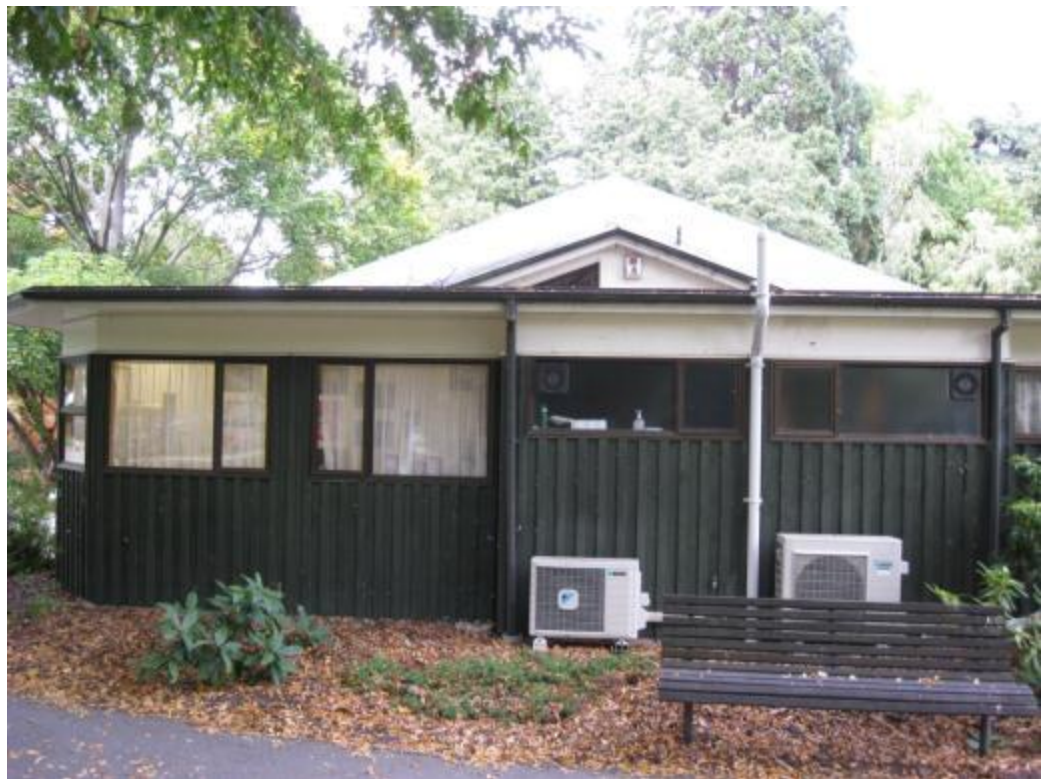
**Photograph 2: North-east elevation with extension showing insignificant short column potential**

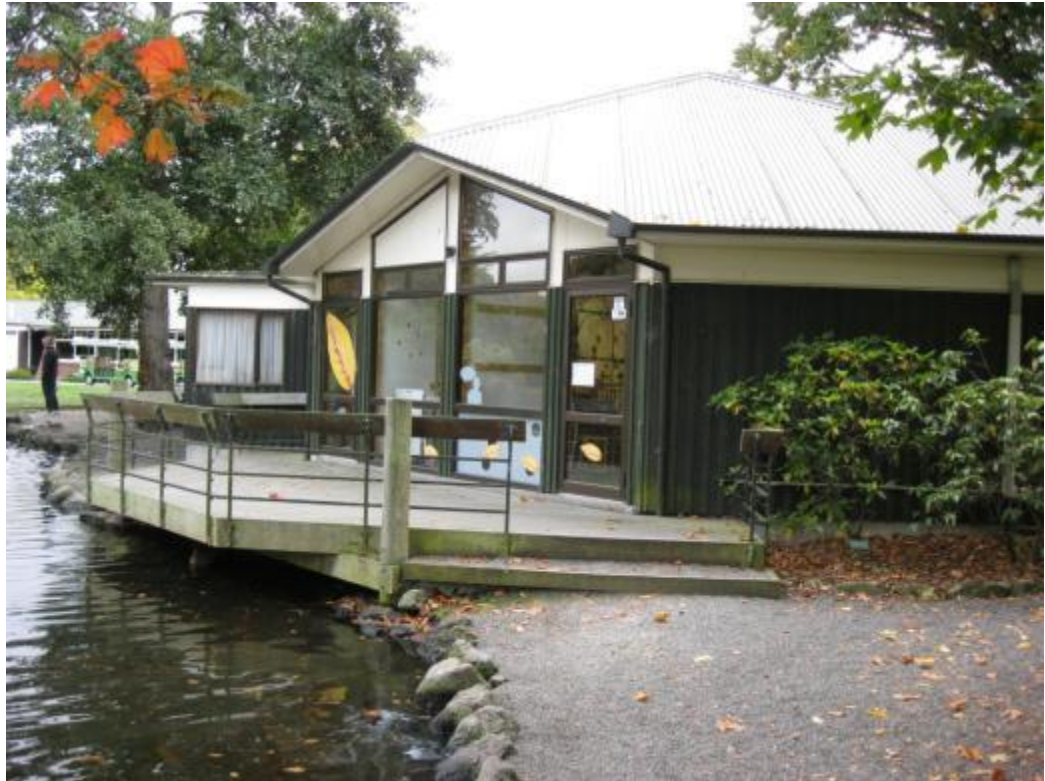
**Photograph 3: Balcony and structure abutting lake with insignificant short column potential**

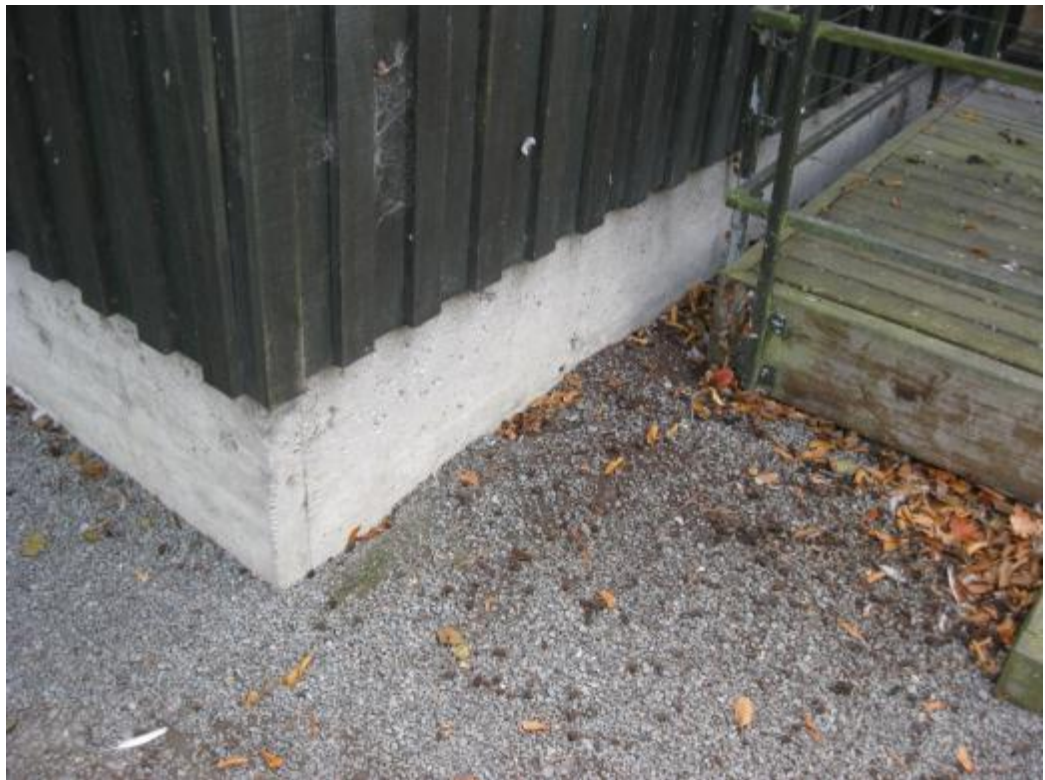
No cracking was noted to the perimeter strip footing.

**Photograph 4: Perimeter strip footing supporting timber framed walls**

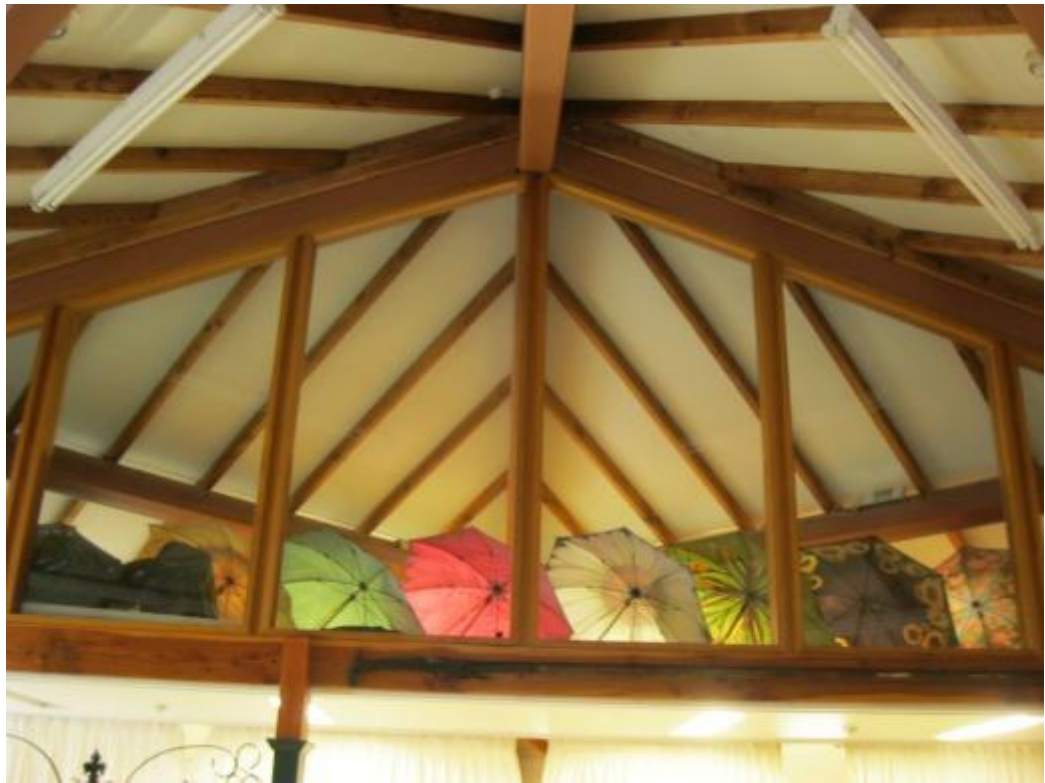
No damage was evident to the roof structure.

**Photograph 5: Steel framework to roof showing exposed timber rafters**

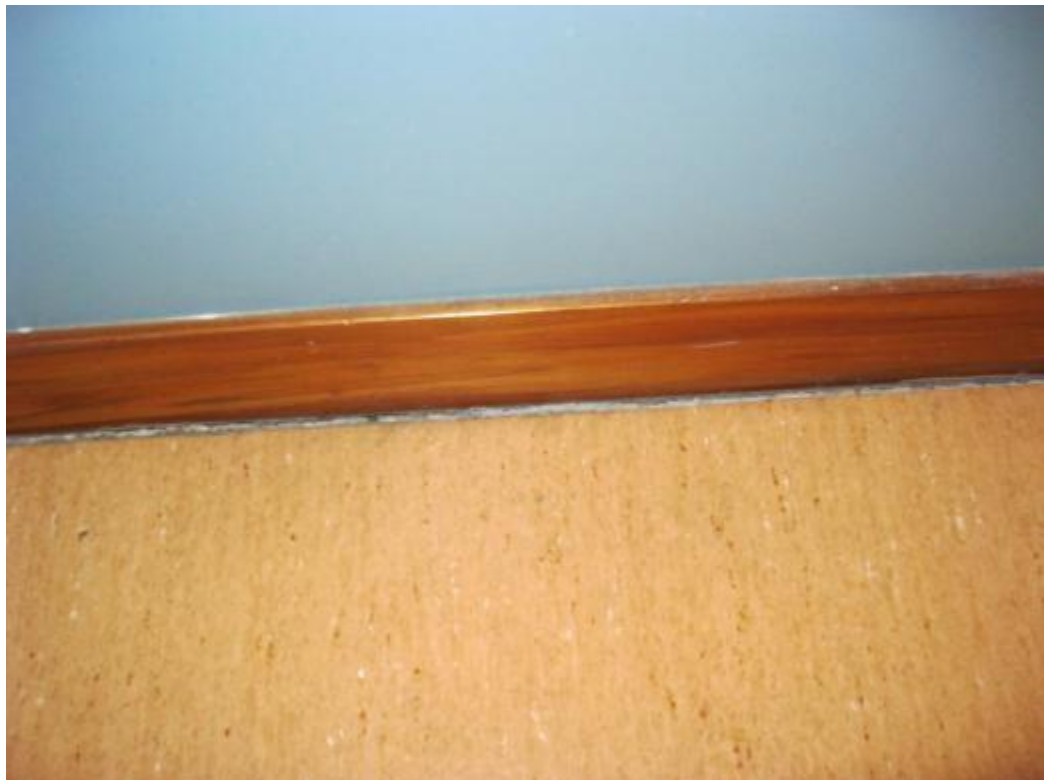
Minor cracking was observed to the plasterboard joint lines particularly at the eastern side of the structure. Slight separation also occurred between the timber framed walls and concrete floor slab. (See Photographs 6 & 7, Appendix B)

**Photograph 6: Separation between concrete floor slab and timber framed wall**

GHD recommend that the minor cracking in the structure; mostly in the plasterboard walls is repaired.

1. Repair minor cracks that are found in the structure, as specified in Section 6.2 and as shown in Photographs 6 and 7 of Appendix B of this report.

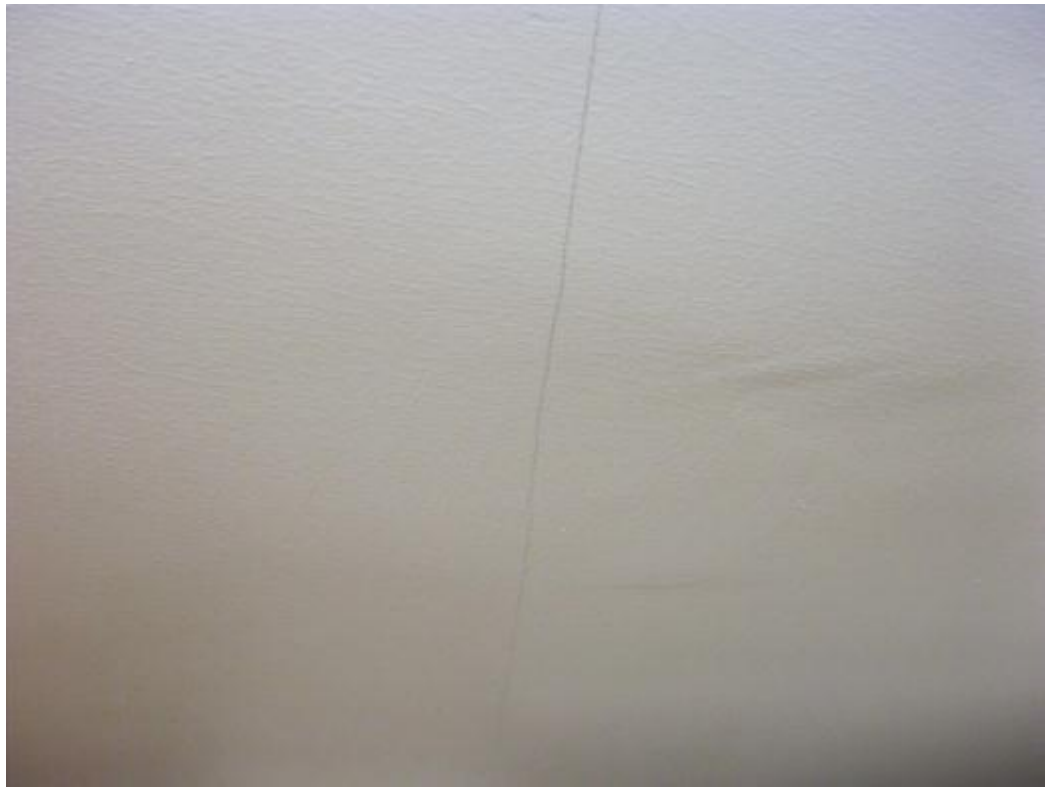
**Photograph 7: Minor cracking in plasterboard**
