Project: Bottle Lake Forest Old Woolshed
Qualitative Engineering Evaluation

Reference: 228593
Prepared for: Christchurch
City Council
Revision: 2
Date: 22 November 2012

Functional Location ID: PRK 0158 BLDG 006 EQ2

Address: 70 Waitikiri Road

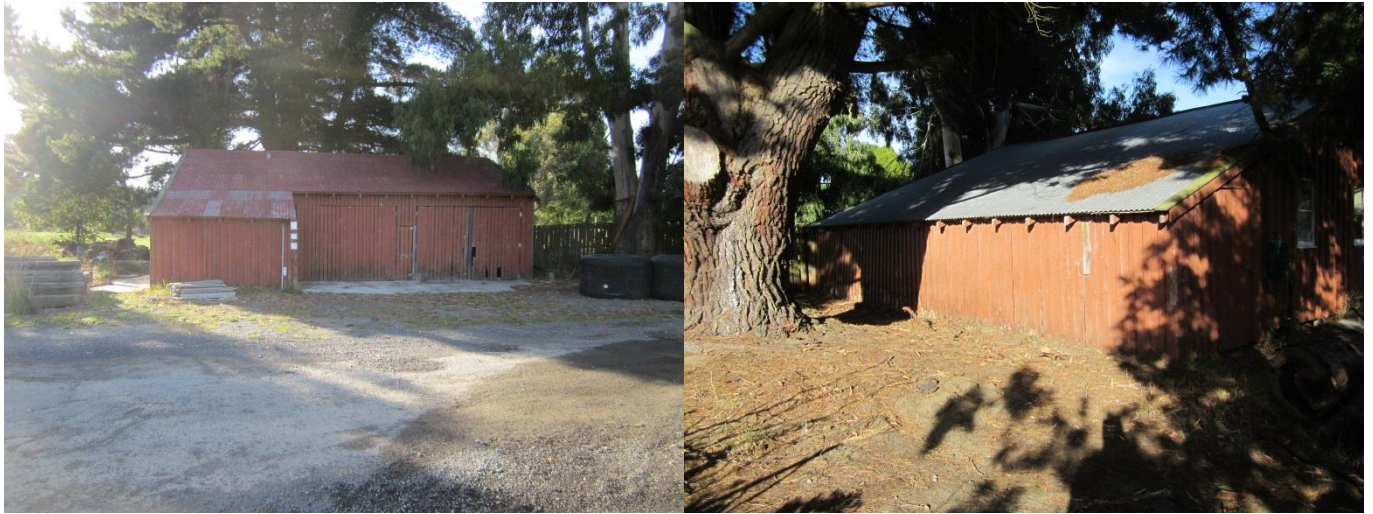
Elevations of the exterior of the old woolshed

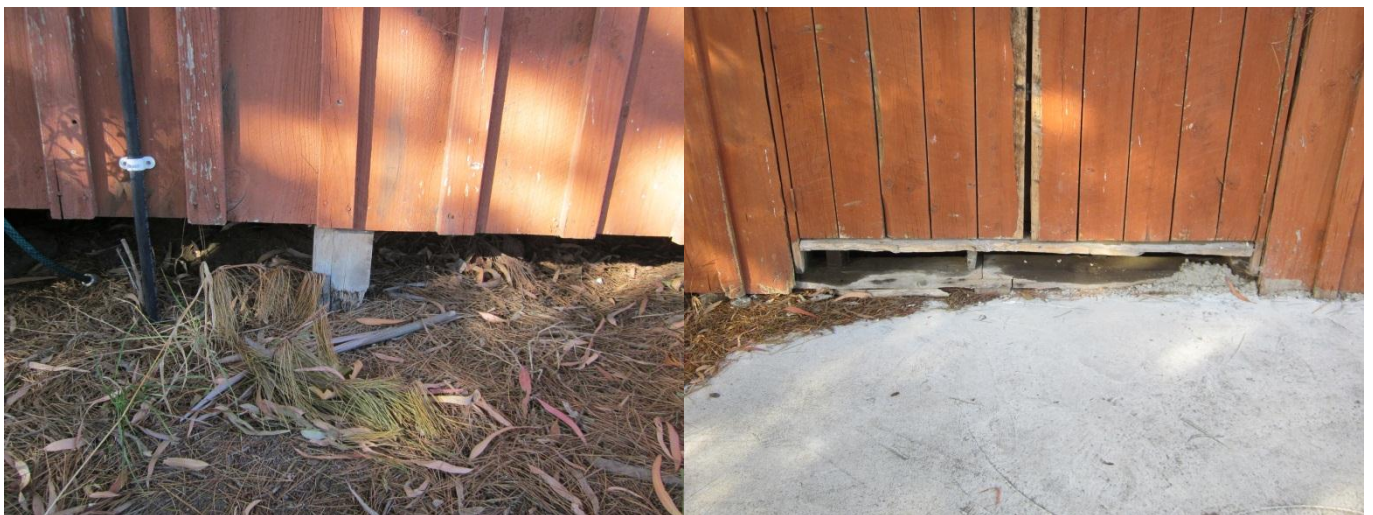
The Bottle Lake Forest Old Woolshed's timber floor is founded on isolated timber pile foundations. The floor for this building has been constructed very close to the ground and although this is good for resisting lateral loads the timber may become vulnerable to decay.

Photos showing a timber floor founded upon timber piles and bearers

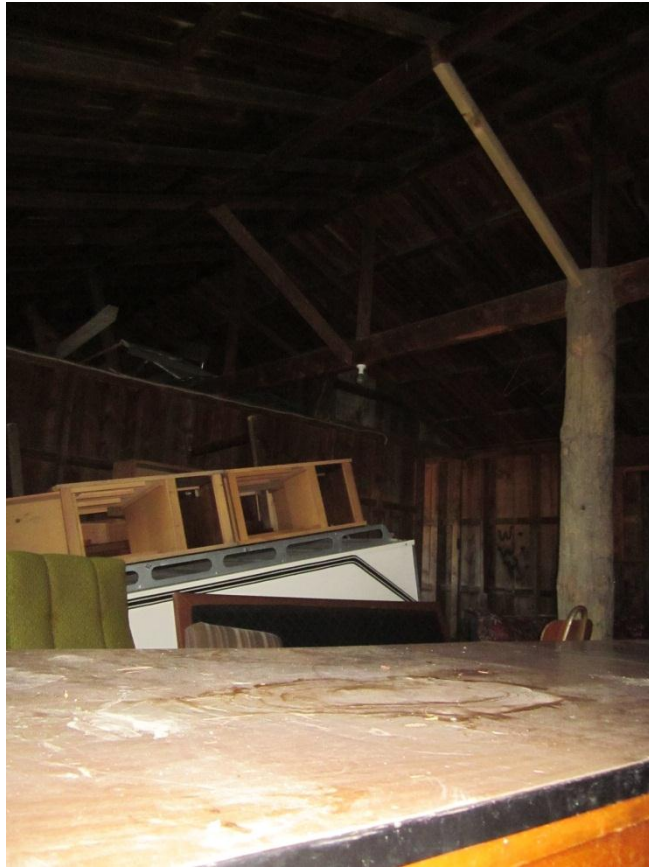
Photo showing a column, beam and struts holding up a timber roof made of timber rafters and purlins.
