**Bottle Lake Forest Rangers House
Qualitative Engineering Evaluation**

Reference: 228594
Prepared for:
Christchurch City Council

Functional Location ID: PRK_0158_BLDG_011

Date: 10 October 2013

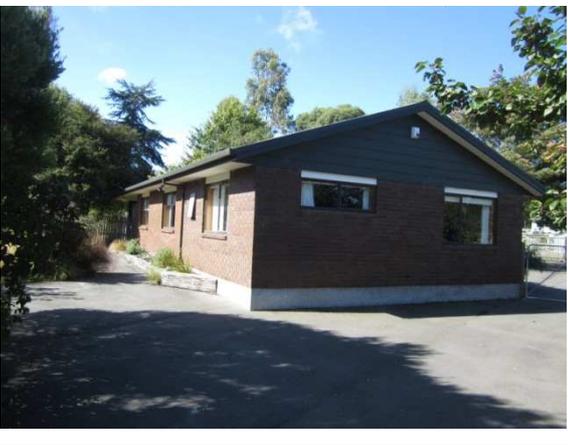
1	Elevation of the exterior of the Ranger's House.

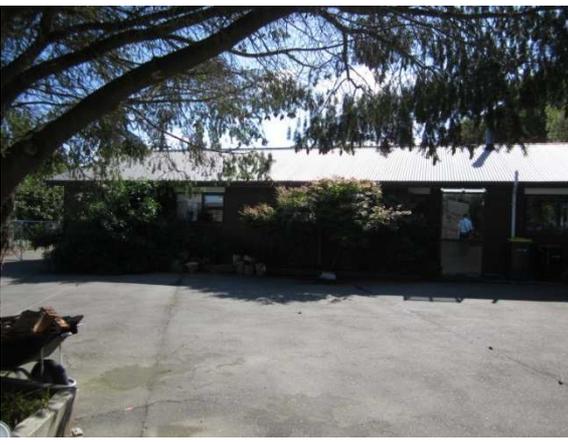
2	Elevation of the exterior of the Ranger's House.

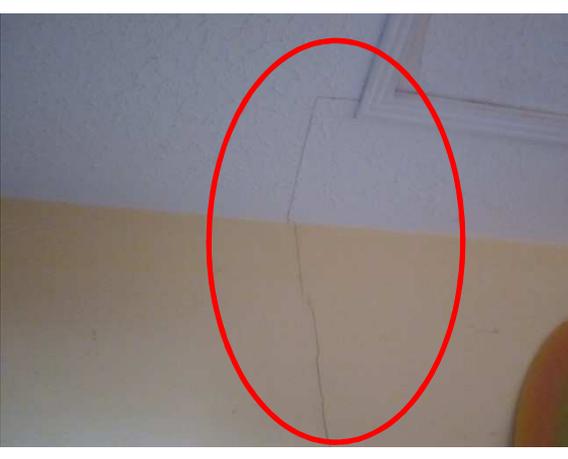
An interior and exterior visual inspection was undertaken. The only visible damage that was seen on 14 March 2012 was minor cracking of the plasterboard linings at wall-ceiling intersections on the building interior. No damage was observed to the brick veneer on the exterior of the ranger’s house.

The Bottle Lake Forest Rangers House has suffered only minor damage as a result of recent seismic activity. Although the cracking in the plasterboard internal lining indicates some degree of displacement damage, lack of associated damage in the mortar of the brickwork indicates that the degree of displacement damage was minor.

3	Cracks in the plaster board in the interior of the Ranger's house

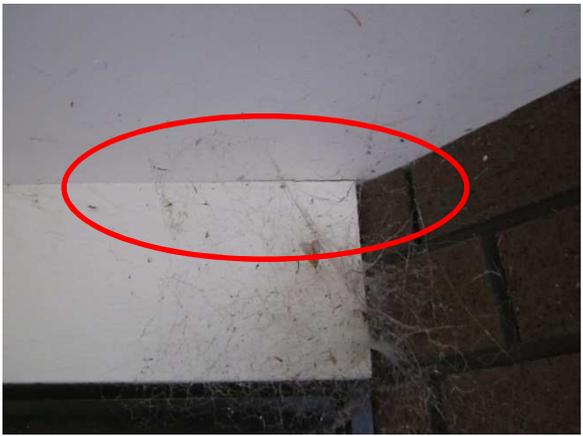
4	Cracks in the plaster board in the exterior of the Ranger's house

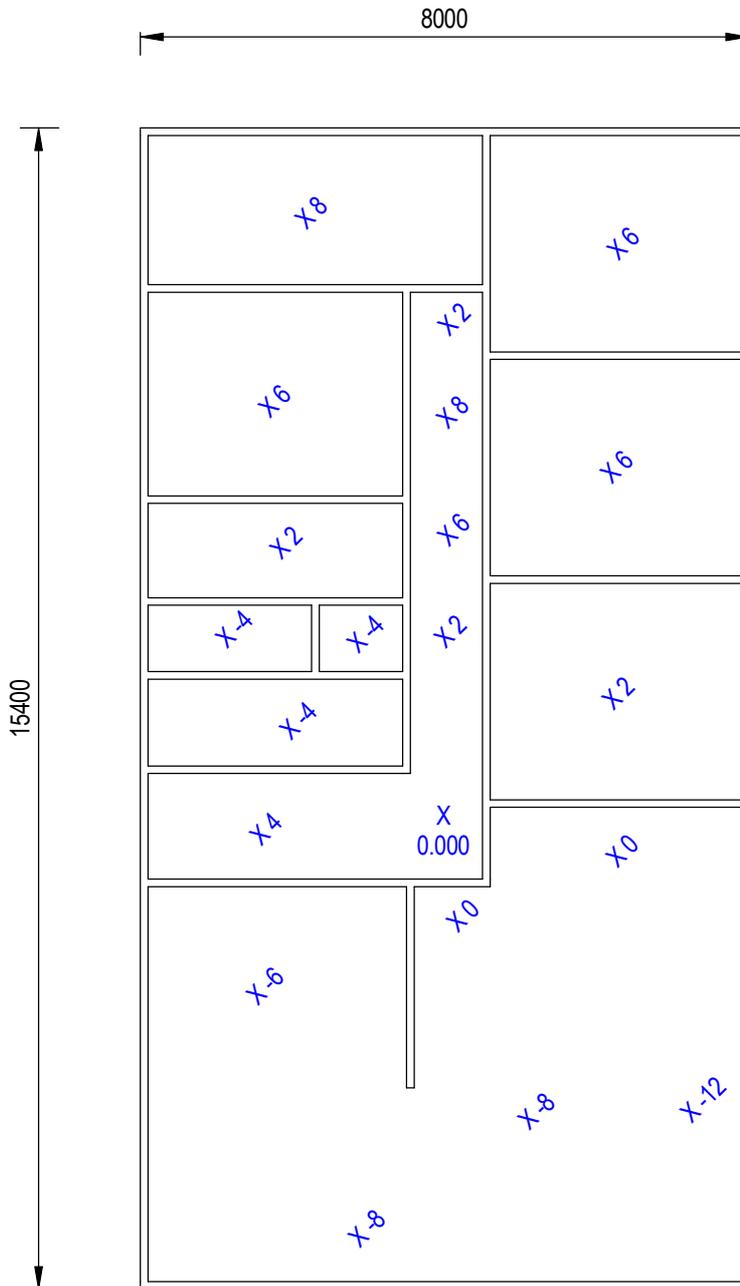
PROJECT
BOTTLE LAKE FOREST CHRISTCHURCH
TITLE
RANGER HOUSE FLOOR LEVEL SURVEY

A levels survey has been carried out in Bottle Lake Forest Rangers House and a sketch of the results is attached in appendix A. The results show that the floor levels are within acceptable limits.
