**Bottle Lake Forest - Toilets
Qualitative Engineering Evaluation**

Reference: 228596
Prepared for:
Christchurch City Council

Functional Location ID: PRK_0158_BLDG_012

Date: 10 October 2013

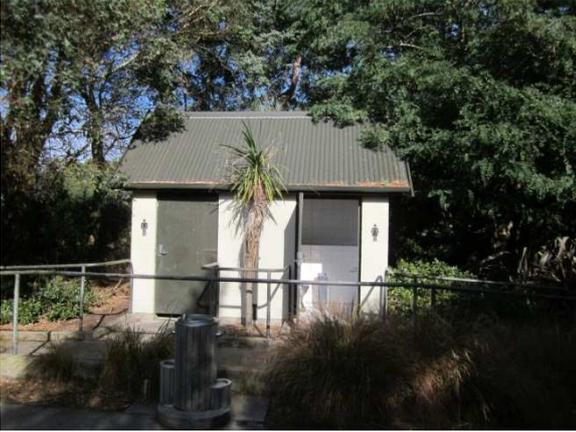
<p>Front elevation of Bottle Lake Forest Toilets</p>

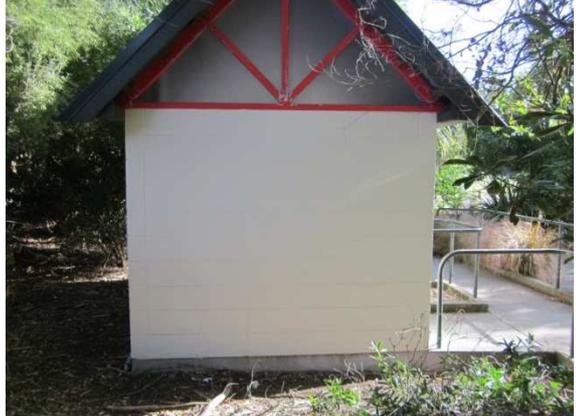
A photograph showing the front elevation of a small, white, rectangular building with a corrugated metal roof. The building is surrounded by trees and a metal railing is visible in the foreground.
<p>Side elevation of Bottle Lake Forest Toilets</p>

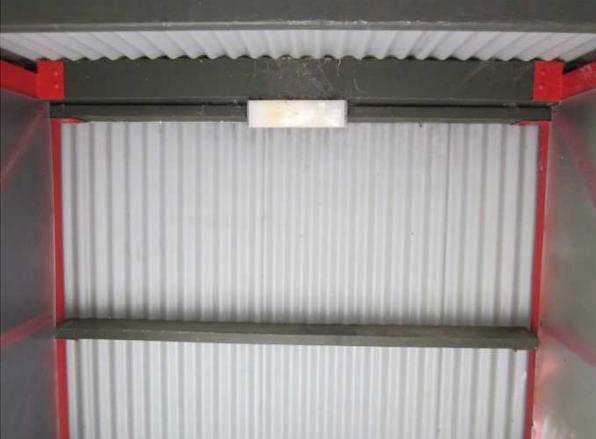
Steel truss to timber purlin connection taken from the interior and exterior of the building

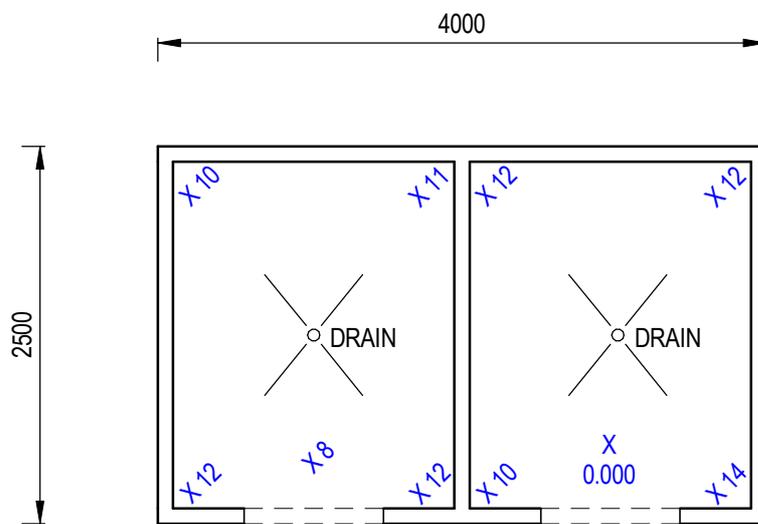
PROJECT
BOTTLE LAKE FOREST CHRISTCHURCH
TITLE
TOILET BLOCK FLOOR LEVEL SURVEY

A levels survey has been carried out and a sketch of the results is attached in appendix B. The results of the survey show that existing floor levels are within acceptable limits.

As a levels survey has been carried out and levels have been found to be within acceptable limits no further action or investigations are required at this point.
