Christchurch City Council

Boyd Cottages Housing Complex PRO 3517

Detailed Engineering Evaluation

**Quantitative Assessment Report –
Following Structural Strengthening
2015**

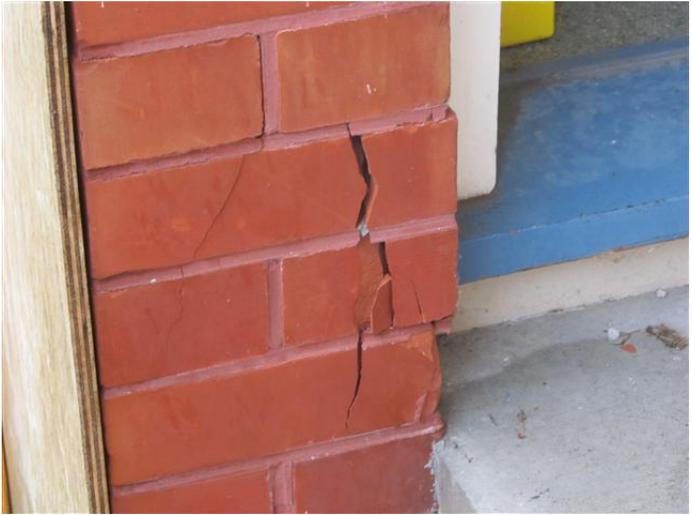
5	Cracking to exterior brick veneer Units 1

Stepped cracking was observed in the brick veneer of all units. This cracking was moderate in units 1-3 and severe in unit 4.

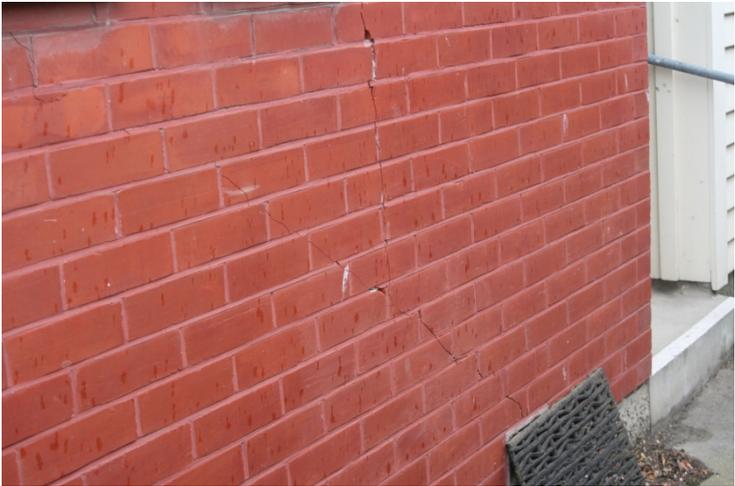
A close-up photograph of a red brick veneer wall. A vertical crack runs through the mortar joints between several courses of bricks. To the right, a blue door threshold and a concrete step are visible.
6	Typical cracking to exterior brick veneer Units 1-3

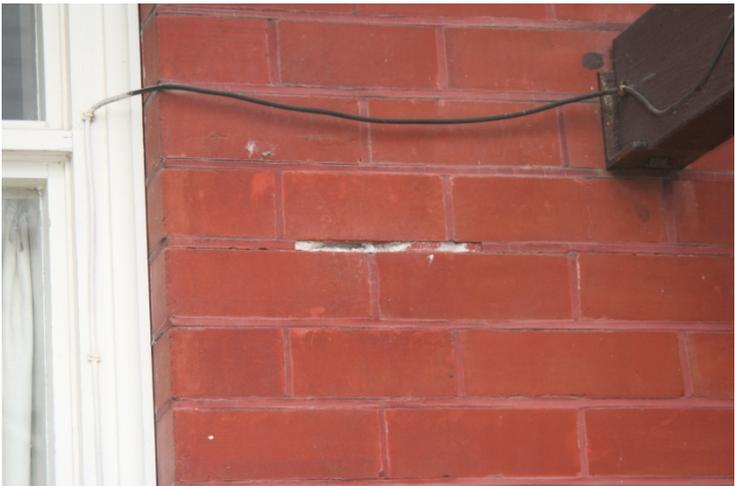
A photograph of a red brick wall showing several diagonal and vertical cracks. The cracks are distributed across the wall surface. A white door frame and a concrete step are visible on the right side.
7	Typical cracking to exterior brick veneer mortar joints Units 1-3

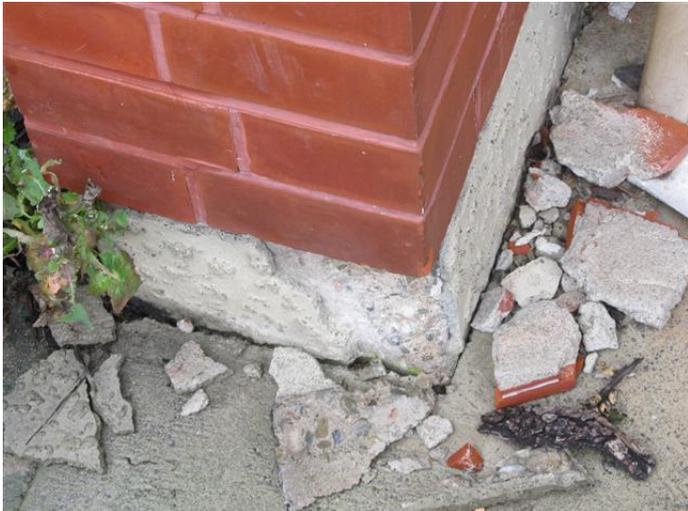
The render finish to the ring foundation of unit 4 has spalled off in the corner. Refer photo 9 in Appendix A. The render finish was repaired as part of the repairs completed in January 2015.

A photograph showing the exterior of a red brick building. The wall is covered with plywood sheathing, which is supported by diagonal wooden bracing. The building is surrounded by some vegetation and a chain-link fence is visible in the background.
9	Unit 4 shattering of concrete foundation

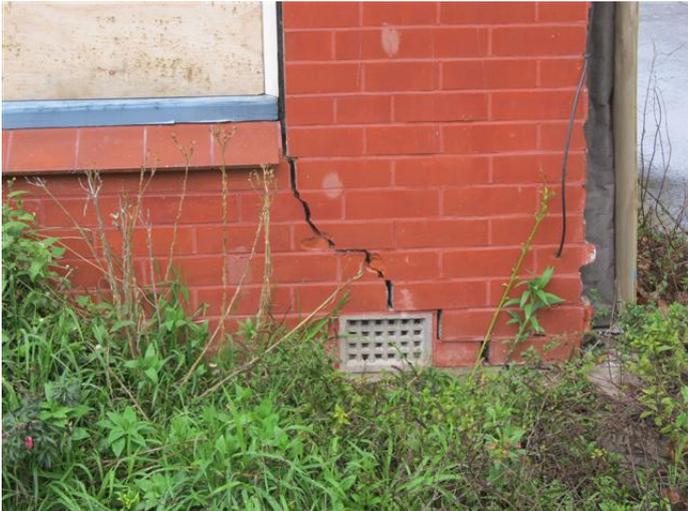
A close-up photograph of the corner of a red brick building. The concrete foundation is severely damaged, with large chunks of concrete crumbling and spalling away, exposing the interior structure.
10	Severe cracking to exterior vener cladding Unit 4

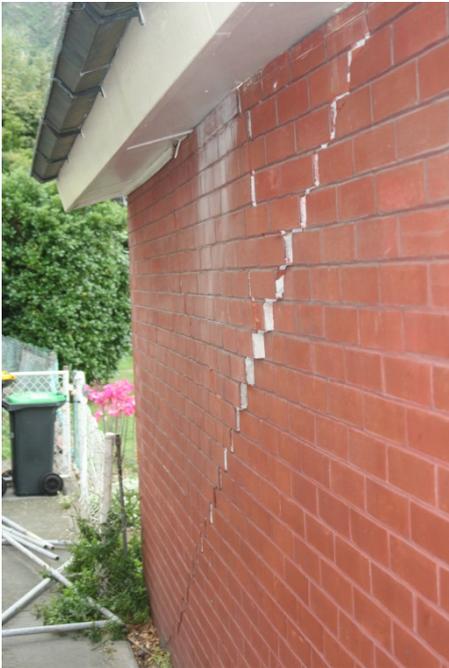
A photograph of an exterior red brick wall. A prominent, jagged, stepped crack runs diagonally across the wall. A grey utility box with a green 'ATTENTION' label is mounted on the wall. A red trash bin is visible at the bottom of the frame.
12	Severe stepped cracking to exterior veneer cladding Unit 4

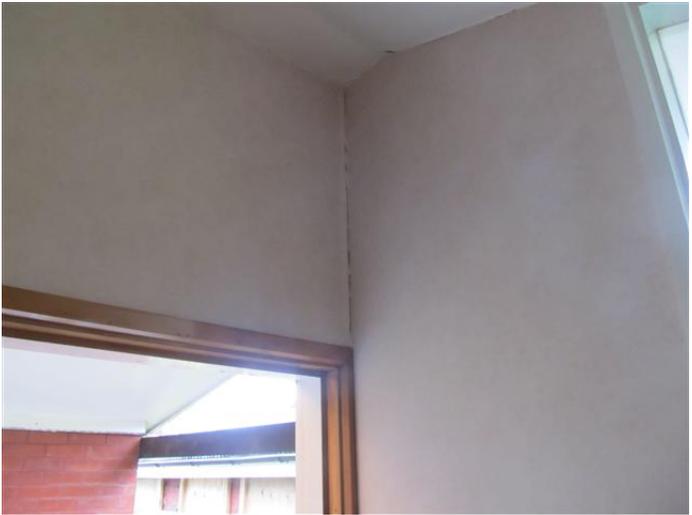
Cracking was observed in the GIB board linings in all units especially above and below openings for doors and windows. This cracking was severe in unit 4.

A close-up photograph of the exterior red brick wall, showing a vertical, stepped crack that follows the mortar joints between the bricks.
13	Units 1-4 typical interior cracking in GIB ceiling and wall lining

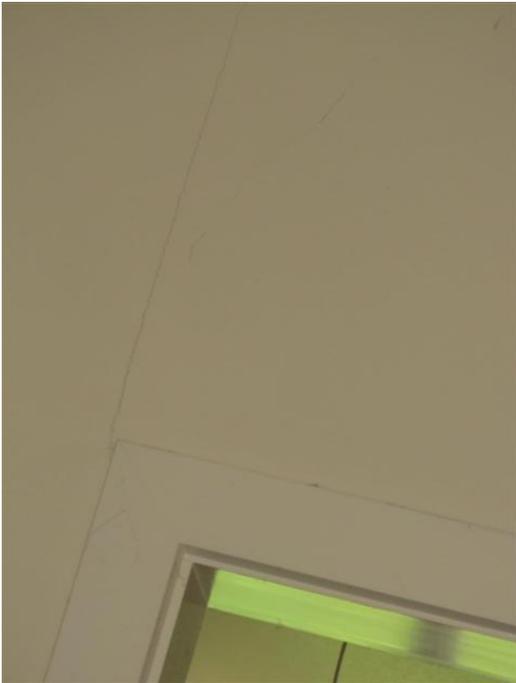
A photograph showing the interior of a unit. The ceiling and wall lining are off-white. There is a visible crack running along the top edge of the wall where it meets the ceiling. A light fixture is visible in the center of the ceiling, and a window is partially visible on the right side.
15	Units 1-4 typical interior cracking in GIB wall lining

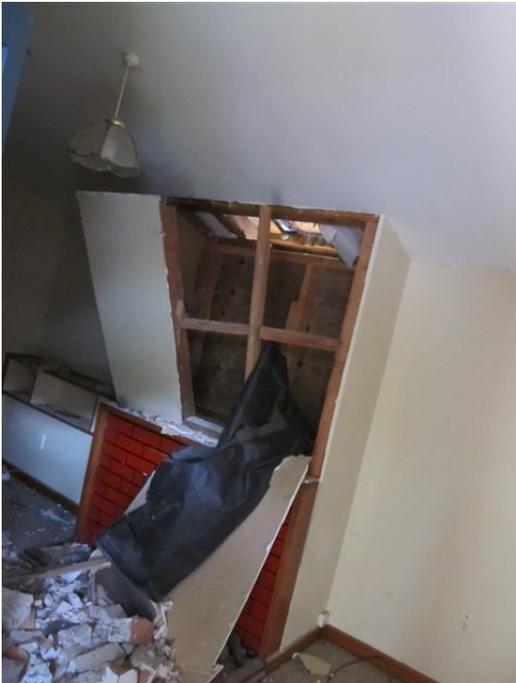
17	Unit 4 Collapsed chimney

Complete collapse of the external chimney on unit 4 resulting in damage to the interior of the unit.

1. A strengthening works scheme was developed with works completed in January 2015 increasing the seismic capacity to 100% NBS.
2. All chimneys were completely removed as part of the repair works completed in January 2015.
3. A geotechnical site investigation has not been carried out to date as there has been no new construction.
4. Cosmetic repairs were completed in January 2015 as part of the repairs works to the complex.
5. The loose brick fall hazard identified at Unit 4 was initially addressed by removal of the bricks in February 2014. The strengthening works included completely replacing brick veneers on all structures with new bricks and veneer ties in accordance with the current building code requirements.
