Branston Park Pavilion
Qualitative Engineering Evaluation

Reference: 229607
Prepared for:
Christchurch City Council

Functional Location ID: PRK_1593_BLDG_001

Address: 15 Witham Street

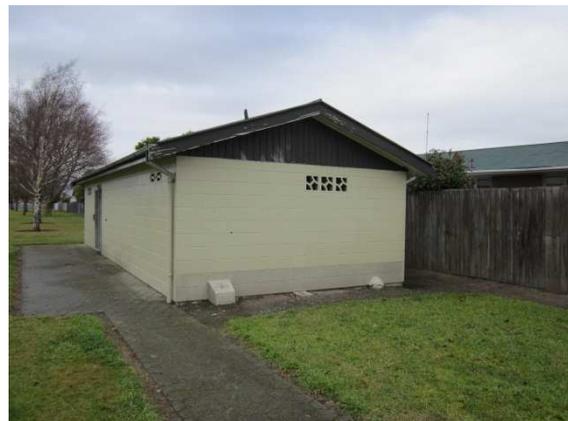
Eastern elevation of the Branston Park Pavilion.

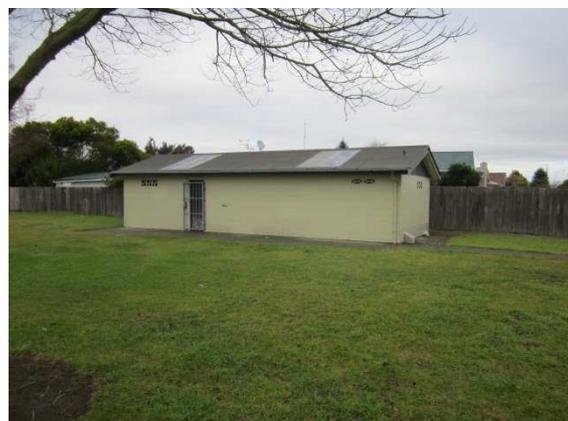
Rear elevation of the Branston Park Pavilion.

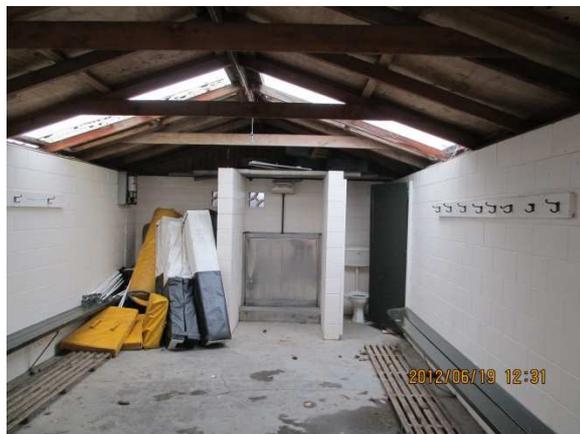
Interior of the pavilion in the south eastern elevation.

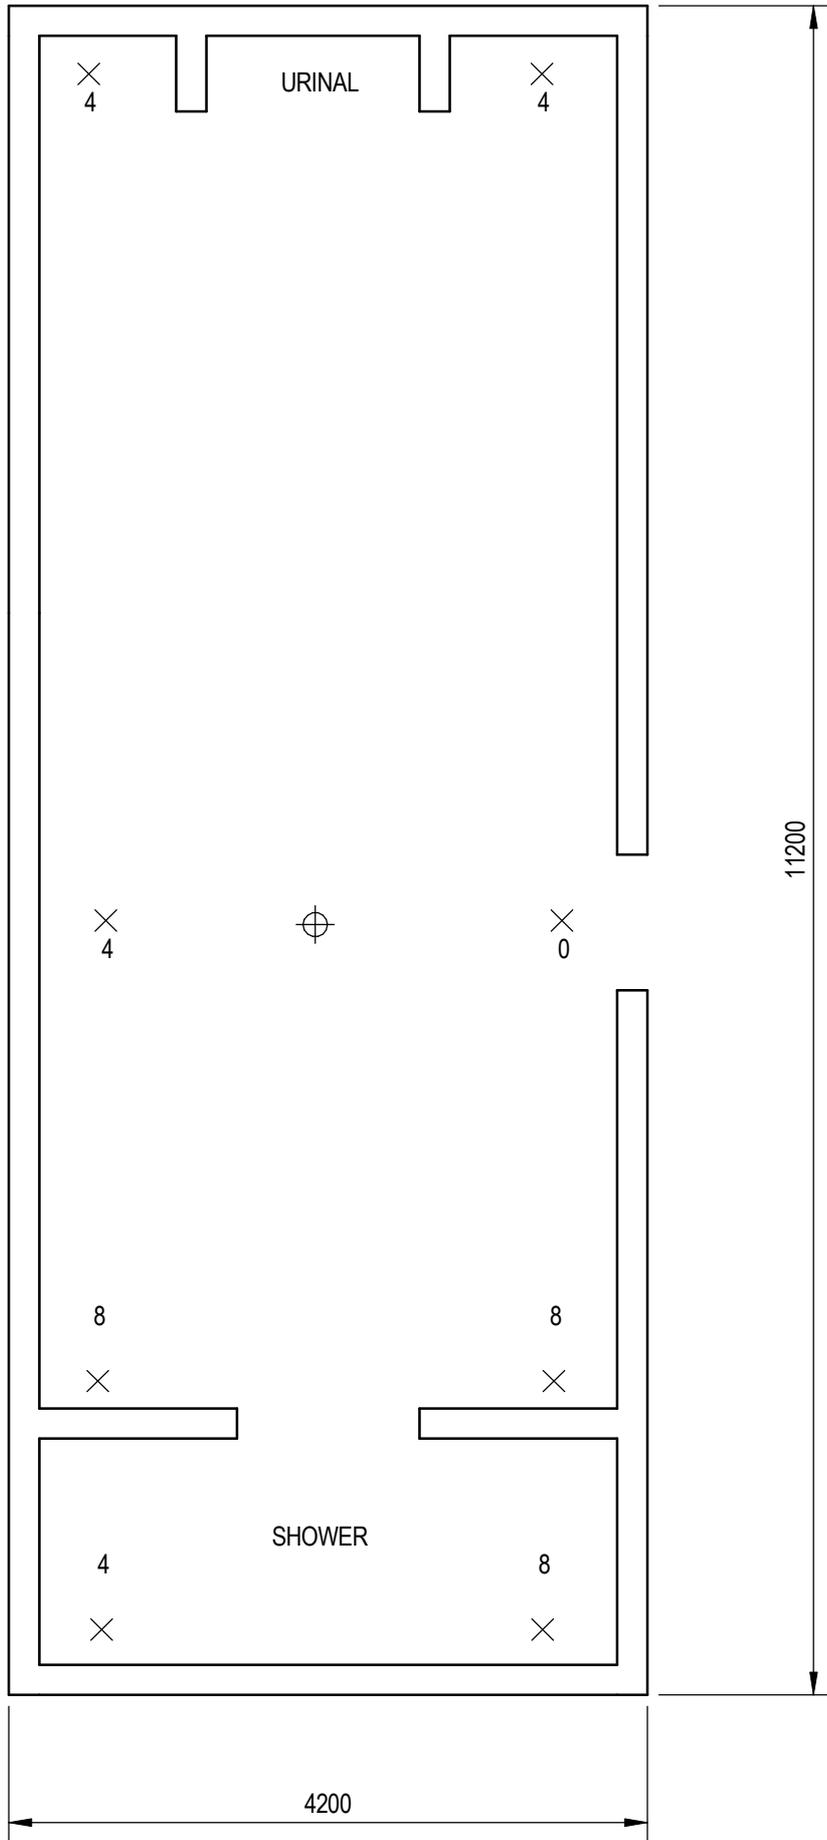
PROJECT
BRANSTON PARK PAVILION 15 WITHAM STREET
TITLE
LEVEL SURVEY

The floor levels for the Branston Park Pavilion were within the recommendations above.
