**Briggs Row
Housing Complex
PRO 3519**

**Detailed Engineering Evaluation
Quantitative Assessment Report**

Briggs Row Housing Complex

31 Winchester Street, Lyttelton,

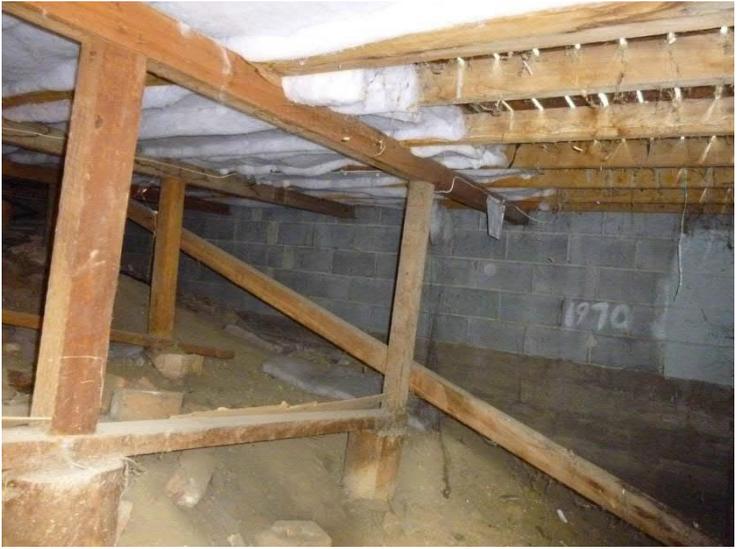
During the subfloor inspection it was noted that several members were rotted and cracking. There were large piles of soil, bricks and other construction debris under the units and in some cases these meant the concrete (structural) piles could not be inspected. These piles of material have buried some timber members which will now be more prone to rotting.

<p>6.</p>	<p>Typical floor void</p>

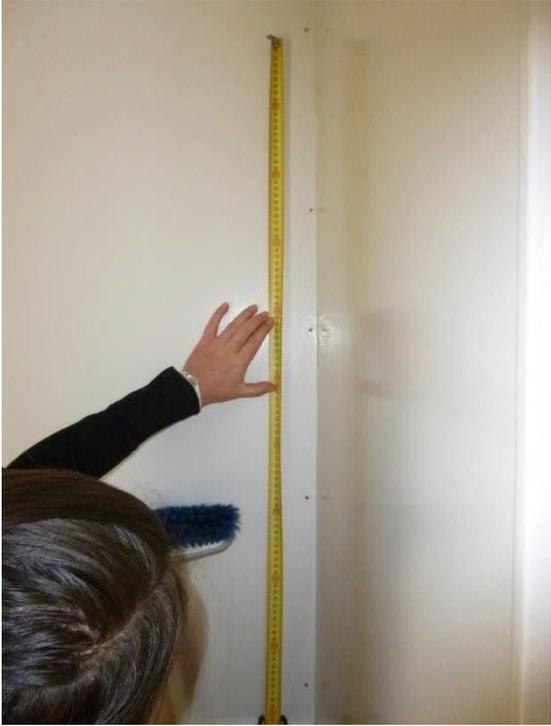
The internal lining nail spacings were measured on site to vary between 200-300mm.

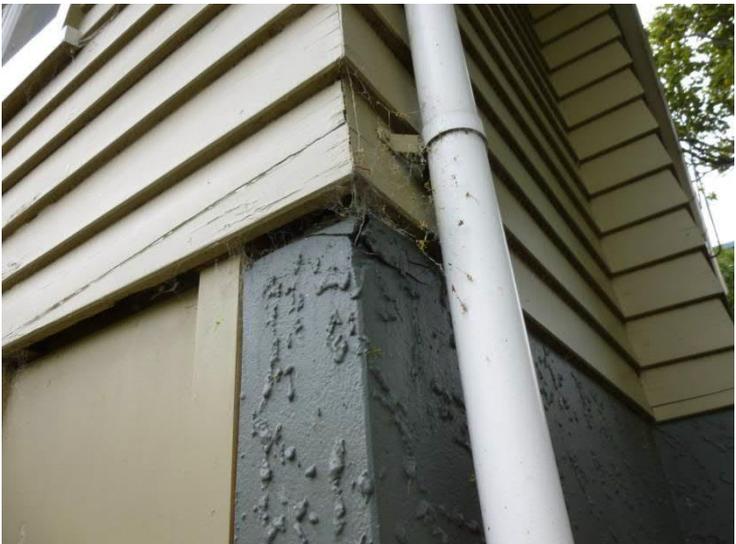
Foundation damage was limited to a small area of spalling in the concrete foundation perimeter footing on the corner of Unit 4 (photo 9).

<p>9.</p>	<p>Spalling of concrete on perimeter footing</p>

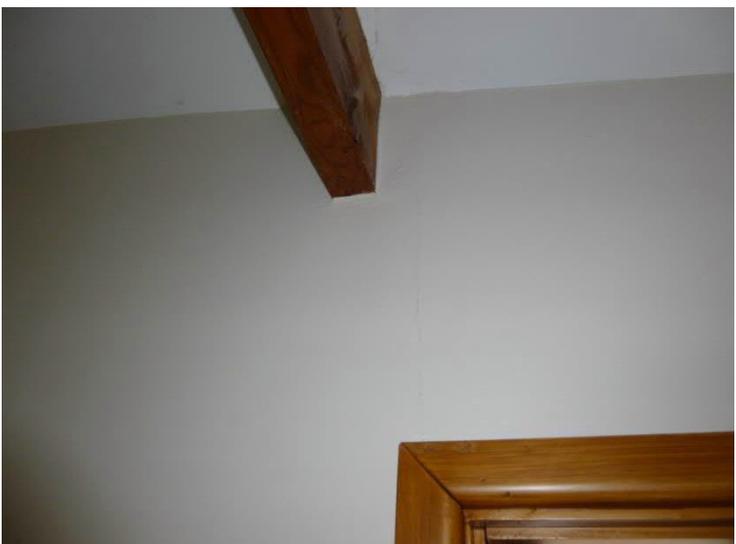
Minimal cracking of plasterboard ceiling diaphragms and wall linings was observed in the units (photo 10). This form of damage is common throughout the units. Cracked external weatherboards were also observed on some faces (photo 11).

<p>10.</p>	<p>Typical cracking of wall lining</p>

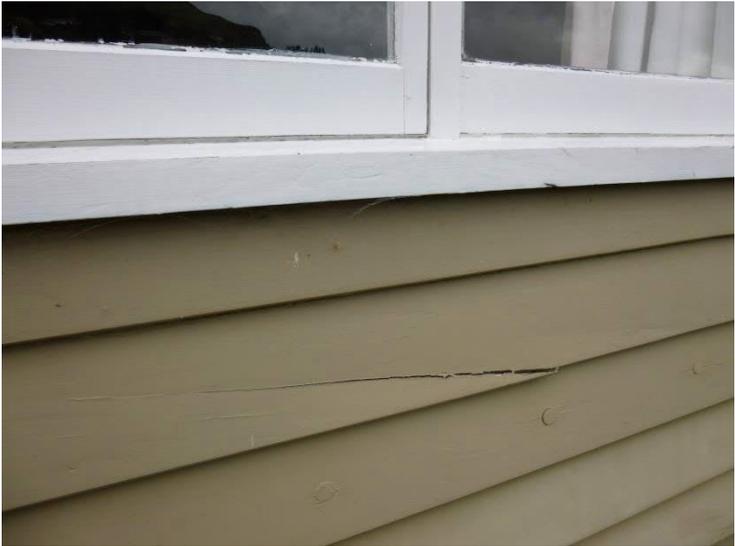
11.	Cracked weatherboard

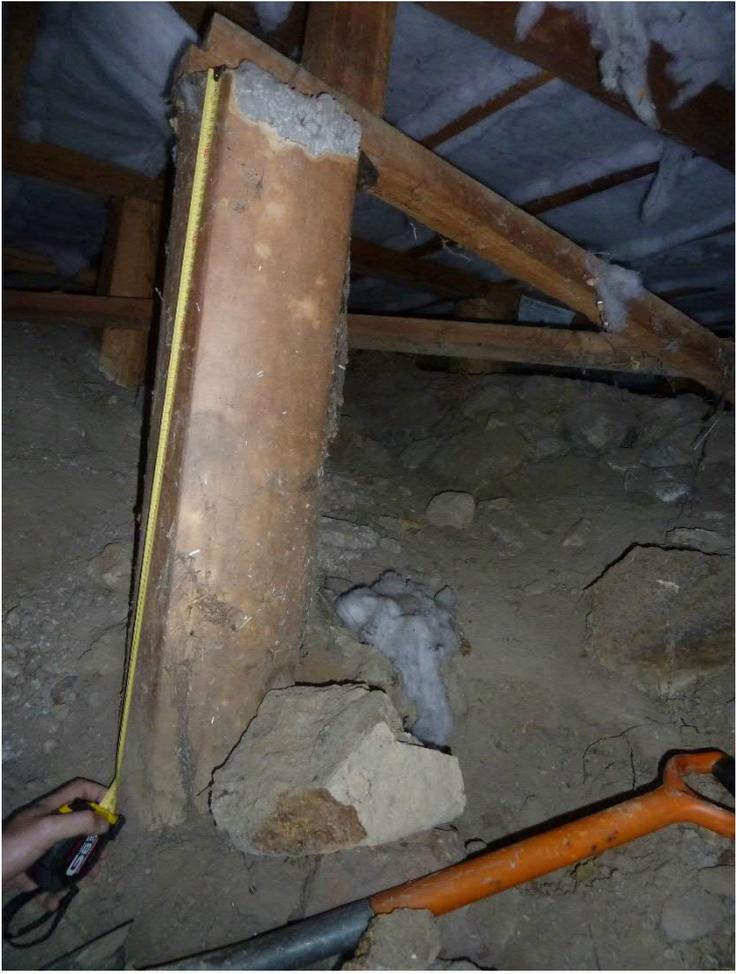
<p>13.</p>	<p>Tall, concrete piles 800mm proud of ground level.</p>
