Bromley Park Pavilion and Toilets
PRK 0766 BLDG 001
Detailed Engineering Evaluation
Quantitative Report
Version FINAL

170 Buckleys Road, Linwood

Christchurch City Council

Date
22 May 2013

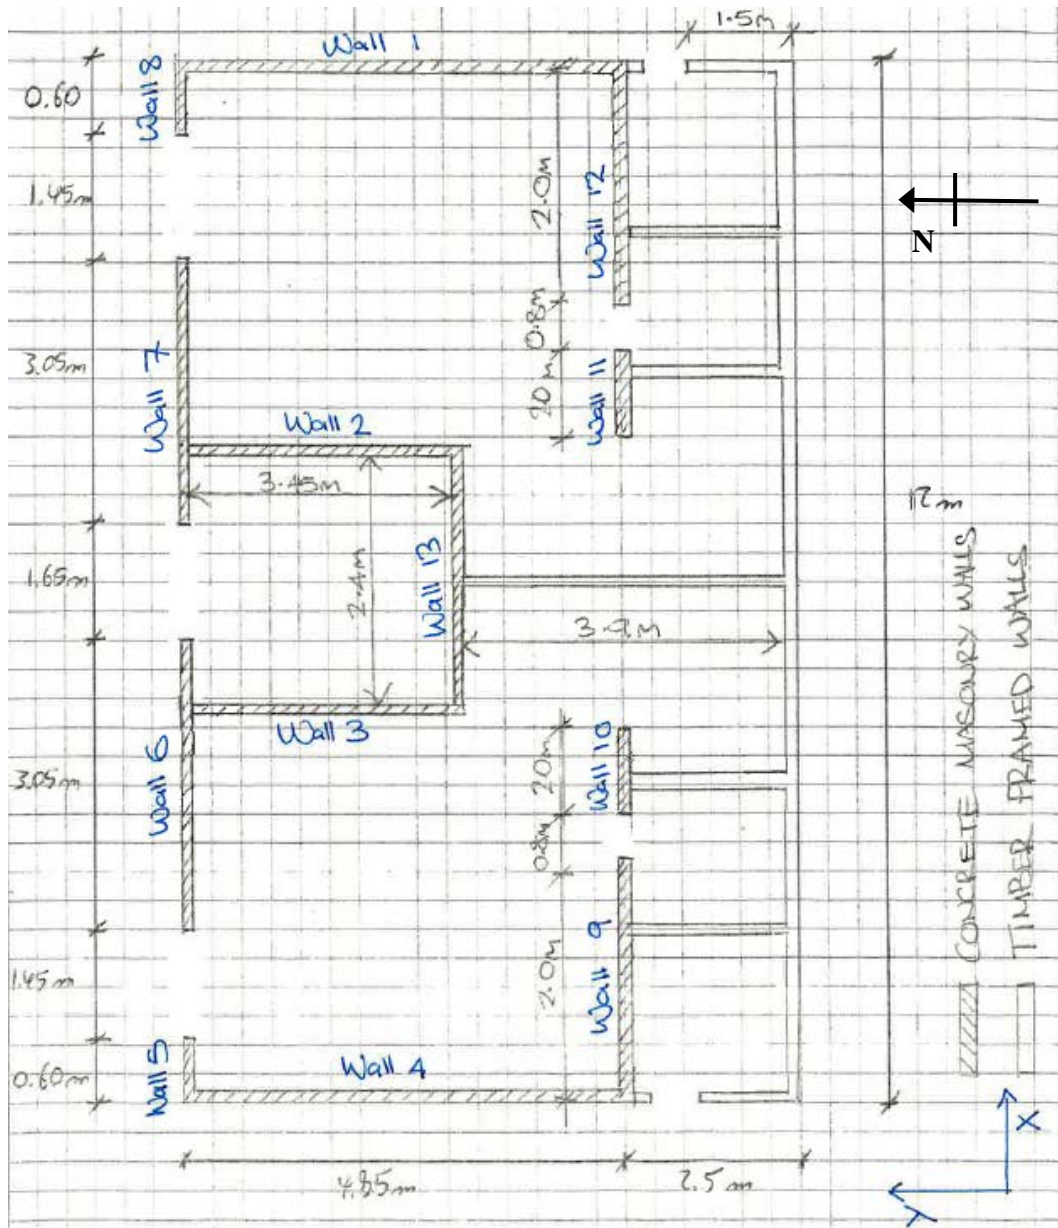
Figure 2 Floor plan of building

The walls in the original section of the building consist of 190mm thick partially filled concrete masonry units. The concrete masonry walls are unreinforced except for reinforcing bars around wall openings. The transverse walls have timber framed gable infill walls above the concrete masonry. The concrete masonry walls form the changing room and storage areas of the building.

The timber framed walls are lined internally with plasterboard and are connected to the original concrete masonry section of the building. The timber framed walls form the toilet and shower areas.

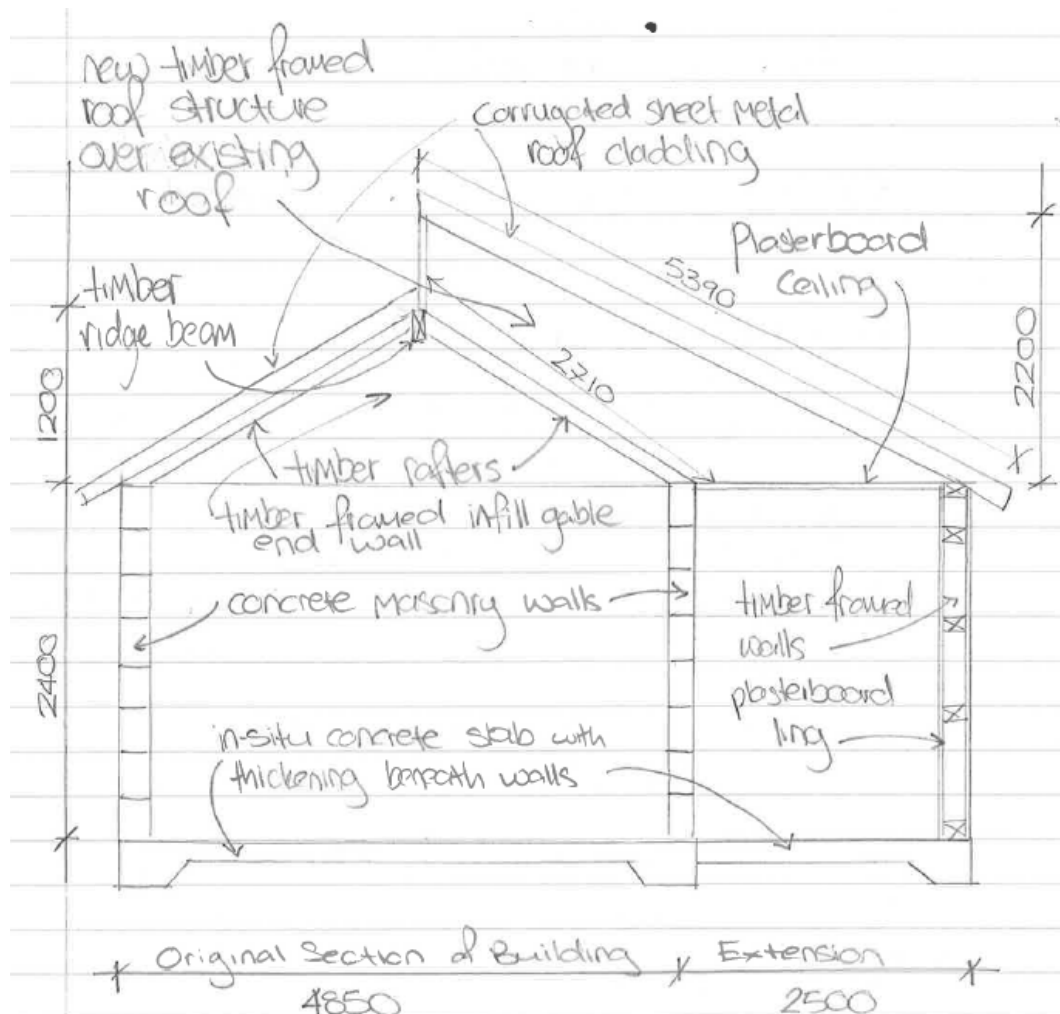
Figure 3 Building cross section

The roof of the timber framed extension has been constructed over the southern half of the roof of the original section of the building. The original roof has been left intact. The roof structure of the original concrete masonry section of the building consists of a duo-pitch roof formed by corrugated sheet metal on plywood as shown in Photograph 4. The mono-pitch roof structure of the timber framed extension consists of corrugated sheet metal on lightweight timber framing with a plasterboard ceiling.

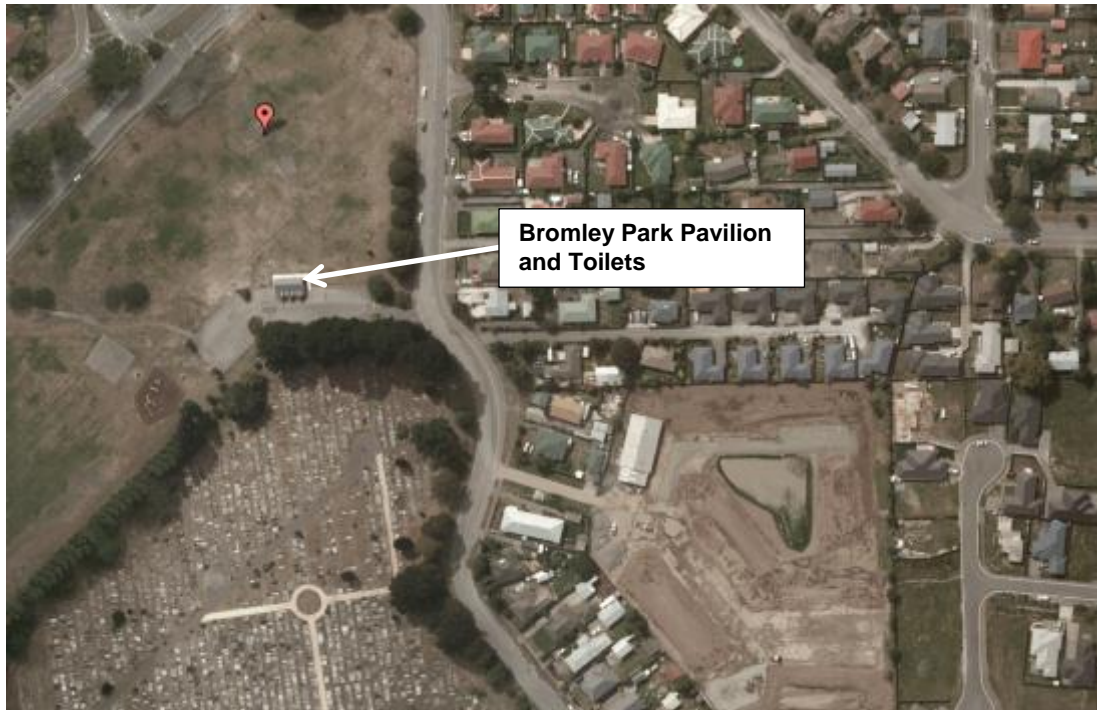
Figure 4 Post February 2011 Earthquake Aerial Photography³

Aerial photography taken following the 22 February 2011 earthquake shows signs of moderate to significant liquefaction at road corridors and nearby properties, as shown in Figure 4.

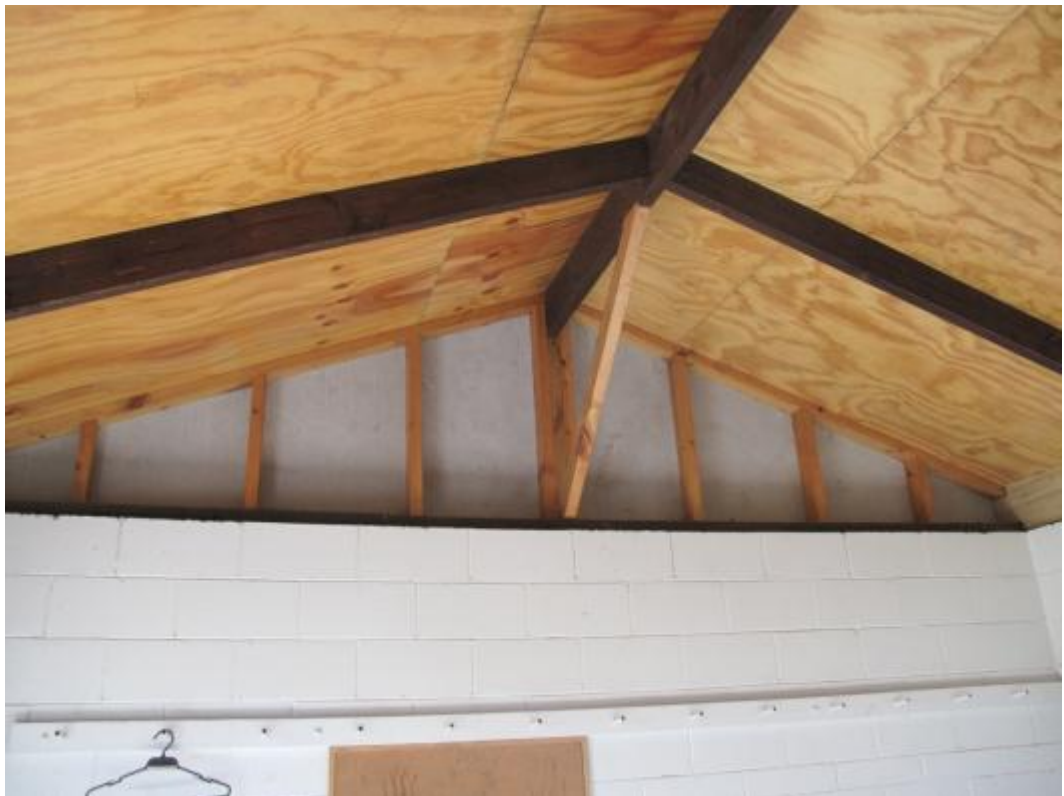
Photograph 4 Timber framed infill wall

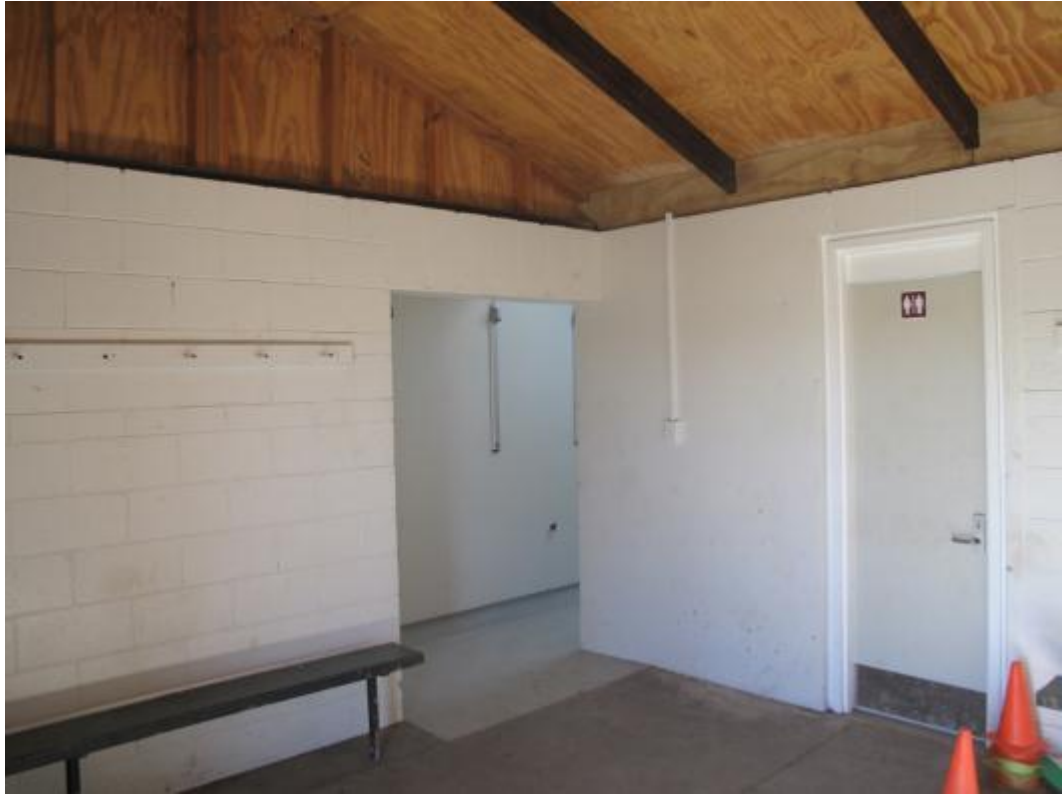
Photograph 5 Concrete masonry lintel over openings

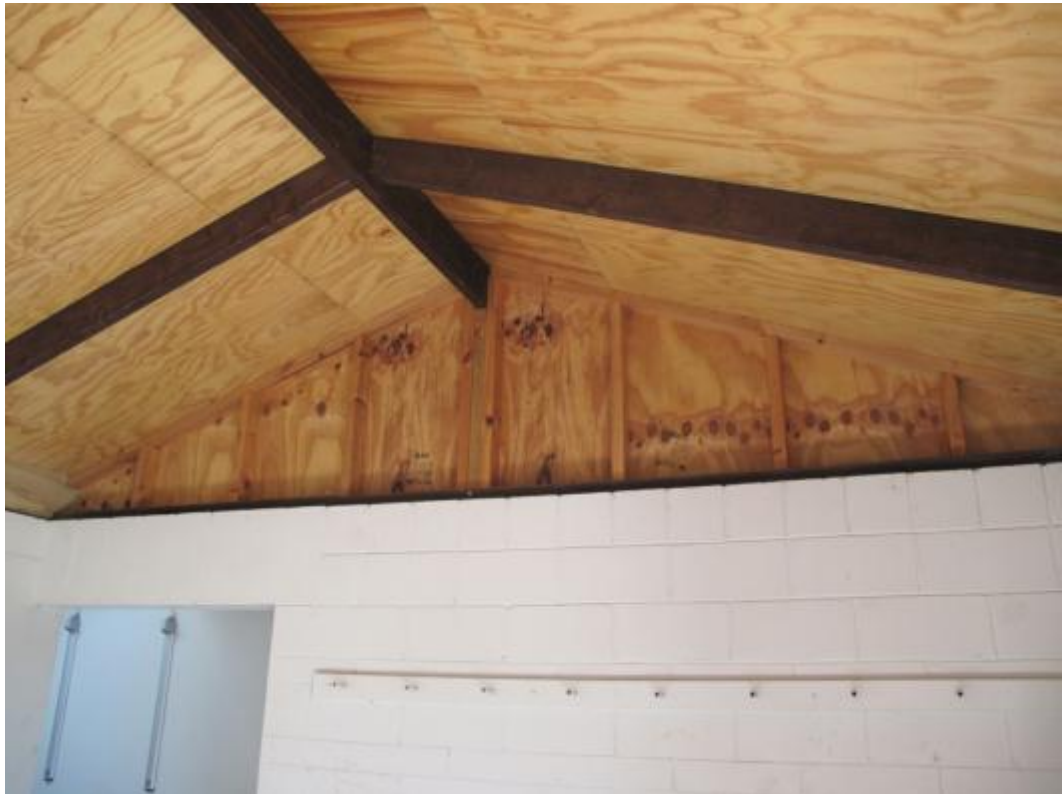
Photograph 6 Plywood lined timber roof structure

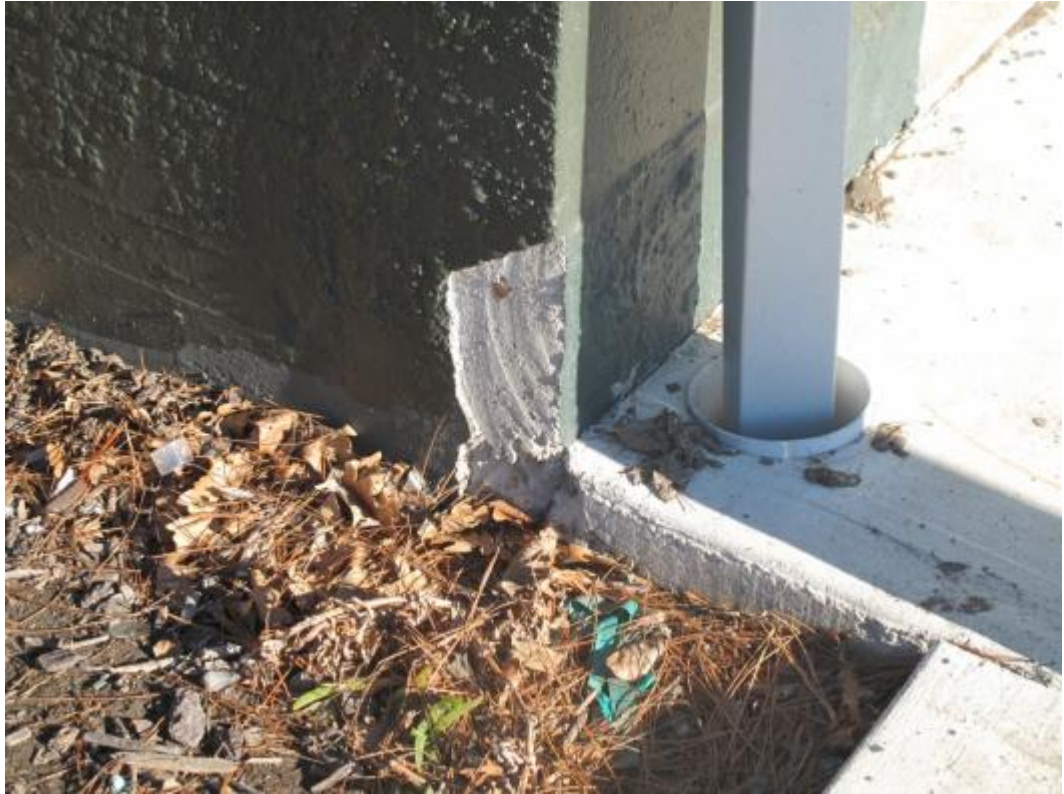
The building was observed to generally be in good condition during the inspection. Minor cracking and chipping of the concrete slab was observed at the joint with the concrete apron. No residual displacements of the structure were observed during the inspection of the building.

The building was observed to generally be in good condition during the inspection. Minor cracking and chipping of the concrete slab was observed at the joint with the concrete apron as shown in Photograph 8.

Photograph 7 Cracking of concrete slab at joint with concrete apron
