**Brougham Village Blocks G and H
Detailed Engineering Evaluation
Quantitative Report**

Detailed Engineering Evaluation Quantitative Report

Brougham Village Blocks G and H
BU 1072-008 EQ2 and BU 1072-009 EQ2

95 and 97 Hastings Street, Sydenham, Christchurch

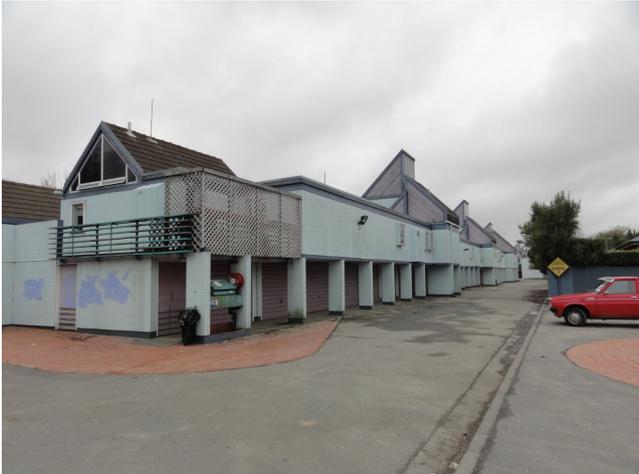
South Elevation of Units 356 – 372

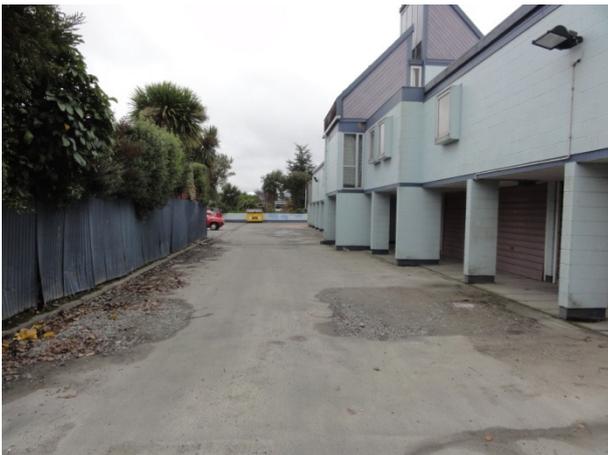
View East, damage to Asphalt

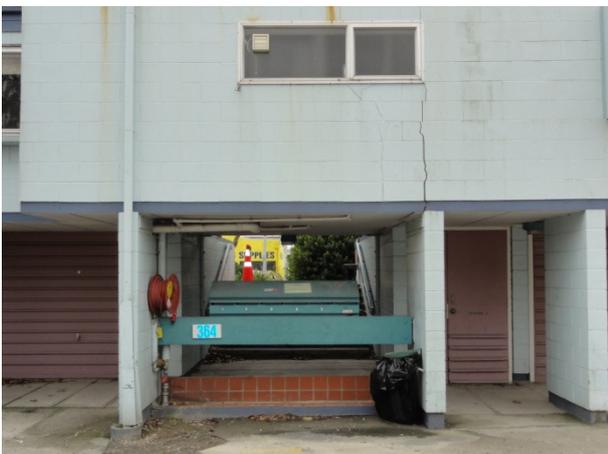
Structural Damage to 2nd and 3rd Storey at Unit 364

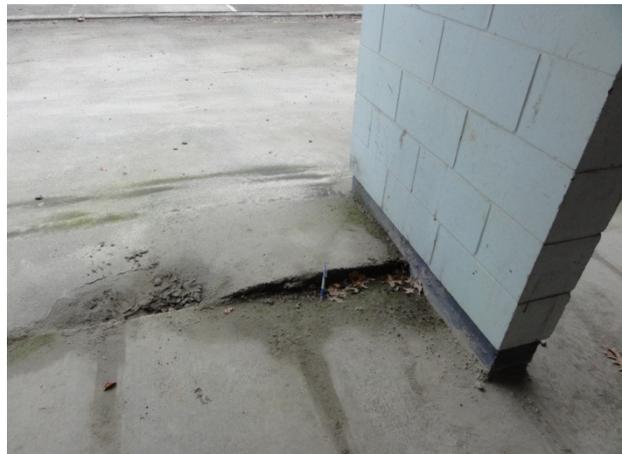
Ground Heave at footing adjacent to Unit 364

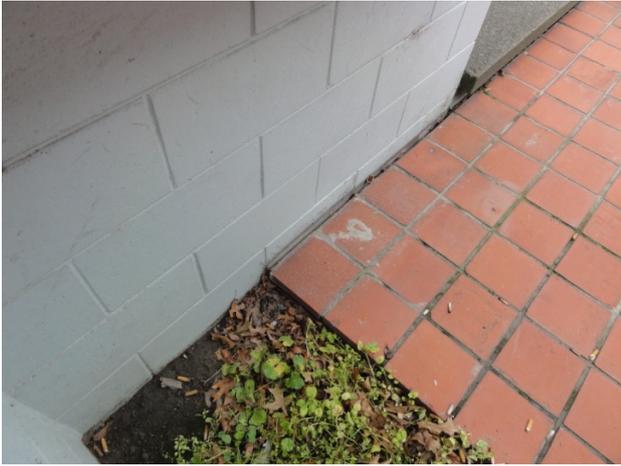
10mm crack, movement towards Brougham Street at Unit 368

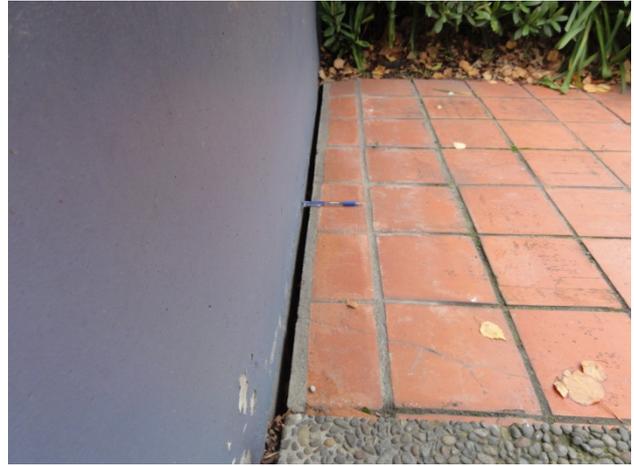
Another example

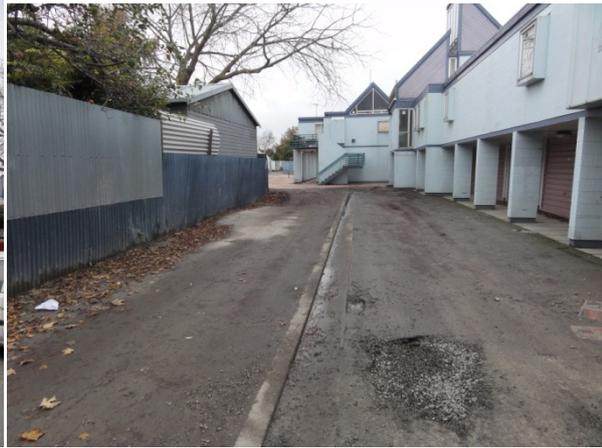
Heave and damage to driveway.

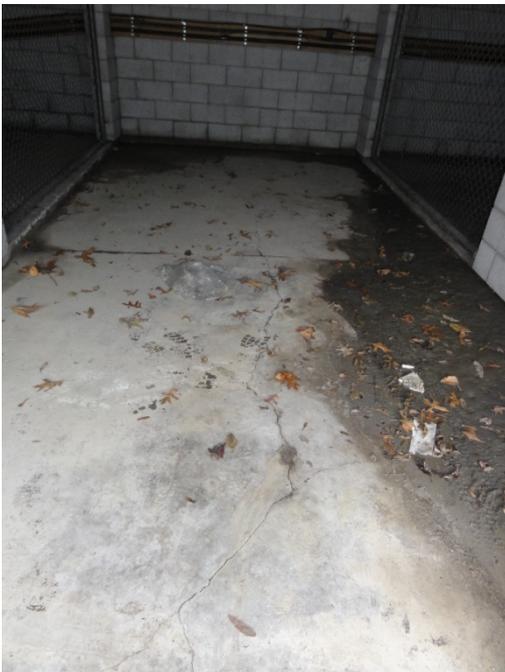
Garage 33 near Unit 388 crack in floor slab and liquefaction

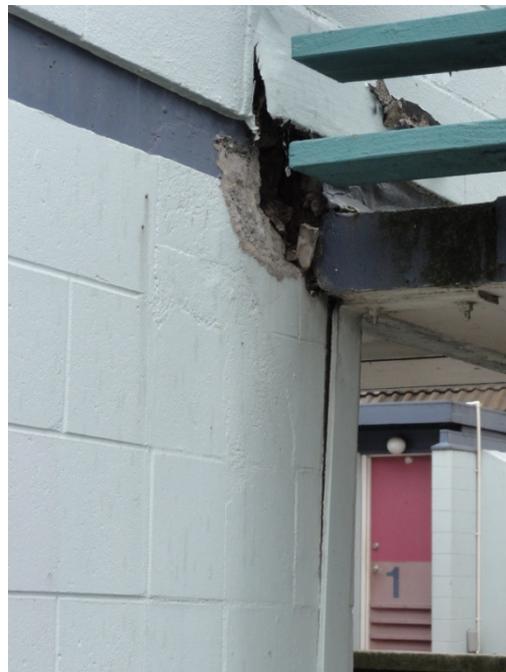
Typical Structural Damage

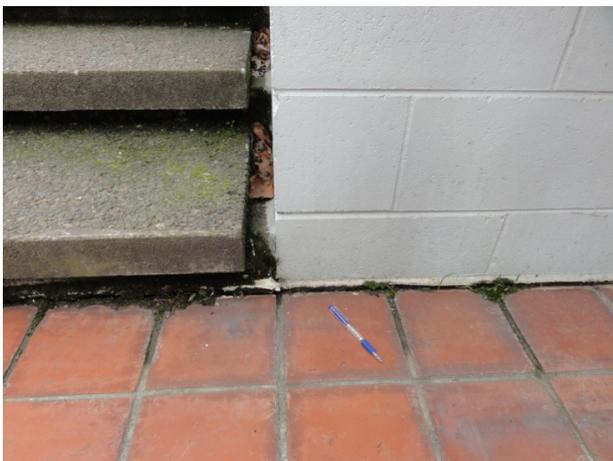
10mm settlement of patio tiles

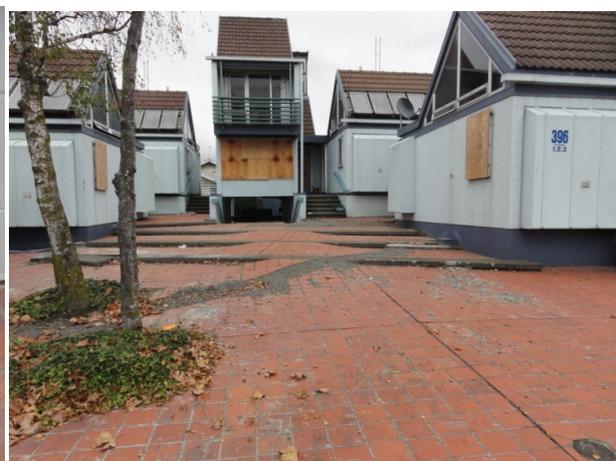
Typical damage to buried services

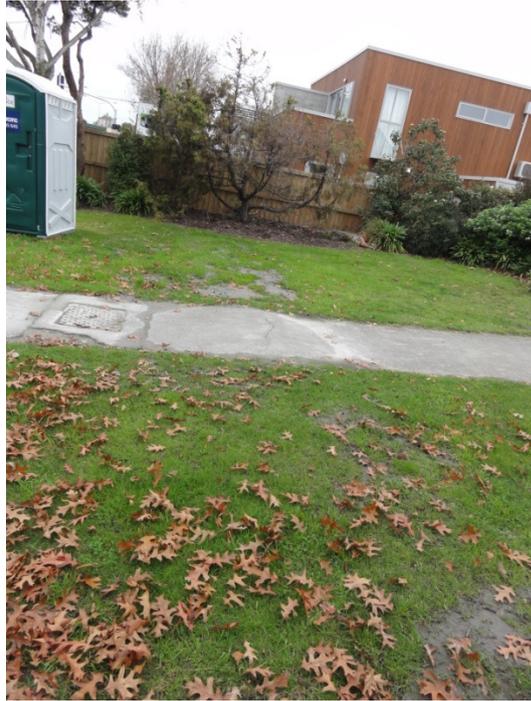
Ground Heave above service trench

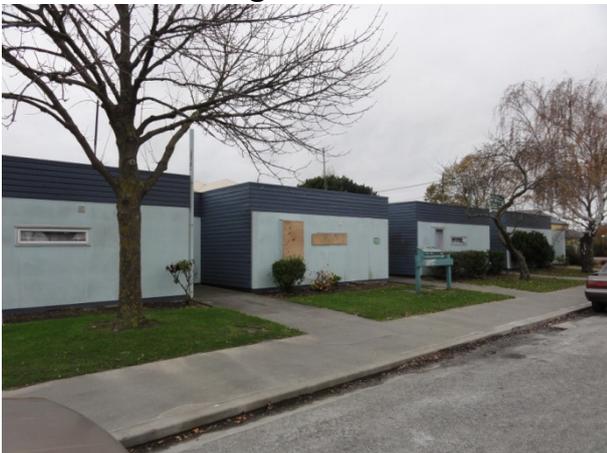
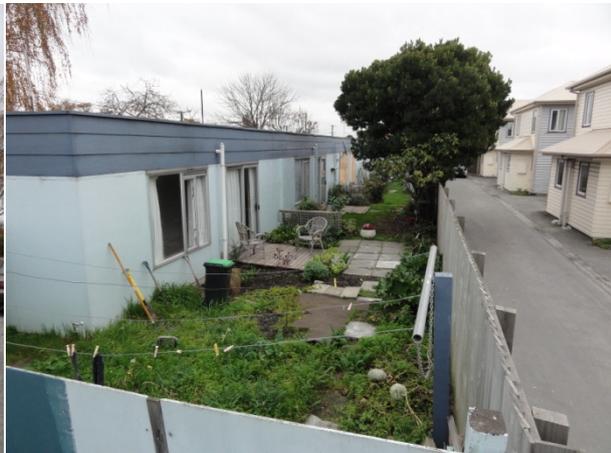
No visible damage, unit 2 yellow stickered due to severe liquefaction

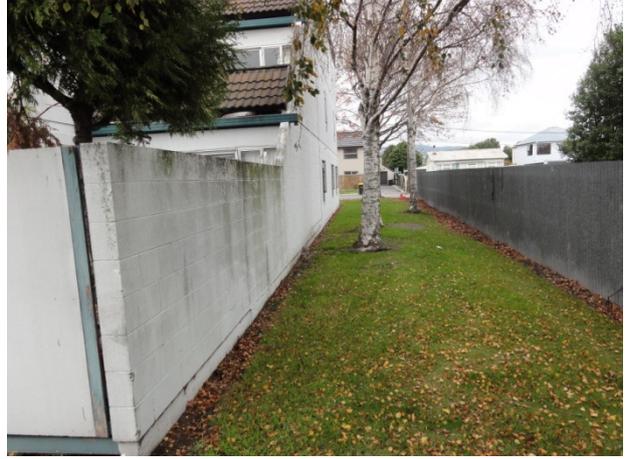
Western limit, no damage visible
