**Bruce Terrace
Cottages
Housing Complex
PRO 3652**

**Detailed Engineering Evaluation
Quantitative Assessment Report**

20 Bruce Terrace, Akaroa

Date: March 2014
Reference: 6-QC321.00
Status: Final

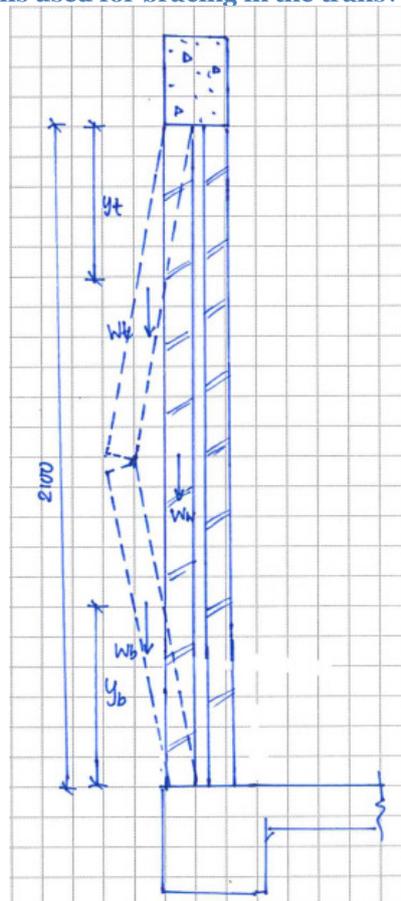
Figure 10: Rocking mode for one skin in the double concrete block wall.

The double skin block walls have a brittle failure mechanism. On site damage indicates that the two skins are not adequately tied. This may be a critical structural weakness depending upon the number of veneer ties.

The residential units have a capacity of 22% NBS as limited by the out of plane rocking mode of the double skin block walls.

Rocking modes of the double skin concrete block walls were also considered. This is demonstrated in Figure 10.

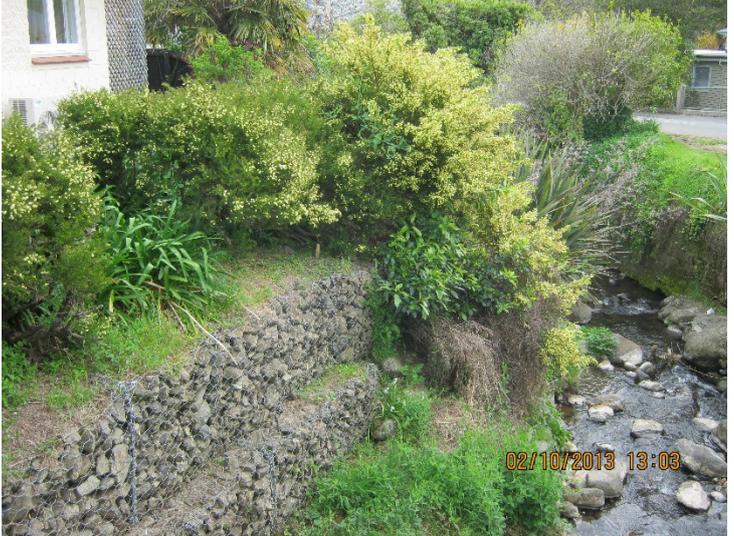
The residential units performed adequately as would be expected from the construction type and location. The residential units suffered moderate structural damage due to the construction type and proximity to a watercourse (photo 5).

<p>5.</p>	<p>Nearby stream and bank protection</p>

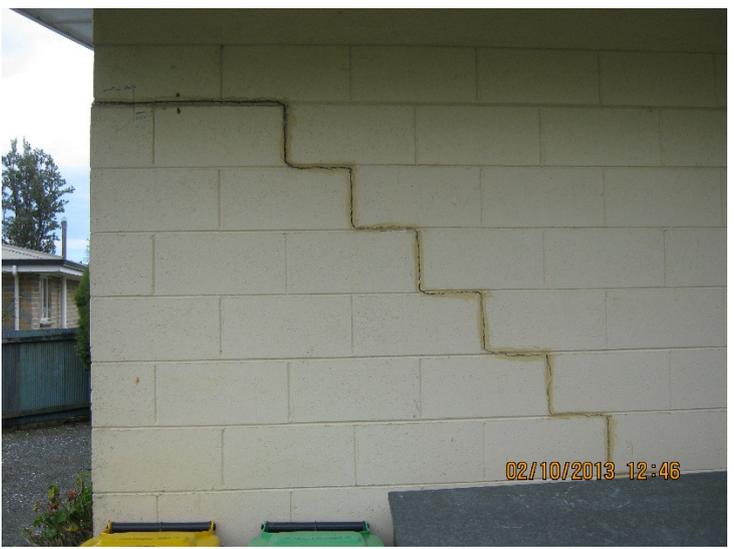
The residential units have suffered moderate damage to structural and non-structural elements. This included cracking of the double concrete block walls through both wythes. Significant step cracking was observed at the ends of the residential block. Cracking of internal linings was not observed on site due to repairs being completed prior to inspection. Settlement was observed at the end of unit 1, closest to the river. Some of this is movement pre-dates the earthquakes and is thought to be caused by flood events and building subsidence.

Cracking to the concrete block exterior walls and block firewall was observed in all units. This was most severe in Unit 1 where cracking has propagated through both skins of block wall (photo 13). Significant stepped cracking was observed at the ends of Units 1 and 3 (photo 11).

- Structural schemes be developed to increase the seismic capacity of the building to at least 67%NBS. Temporary propping may be installed in the short term.
- A veneer tie investigation be carried out to determine the frequency of ties and assist with the temporary strengthening solution.
- A geotechnical investigation be conducted to investigate the bank stability to provide foundation recommendations for remediation works.
- Cosmetic repairs be undertaken as required.

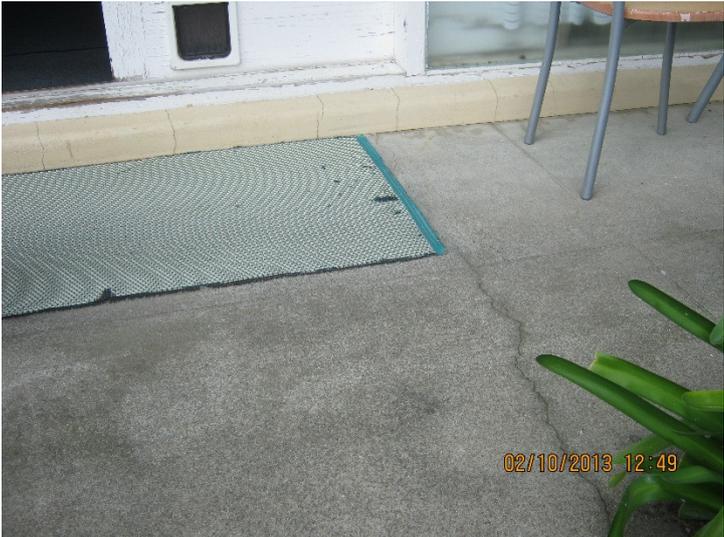
12.	Cracking of the concrete entrance patio

Ground settlement around Unit 1 has caused a gap to form under the corner of the concrete entrance patio (photo 15). Cracking of the concrete entrance patios was observed in all units (photo 12).

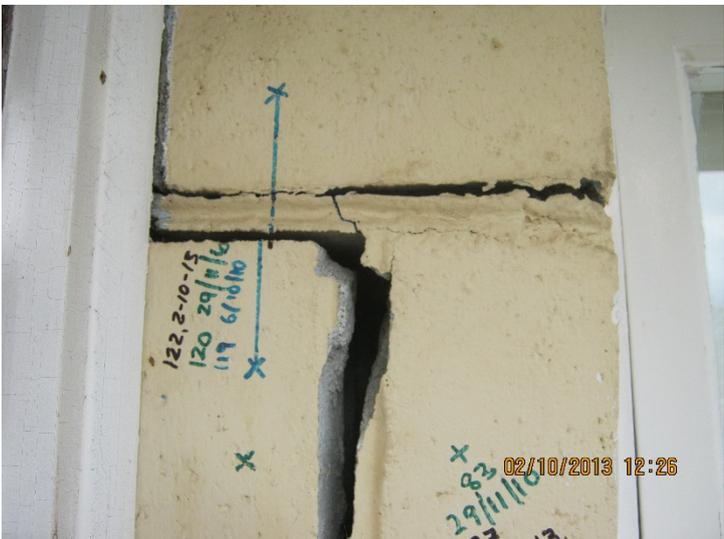
Severe cracking of the concrete block walls and firewalls reduce the lateral-resistance capacity of the structure. Cracking in the internal linings was expected to be observed however these have been repaired prior to the inspection.

13.	Cracking through both brick wythes (Unit 1)

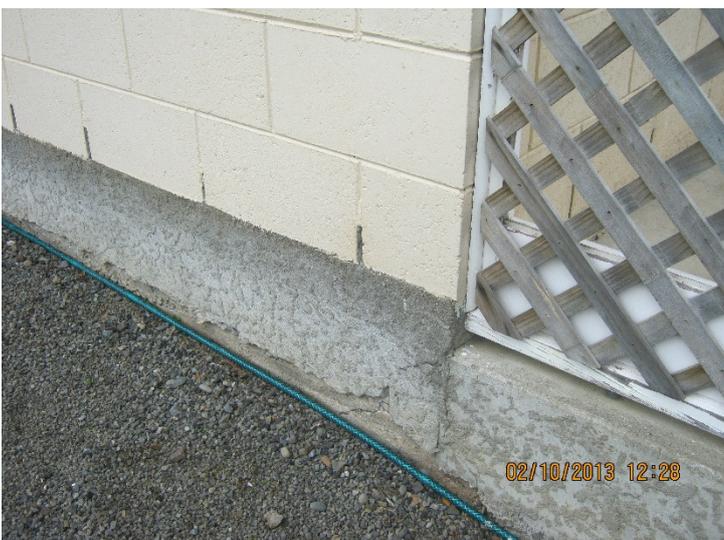
Minor cracking was observed in the render on the concrete pad foundation in Unit 1 (photo 12).

14.	Minor cracking of concrete pad foundations (Unit 1)

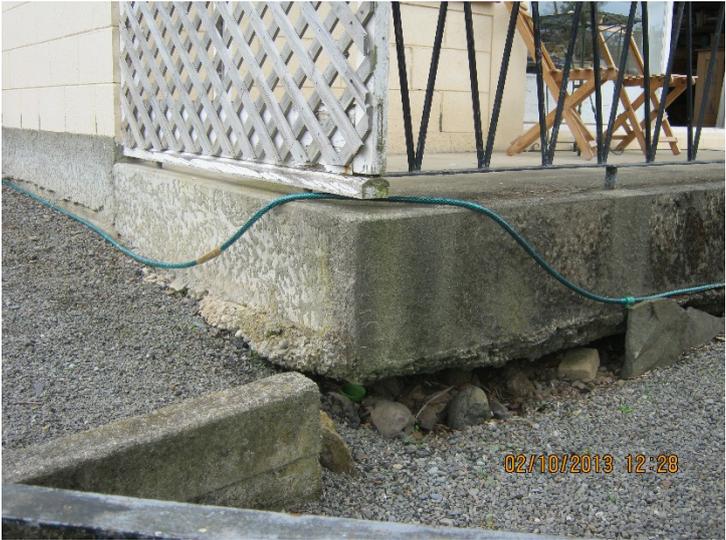
<p>15.</p> <p>Gap under concrete patio (Unit 1)</p>

Further investigation is warranted into the causes of the banks instability, and is recommended to provide foundation recommendations for the remediation of the gable end of Unit 1.

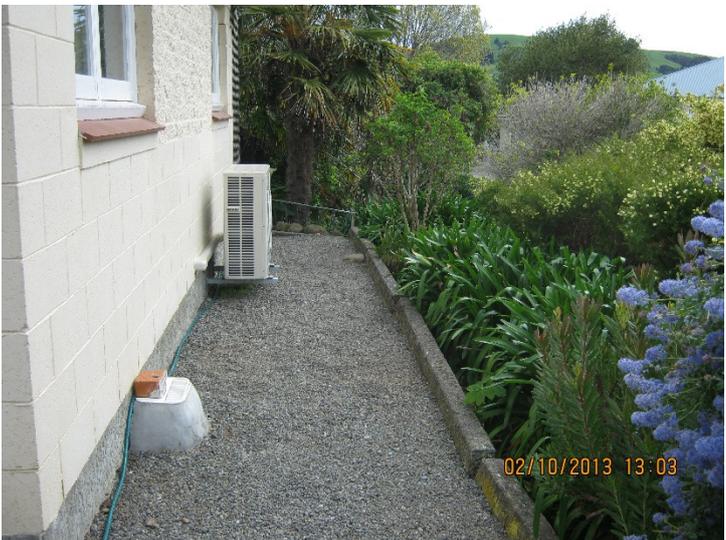
No residual displacements were observed within residential units. Ground subsidence was observed at the end of Unit 1, sloping toward the creek (photo 16).

The site slope is thought to be stable in regards to earthquake movements. Flood events are thought to cause bank subsidence and erosion.

<p>A close-up photograph of a concrete patio structure. The concrete is light-colored and shows signs of weathering. A blue cable runs along the top edge of the concrete. Below the concrete, there is a gap filled with gravel and some rocks. A white lattice fence is visible in the background. A timestamp in the bottom right corner reads "02/10/2013 12:28".</p>
<p>16.</p> <p>Settlement at the end of Unit 1</p>
