Bryndwr Courts Housing Complex
Qualitative Engineering Evaluation

Reference: 232881

Prepared for:
Christchurch City Council

Date: 27 May 2013

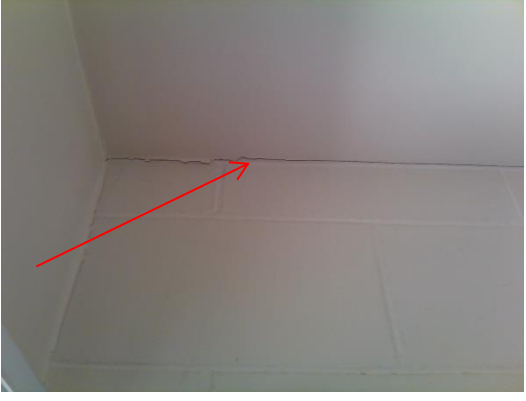
- Cracks were observed along the joints between the reinforced masonry wall and the ceiling or other linings (Photo #1).
- A few cracks were found in the interior plaster lining (Photos #2 and 3).
- A floor level survey using the zip level was carried out on the slab-on-grade and structural slab and has shown that the levels do not exceed the DBH guidelines limits (see Appendix A).

<p>#1.</p>	<p>Cracking at joint between the reinforced masonry wall and the ceiling or other linings.</p> <p>Block A Units #1, 2, 3,</p> <p>Block B Units #6, 7, 9,</p> <p>Block C Unit #11,</p> <p>Block D Units #16, 20.</p>

1. All cracks in the exterior cladding should be repaired.
2. Cracks in exterior patio concrete slabs of blocks should be repaired.
3. Plaster cracking should be repaired according to plaster specifications wherever applicable.
4. Blocks C,D, and E should be reinforced above 67% NBS in the longitudinal direction and if economically feasible 100% to NBS.

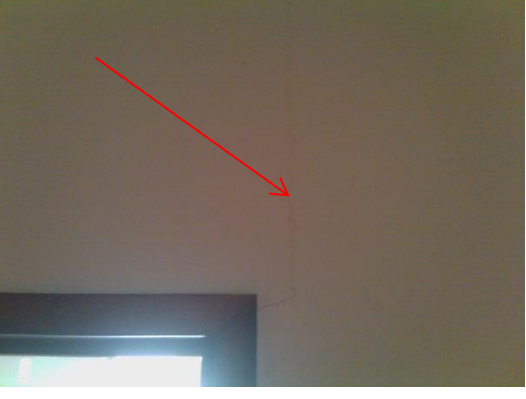
<p>#2.</p>	<p>Cracking in plaster starting at the corner of door or window.</p> <p>Block A Units #1, 2, 3,</p> <p>Block B Units #4, 5, 6, 7,</p> <p>Block C Unit #12,</p> <p>Block D Unit #20,</p> <p>Block E Unit #26, 27,</p> <p>Block F Unit #32,</p> <p>Residents' Lounge.</p>

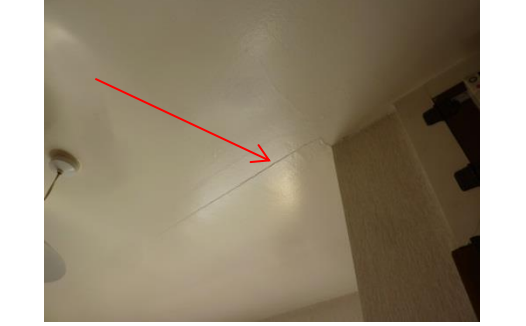
<p>#3.</p>	<p>Cracking of the ceiling linings.</p> <p>Block A Unit #3,</p> <p>Block B Unit #7,</p> <p>Block C Units #10,12,</p> <p>Block D Unit #20,</p> <p>Block E Units #26, 28,</p> <p>Residents' Lounge.</p>

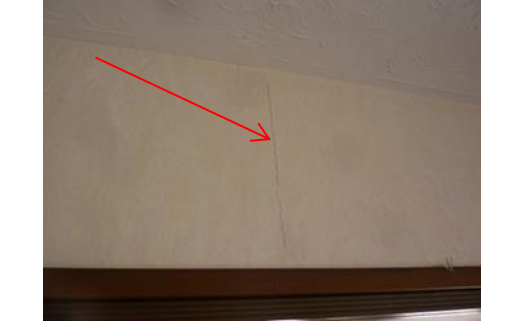
- There is a visible gap between the primary and secondary timber rafters (Photo #2).
- A crack was found on the plaster lining over an opening at mid span (Photo #4).
- Cracking was observed to the exterior slab (Photo #11)
- A floor level survey using the zip level was carried out on the slab-on-grade and structural slab and has shown that the levels do not exceed the DBH guidelines limits (see Appendix A).

<p>#4.</p>	<p>Cracking of linings over an opening, at mid span.</p> <p>Residents' Lounge.</p>

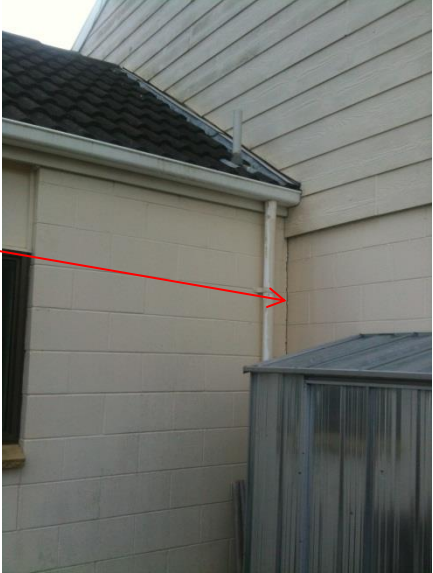
- Some cracks were found in the exterior veneer (Photo #5).
- Cracking was observed along the mortar joint between the two storey high section and the one storey high section (Photo #6).

<p>#5.</p>	<p>Cracking at mortar joint on exterior 90mm block veneer.</p> <p>Block C, Block D.</p>

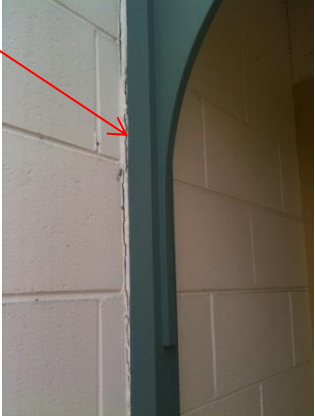
<p>#7.</p>	<p>Cracking at the joint between the 190mm block wall in the transversal direction and architectural elements.</p> <p>Block C.</p>

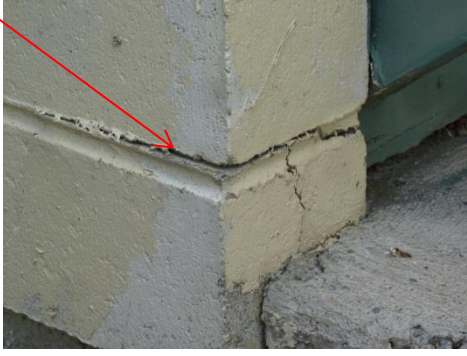
- A few cracks were found in the interior plaster lining (Photos #2 and 3).
- Some cracks were found in the exterior veneer (Photo #5).
- A few cracks were found at mortar joint between the two bottom rows of block, at the end of the wall (Photos #9).
- Cracking was observed to the window block sill continuing through the block wall (Photo #10).
- A floor level survey using the zip level was carried out on the slab-on-grade and structural slab and has shown that the levels do not exceed the DBH guidelines limits (see Appendix A).

#9.	Cracking at mortar joint between the two bottom rows of blocks. Block E.

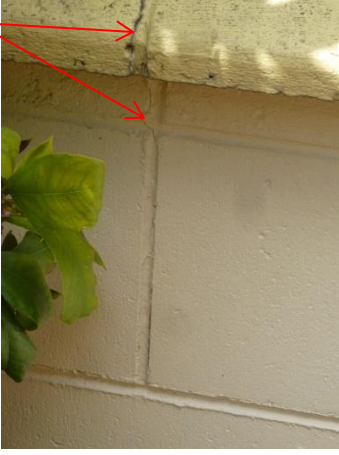
#10.	Cracking of the window block sill continuing through the block wall. Block E.

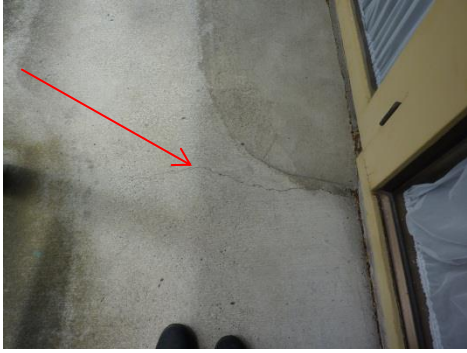
#11.	Cracked exterior slab of the Residents' Lounge.

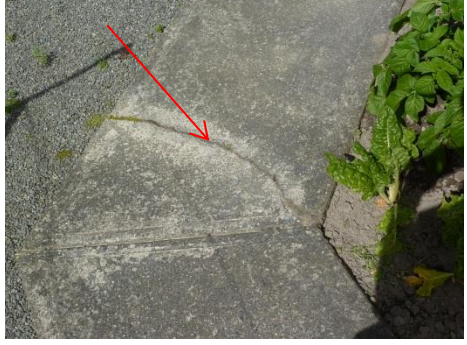
- Some cracks were found along the sidewalk used to access each block (Photo #12).

#12.	Cracked exterior concrete sidewalk.
