Christchurch City Council
PRK_0275_BLDG_015
Burnside Park Water Tower
336 Avonhead Road, Burnside

QUANTITATIVE ASSESSMENT REPORT
FINAL

- Rev B
- 03 October 2013

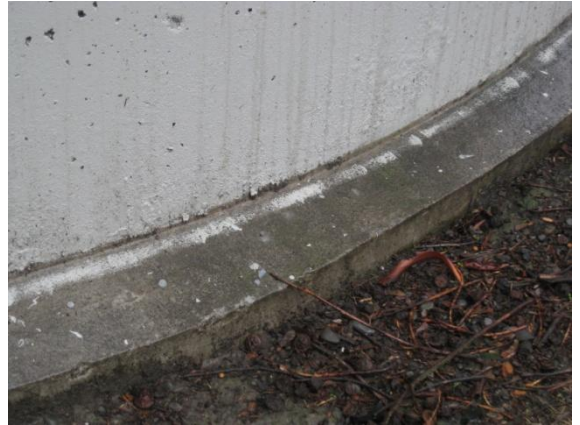
Photo 2: Top of foundation at joint with tower walls.

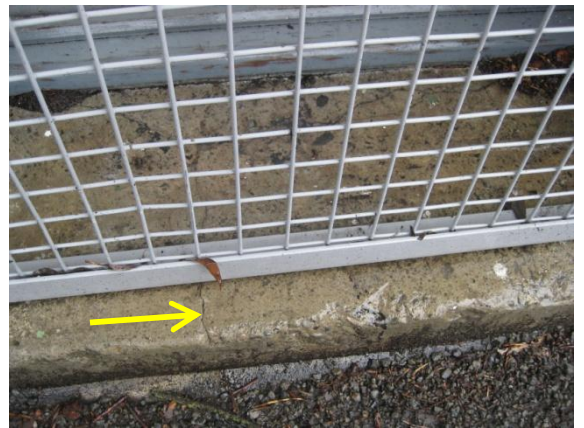
- 1) Hairline cracks in external concrete ground slab at the entrance door and to the north of the entrance.
- 2) Water leakage was suggested from calcium carbonate build-up beneath the top storey extension on the east side of the structure.

Photo 4: Hairline crack located at entrance in top of concrete foundation

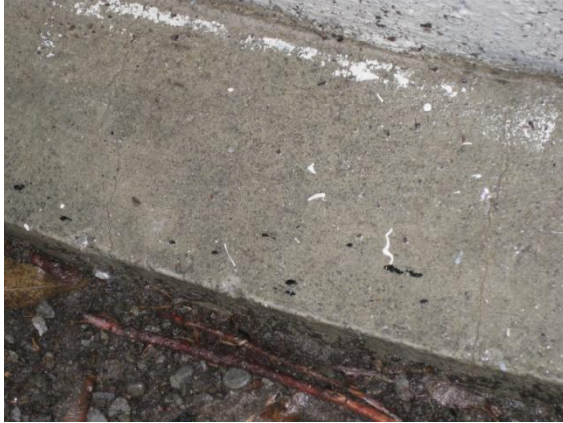
Photo 5: Hairline cracks in top of concrete foundation to the north of the entrance

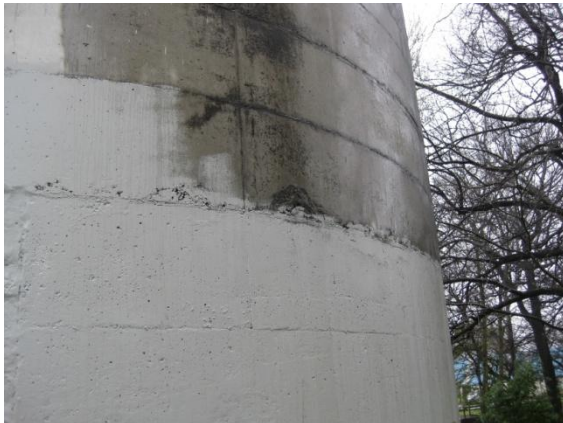
Photo 7: 450mm high shuttering marks in concrete wall.

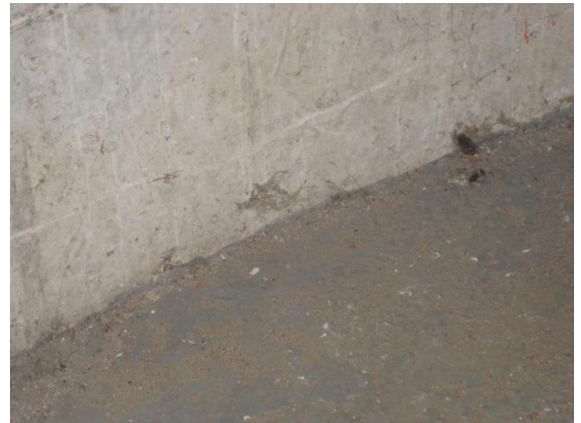
Photo 16: Joint between the concrete foundation and concrete wall

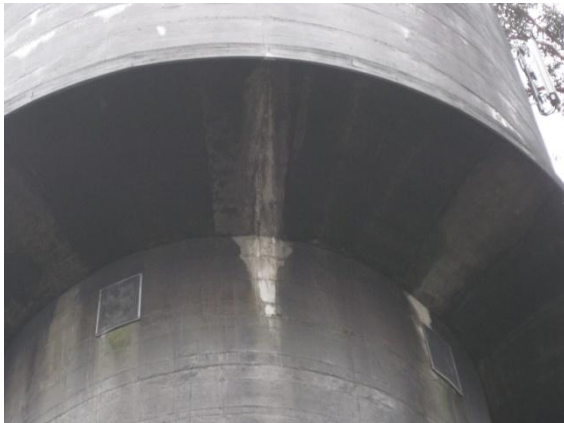
Photo 19: Build up of calcium carbonate noted on the underside of the top level extension indicating water leakage.

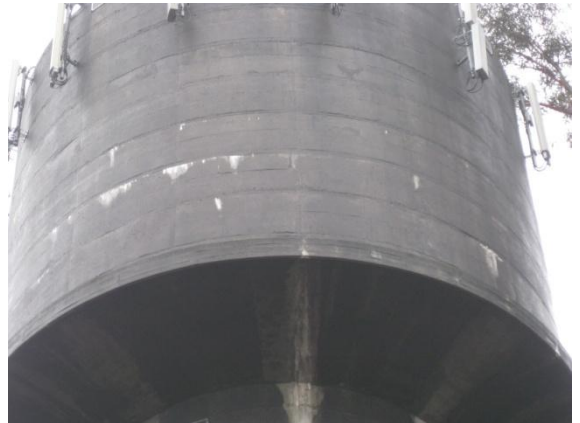
Photo 20: Close-up at the underside of the tank

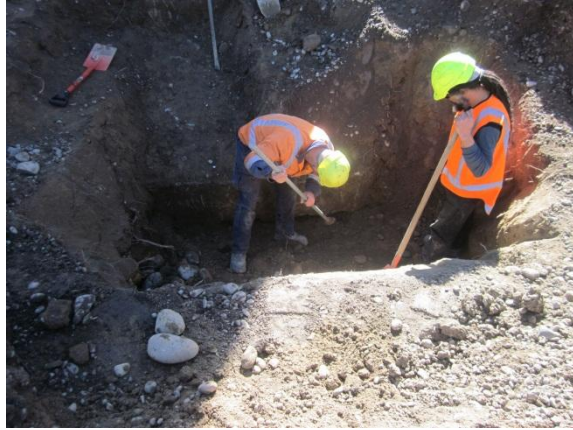
Photo 21: Foundation profile as exposed during excavation.

The ground investigation was carried out on 15 August 2013. It comprised one machine excavated trial pit and one hand-auger hole with DCP tests adjacent to the auger hole. The trial pit was carried out to expose the footing. The underside of the footing was found to be at 2 mbgl and the trial pit was terminated at this depth. The hand-auger hole and DCP tests were then performed in the base of the trial pit to 4.2 mbgl. The approximate location of the trial pit is shown on the site plan in Appendix A.
