# **Burnside RFC & Toilets PRK 0275 BLDG 007**

**Detailed Engineering Evaluation**

**Quantitative Assessment Report**

Date: May 2013  
Reference: 6-QUCC1.63  
Status: Final

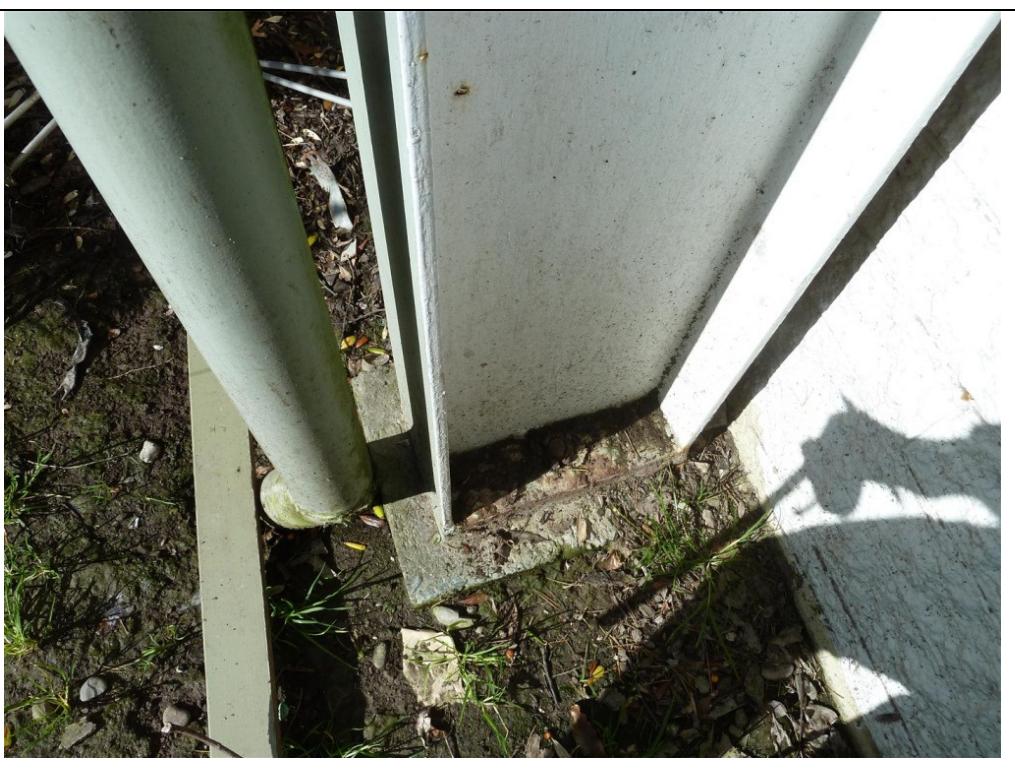
We note here that there is significant corrosion to the original building portal frame baseplates and holding down bolts. This is not seismic damage, but repairs should be undertaken to rectify this.

4.	Portal column view of corroded baseplate

- a) Undertake an intrusive investigation to determine the details, if any, of the roof bracing provided in the original building, and analyse its strength. The roof bracing is expected to be in the roof plane of the wall-braced bay between grids 11 and 12.
- b) Strengthening designs should be developed to increase the seismic capacity of the building to at least 67%NBS.
- c) Undertake repairs to the corroded portal frame baseplates and holding down bolts.

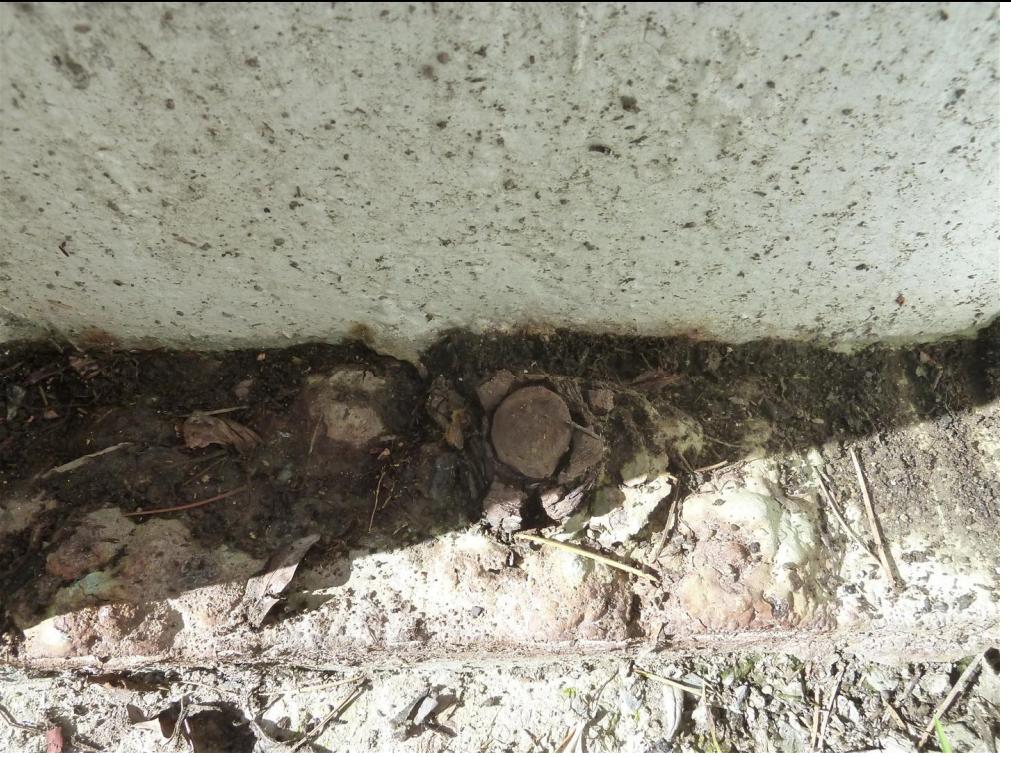
5.	Close-up view of column base showing corroded holding-down nut

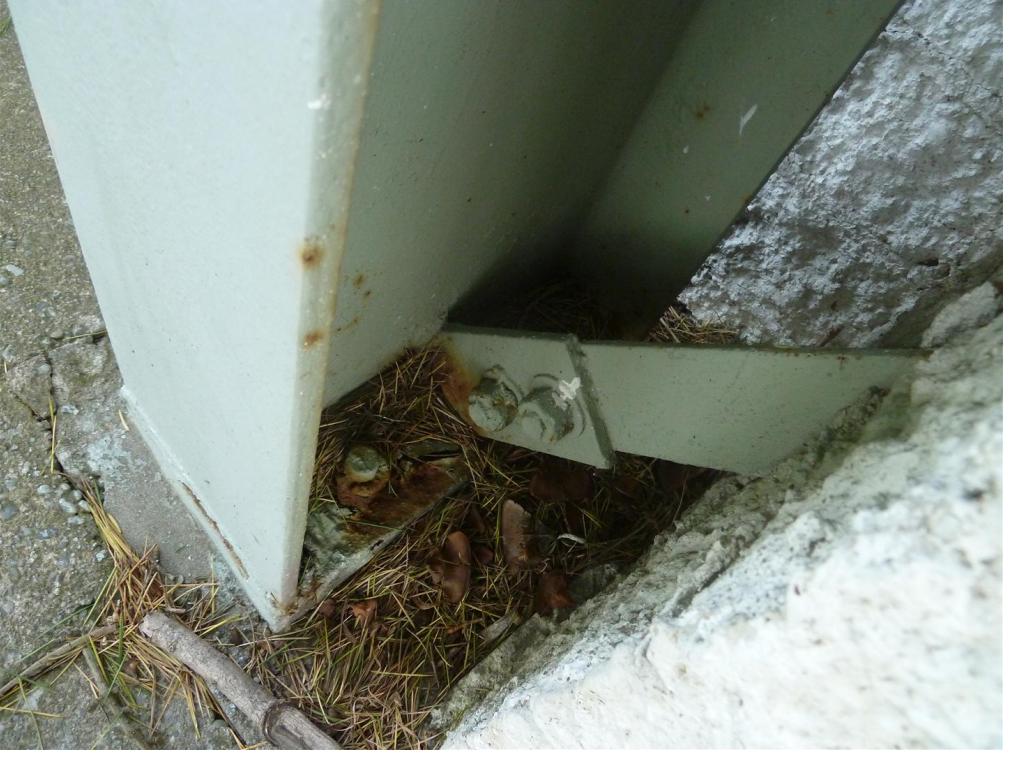
A close-up photograph of a concrete column base. A single, large, round, dark-colored holding-down nut is visible, protruding from the concrete. The surrounding concrete appears weathered and stained. The ground in front of the base is covered with dirt, small rocks, and some dried plant debris.
6.	Steel Bracing connection to portal base

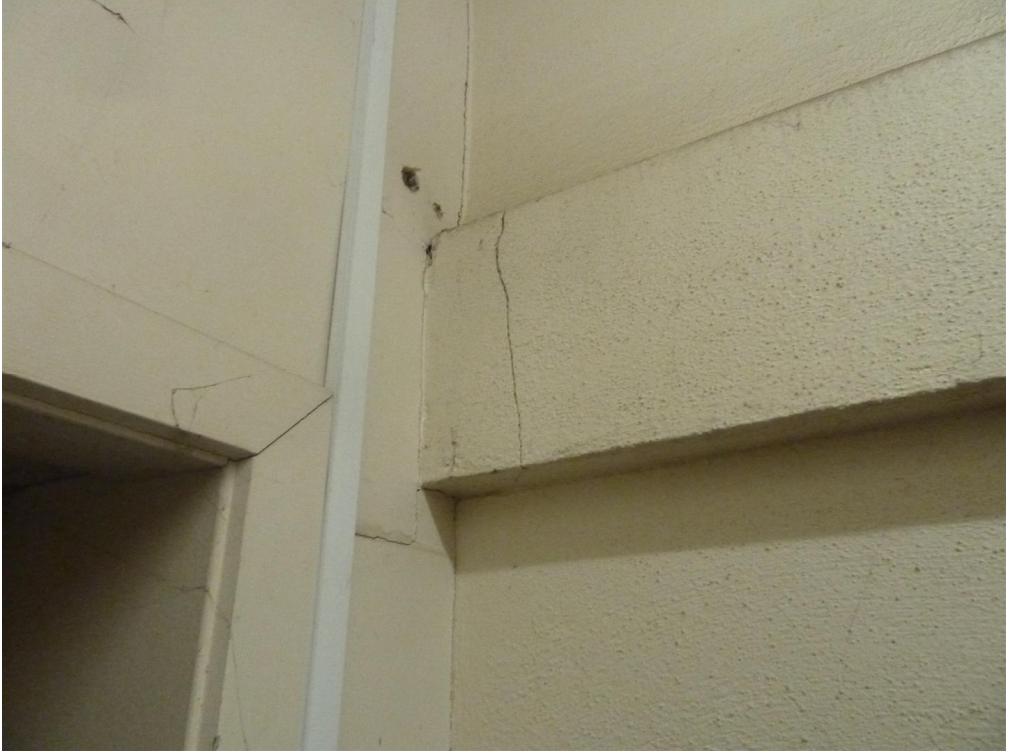
7.	Crack in internal wall bond beam

- d) Undertake repairs to damaged wall cladding around the entrance stairwell, and repair block wall cracks.

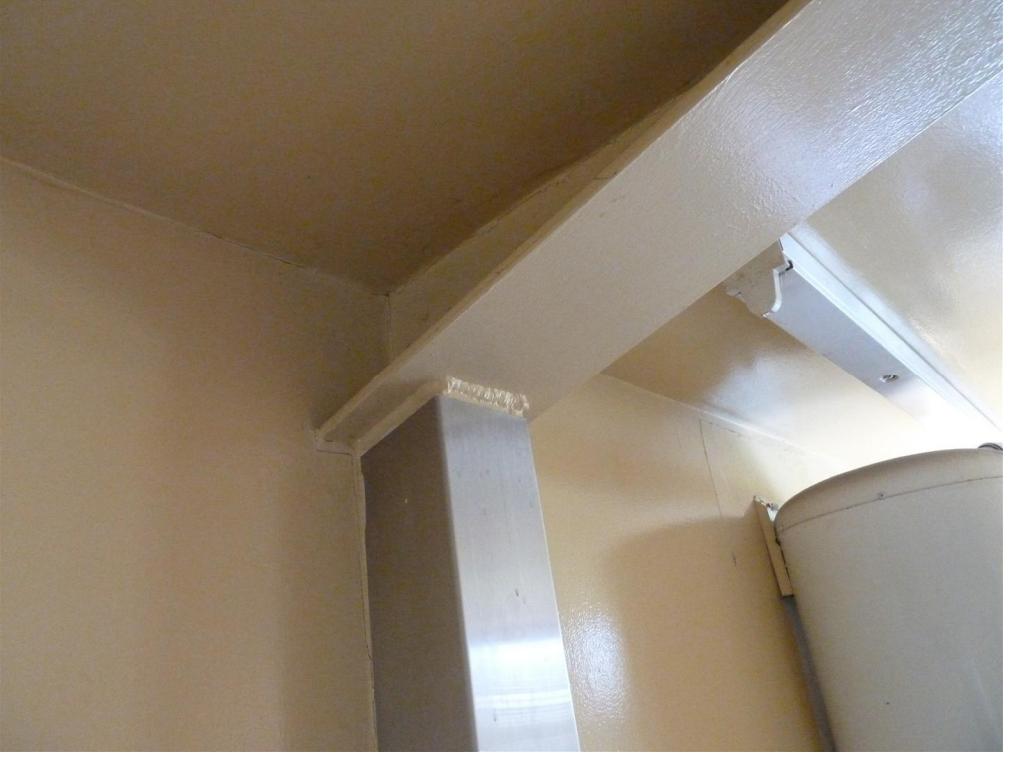
10.	Portal frame - welded column to rafter joint

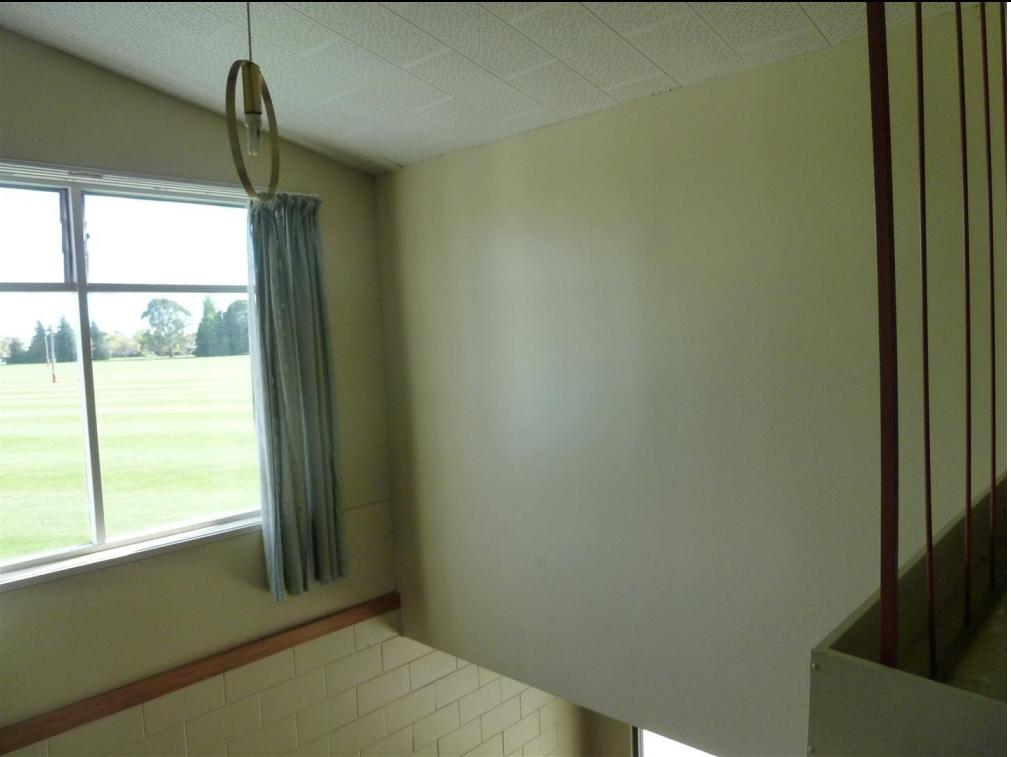
11.	Ply bracing wall over foyer entry stairs

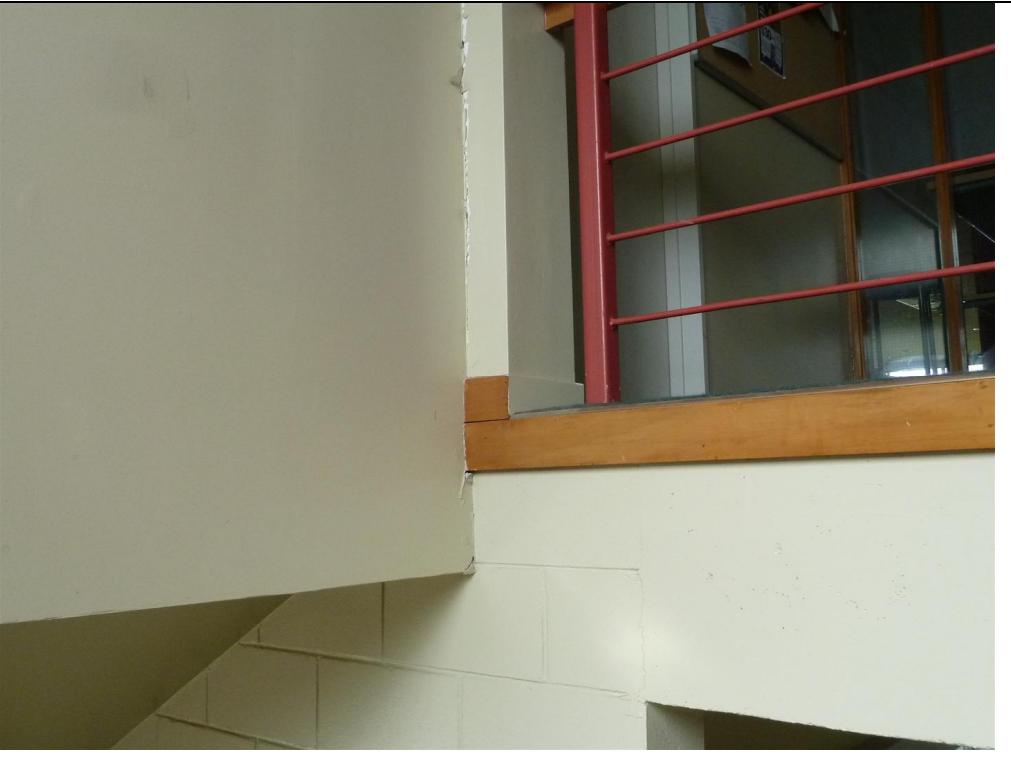
No significant structural damage has been observed following visual inspections undertaken following the 22 February earthquake. There is cracking to plasterboard wall lining, mainly around the upper level walls to the entrance stairs, and also minor block wall cracks, indicating that large displacements have occurred during seismic activity.

12.	Cracking at edge of ply bracing wall over foyer entry stairs

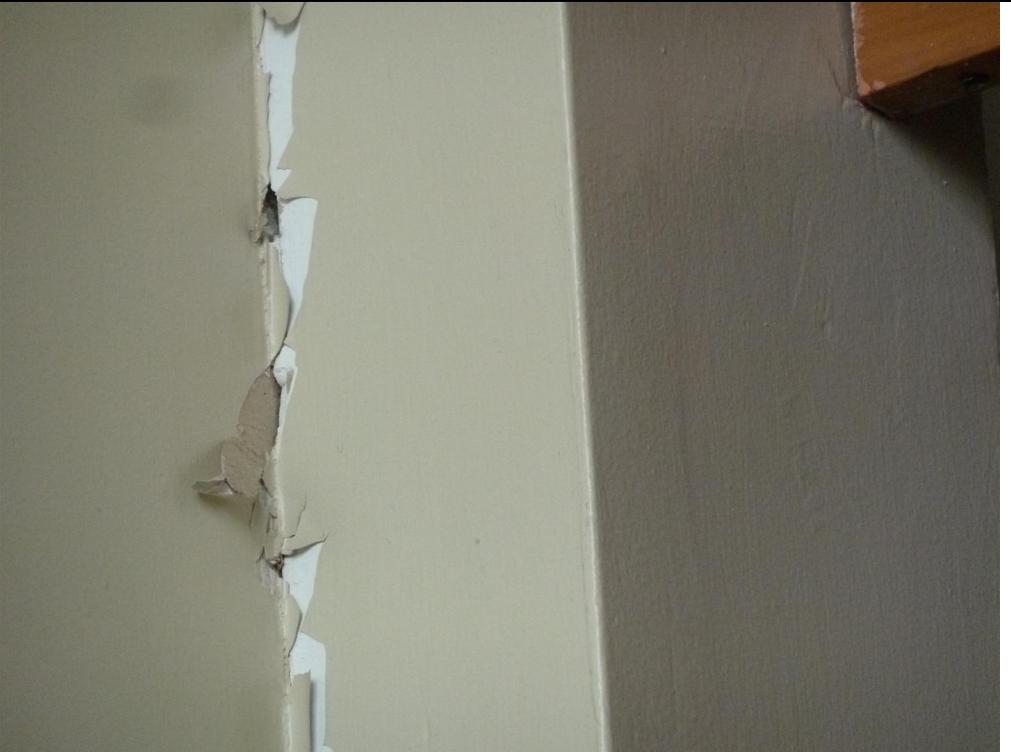
13.	Close up view of ply wall brace cracking

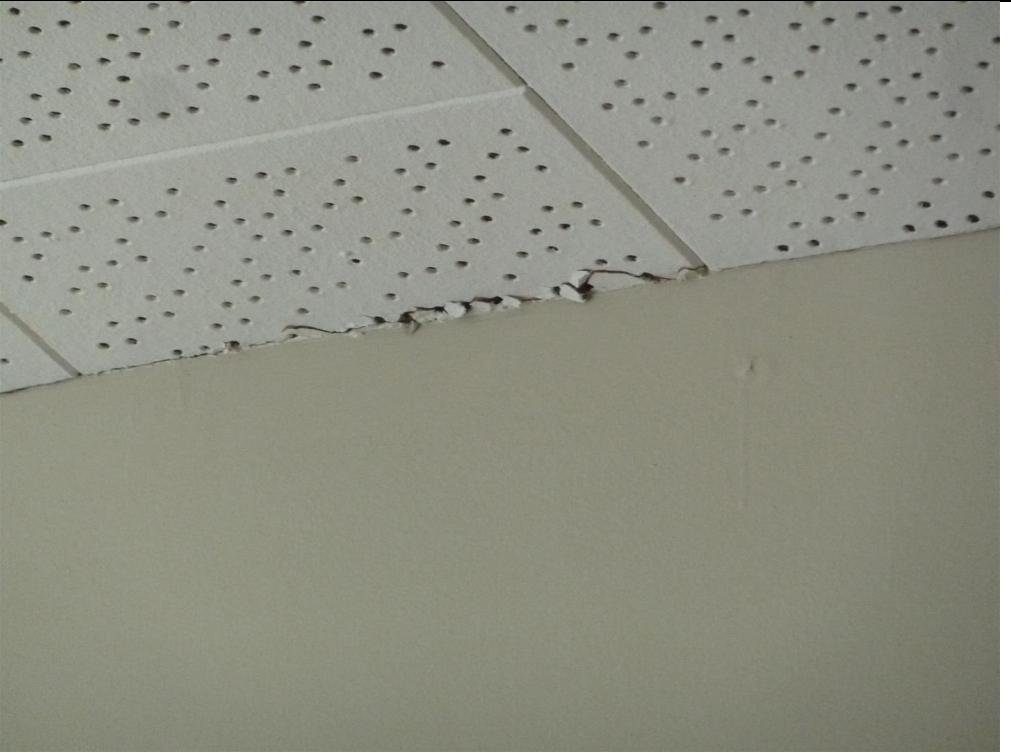
14.	Wall ceiling cracking to ply bracing wall at foyer entry stairs

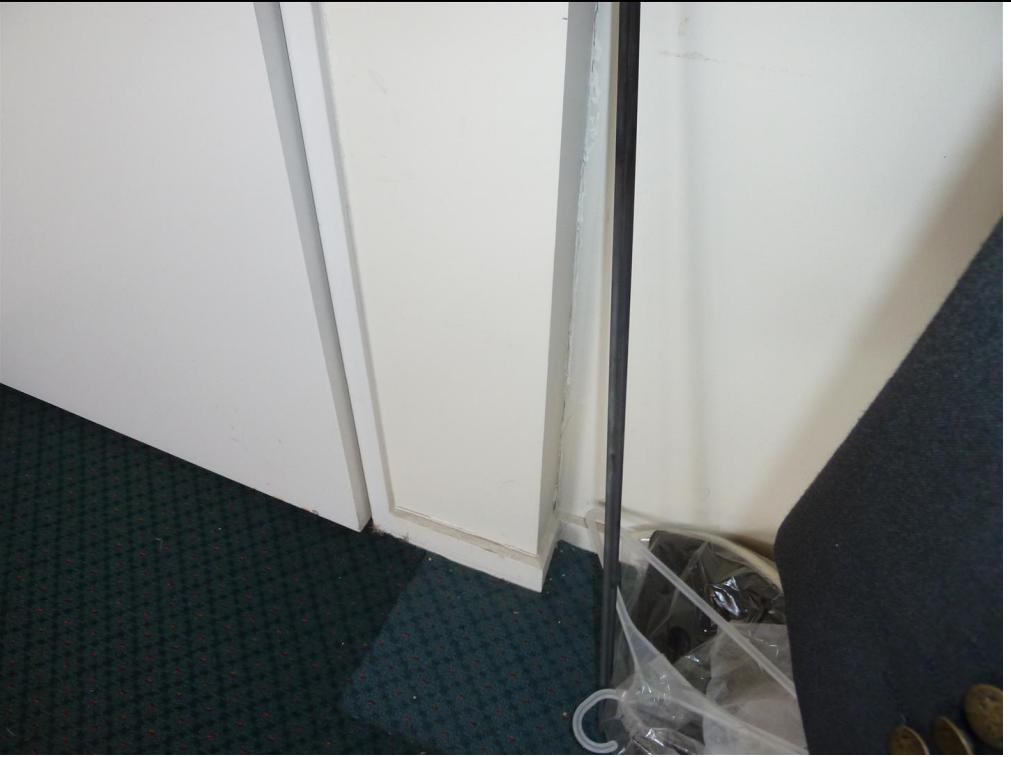
15.	Wall joint cracking to 1 <sup>st</sup> floor office

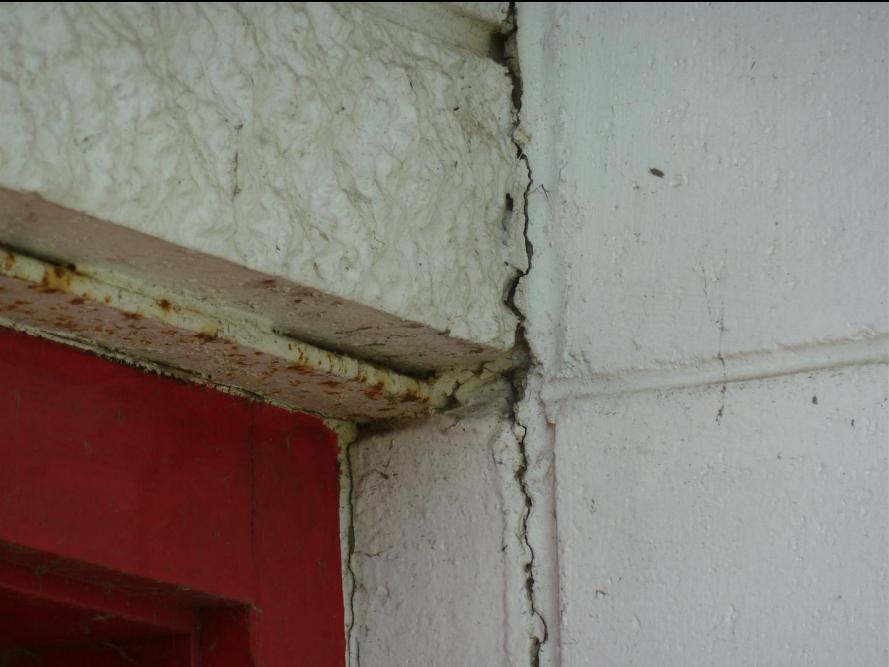
21.	Cracking at joint interface with original building

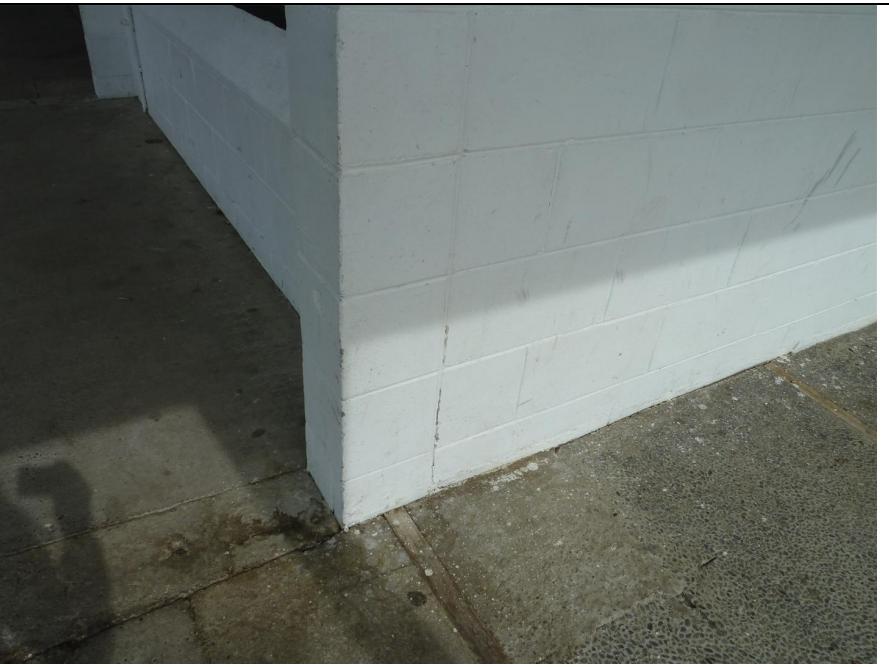
22.	Crack in blockwork at interface with 1981 extension

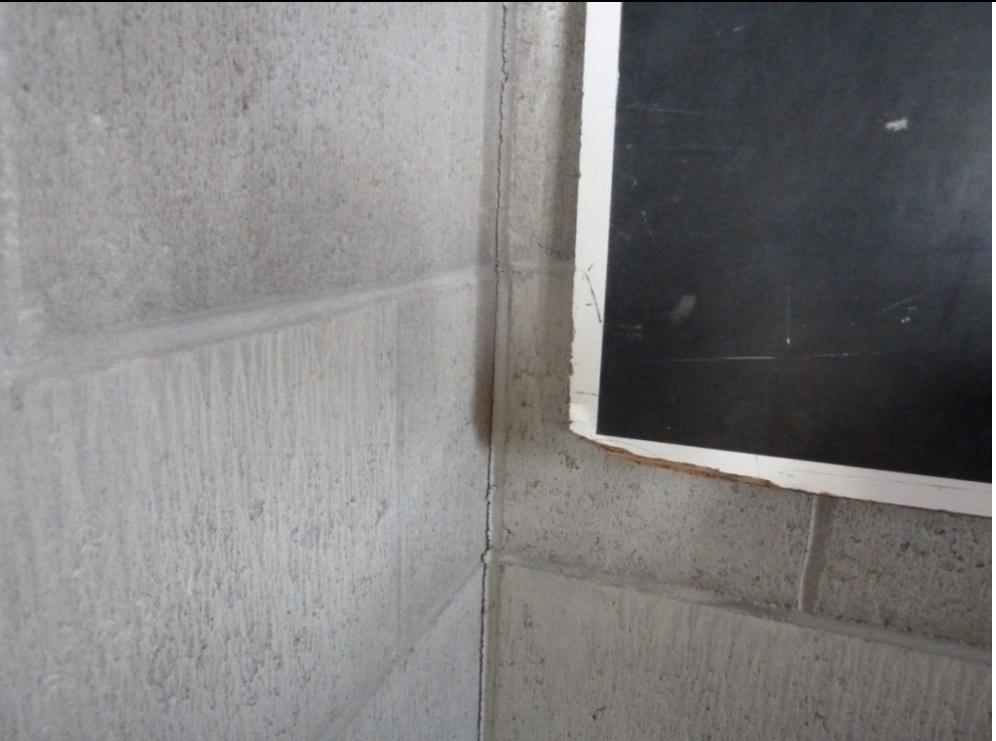
29.	Crack to block wall joint in scrum room
