# Office and Cafeteria Building – Christchurch Wastewater Treatment Plant – Detailed Engineering Evaluation BU 0879-016 EQ2 Qualitative Report

**Prepared for Christchurch City Council**

**By Beca Carter Hollings & Ferner Ltd (Beca)**

2 April 2014

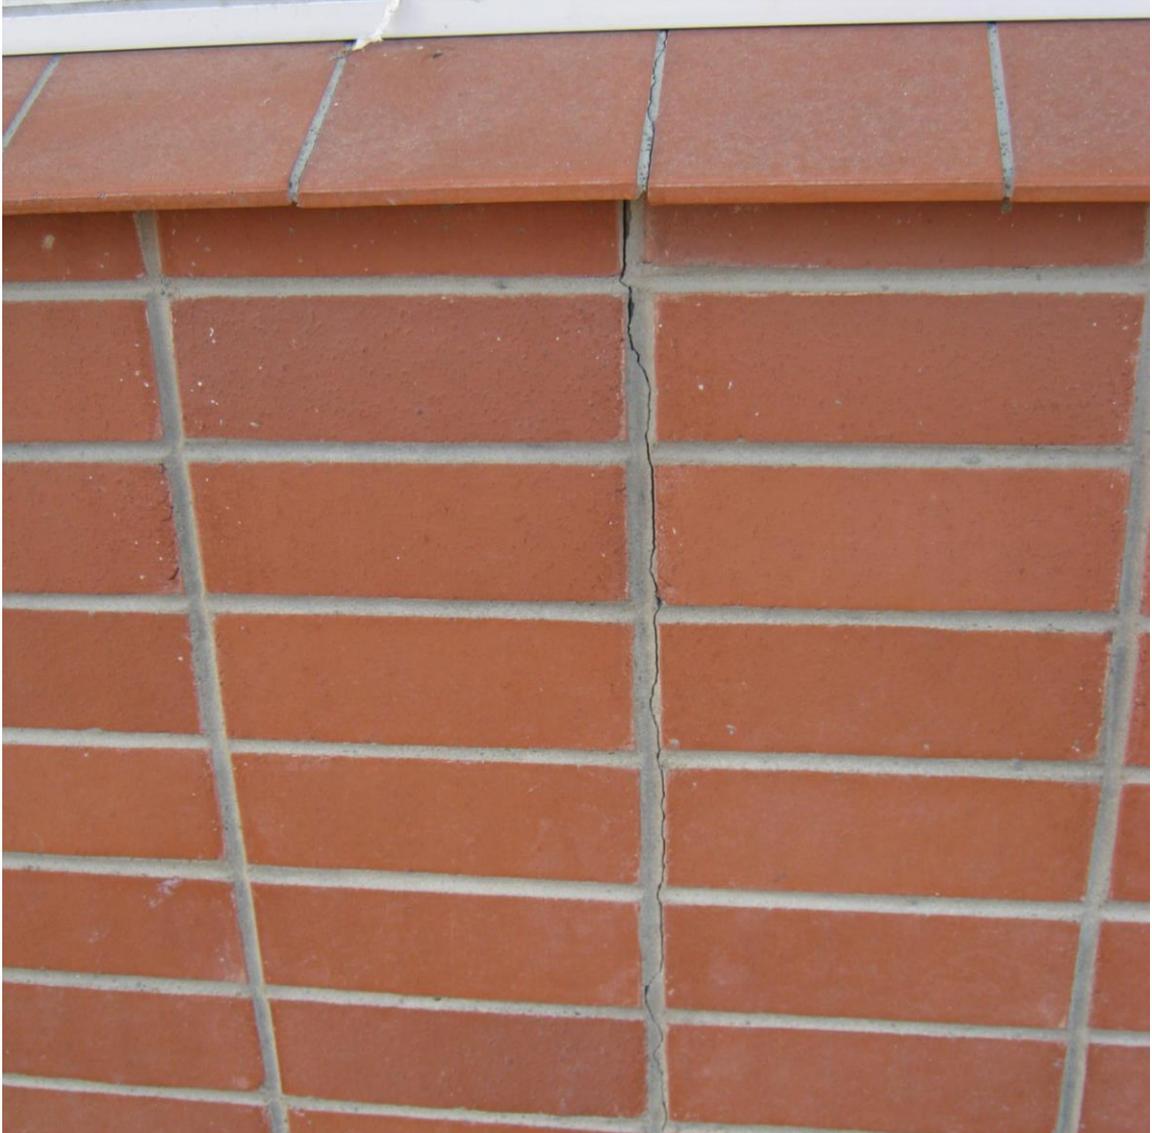
**Damage at location 1**

**Typical crack at masonry mortar**

General damage description: Damage to mortar in masonry elements.

Recommended repair: damaged mortar should be removed and masonry re-pointed.

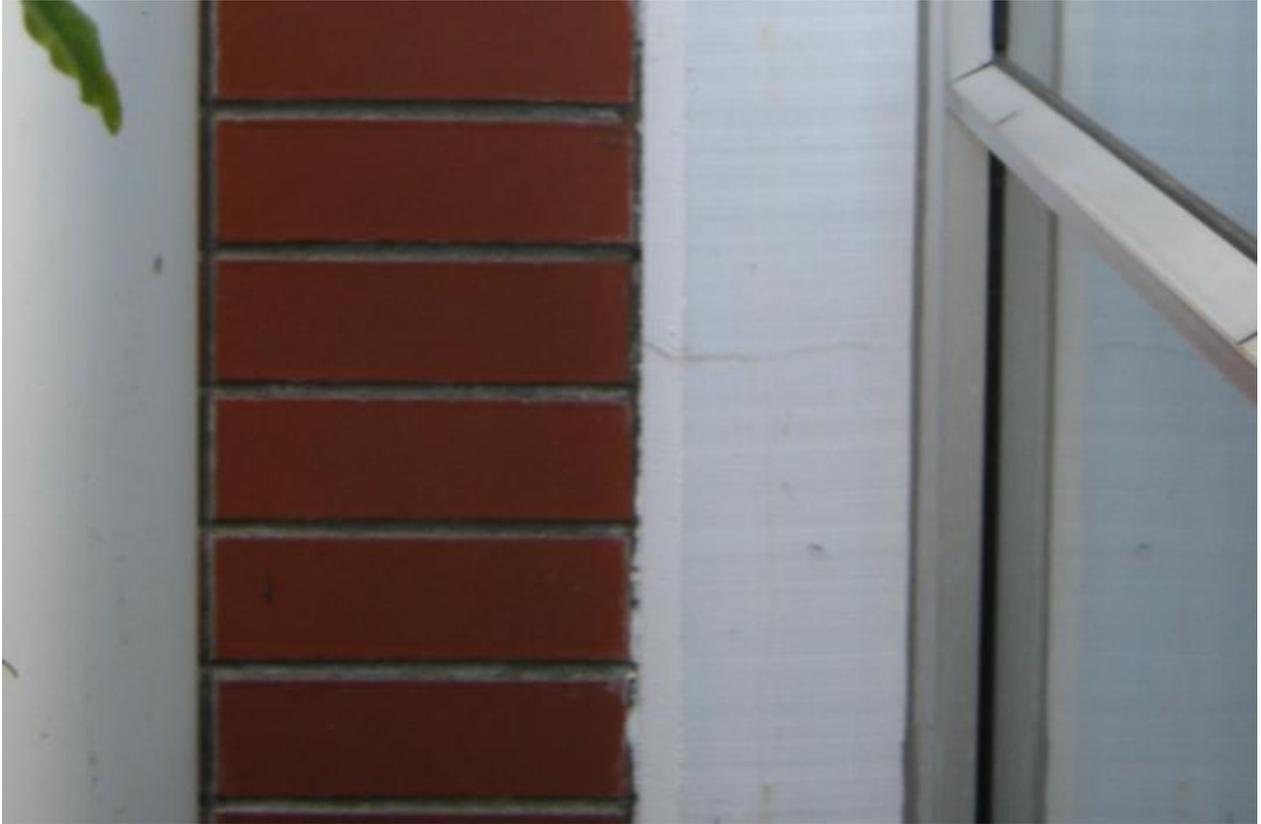
## Damage at location 2

### **Typical crack at concrete frame (less than 0.4mm crack width)**

General damage description: Cracks in concrete structures that do not exceed a width of 0.4mm. These cracks are not likely to have any adverse effect on the structural capacity or durability.

Recommended repair: Epoxy injection of cracks over 0.2 mm in width.

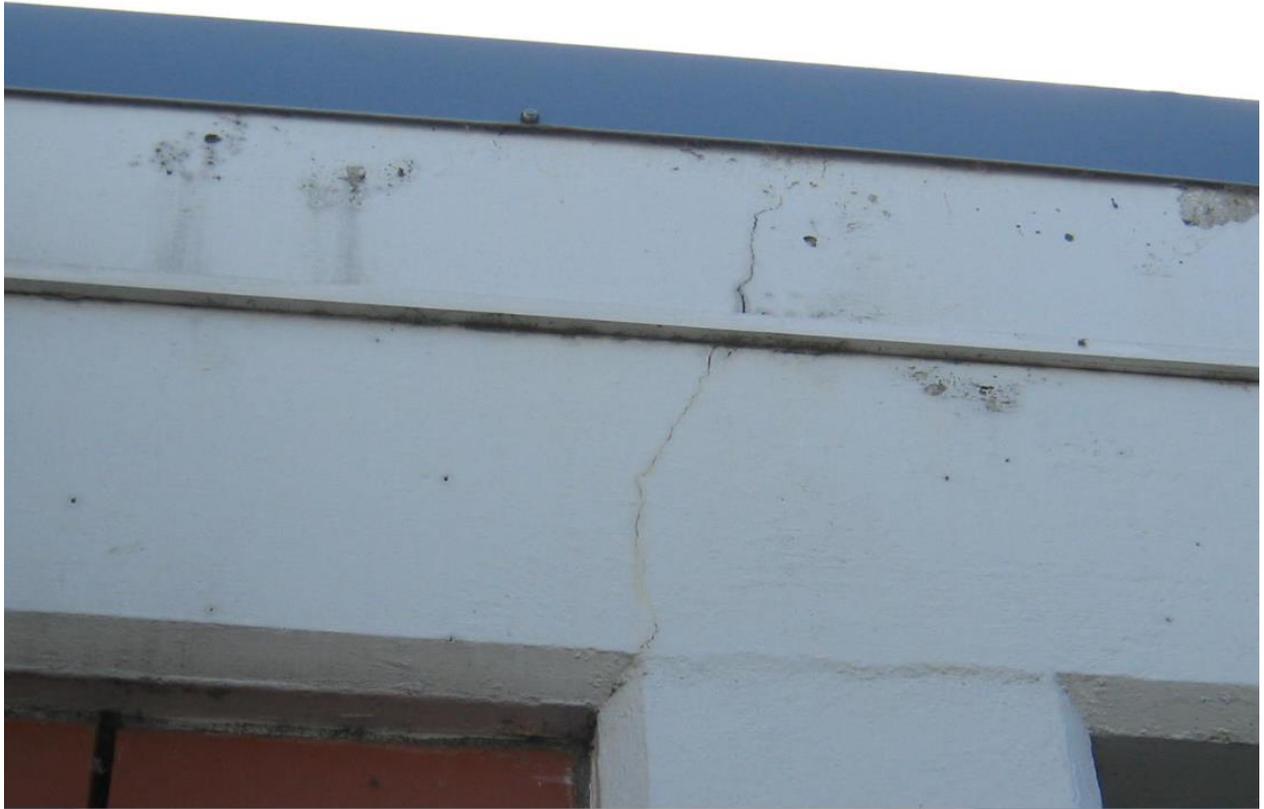
### Damage at location 3

#### **Typical crack at concrete frame (exceed a crack width of 0.4mm but less than 1mm)**

General damage description: Cracks in concrete structures that exceed a crack width of 0.4mm, but less than 1.0mm. These cracks require remedial work.

Recommended repair: The cracks should be repaired with an epoxy or grout injection system.

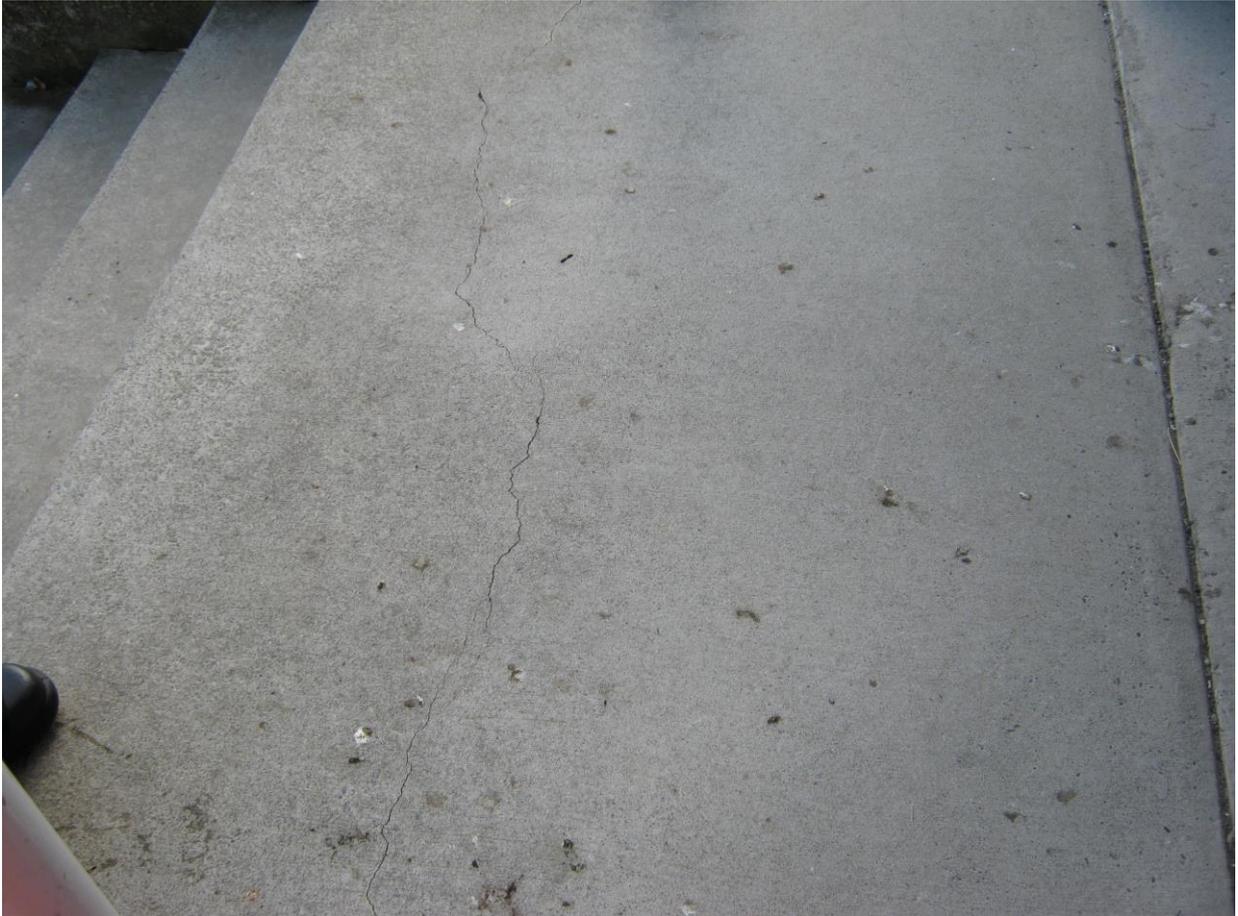
#### Damage at location 4

**Typical crack at concrete slab at outside of the building (exceed a crack width of 0.4mm but less than 1mm)**

General damage description: Cracks in concrete structures that exceed a crack width of 0.4mm, but less than 1.0mm. These cracks are not considered essential structural damage.

Recommended repair: The cracks should be repaired with cementitious grout or replaced. Insurance entitlement would probably cover removal and replacement.

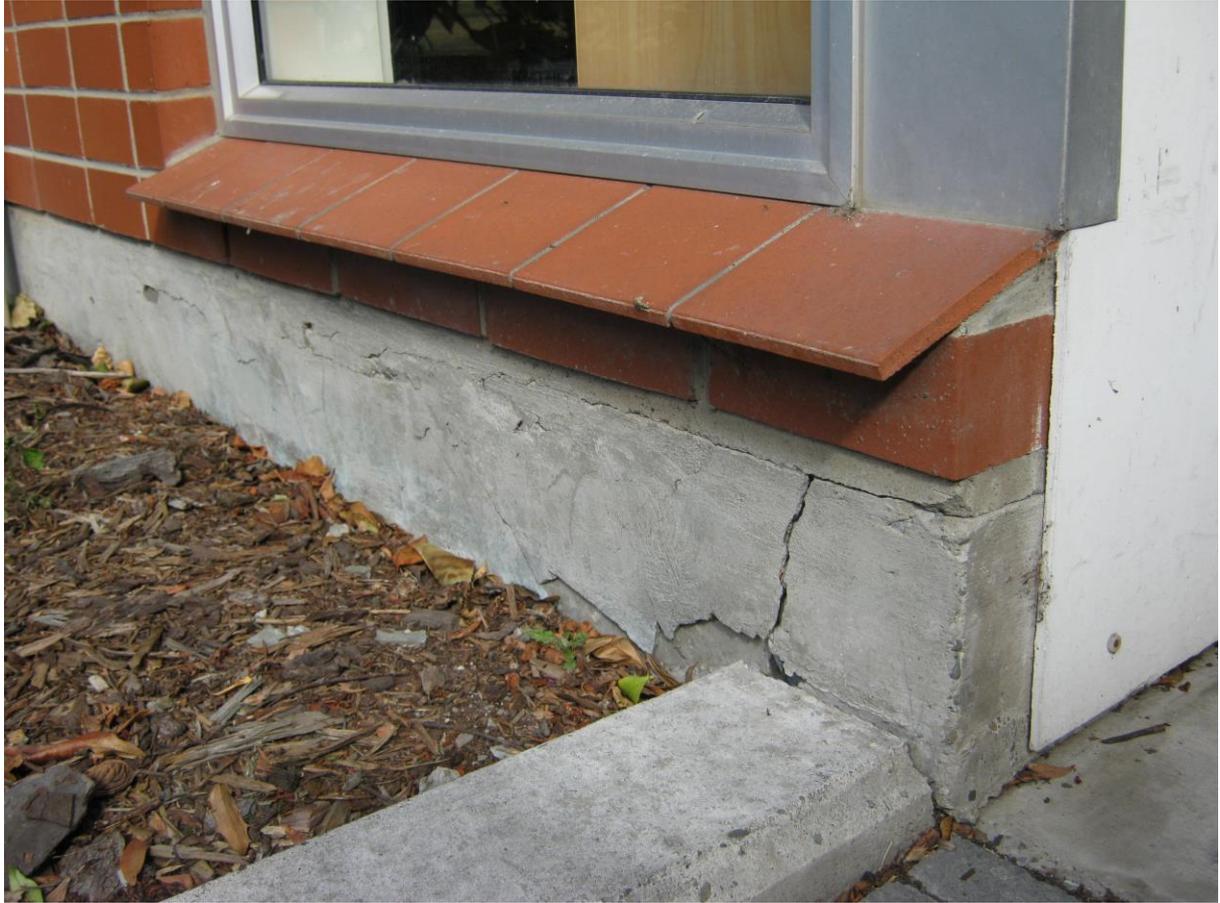
## Damage at location 5

### **Typical crack at concrete frame (exceed 1mm crack width)**

General damage description: Cracks in concrete structures that exceed a crack width of 1mm and approximately 150mm or more in length.

Recommended repair: Due to the size of the crack observed the steel has potentially yielded. This may provide justification to break out and reinstate the reinforcing detail in this location. Further investigation may be required to confirm extent of cracking, yielding of reinforcing and to develop suitable repair options.

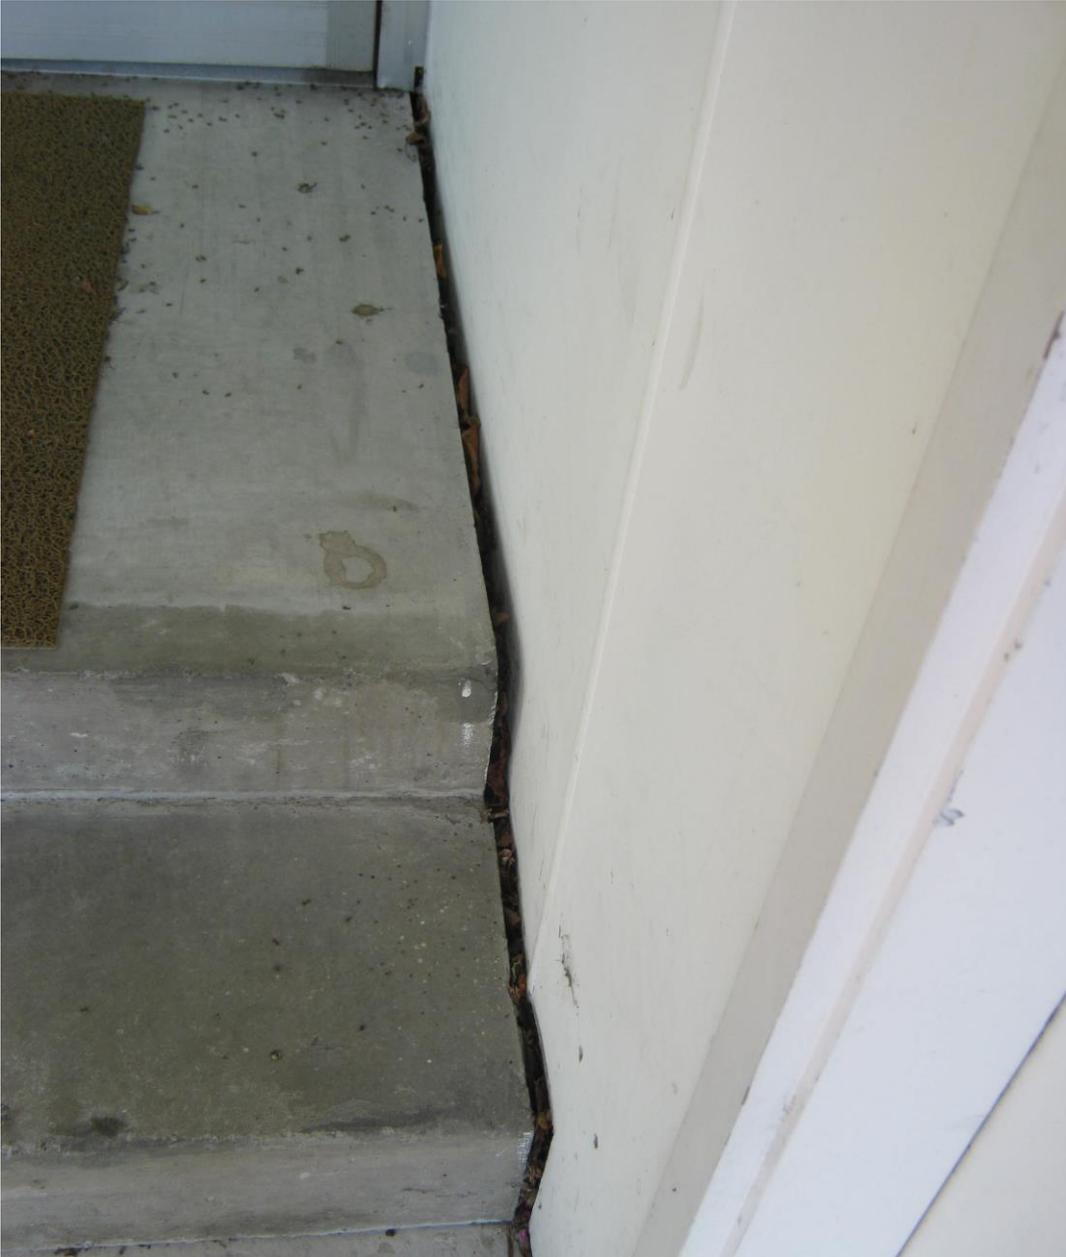
### Damage at location 6

#### **Separation between concrete slab and wall**

General damage description: Separation between concrete slab and wall exceed a crack width of 1mm. This damage requires remedial work to visible affected area.

Recommended repair: The separation should be filled with backing strip and flexible sealant.

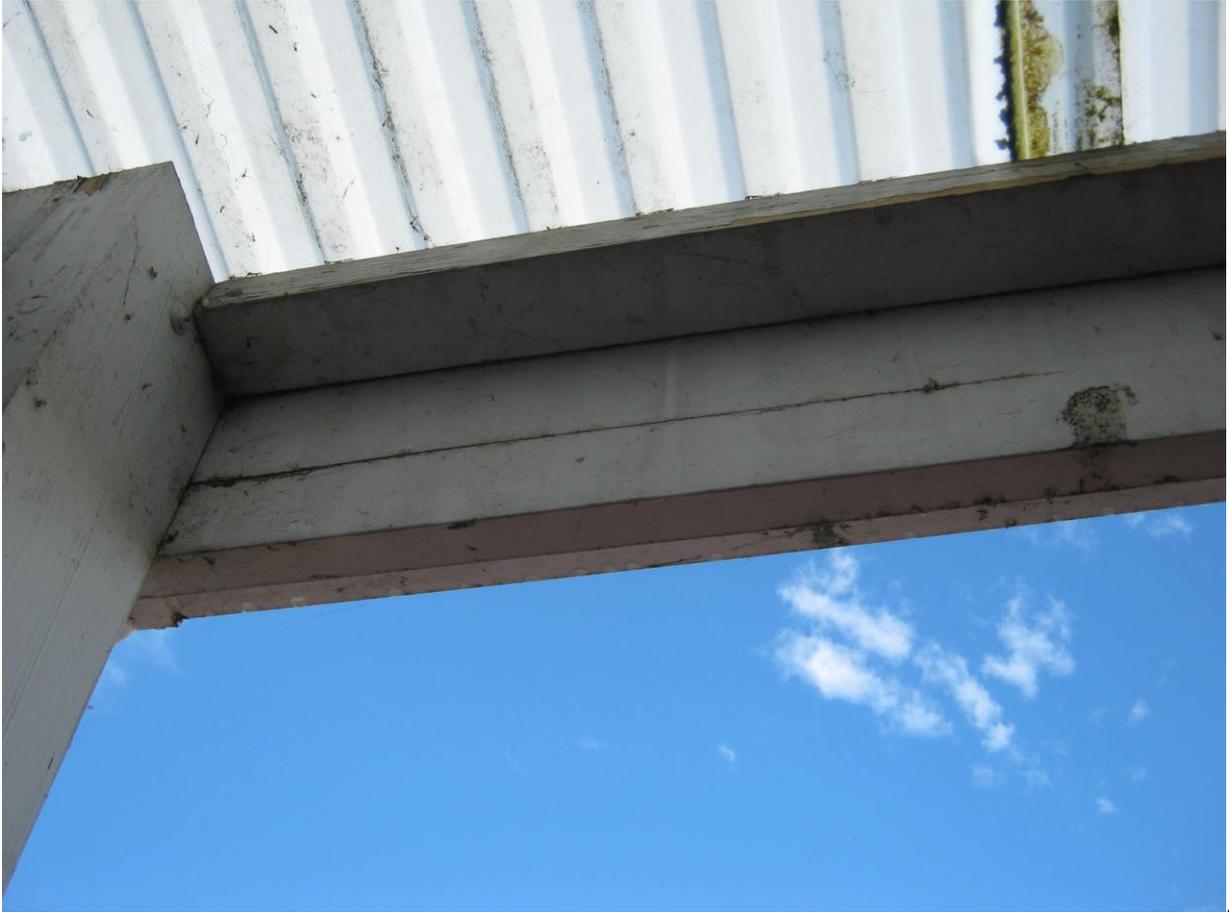
**Damage at location 7**

**Crack at timber**

General damage description: Cracking to timber beam.

Recommended repair: Replace timber.

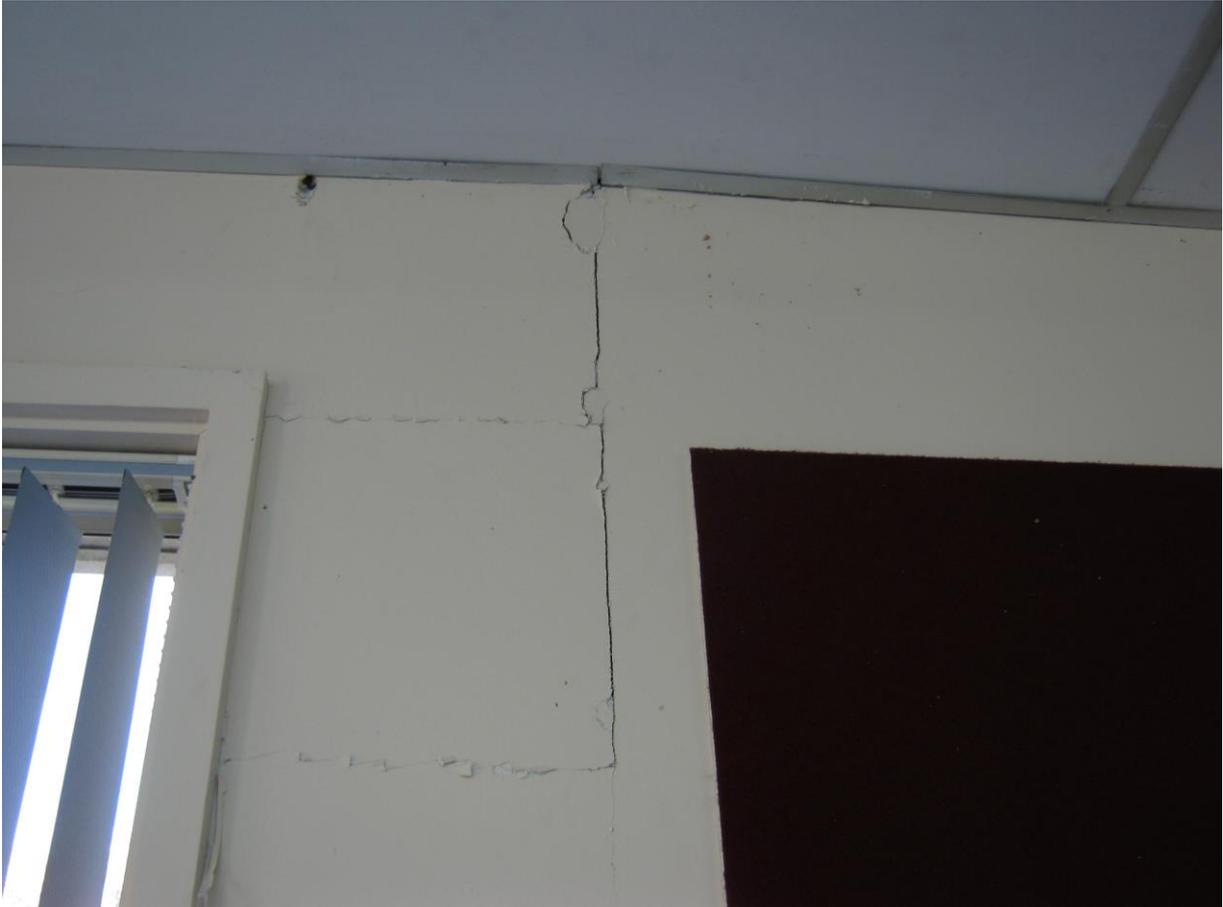
## Damage at location 8

### Typical damage to gypsum clad timber wall

General damage description: Crack in timber structure including crack at gypsum board and separation at gypsum board joint.

Recommended repair: Replace damaged gypsum board with GIB.

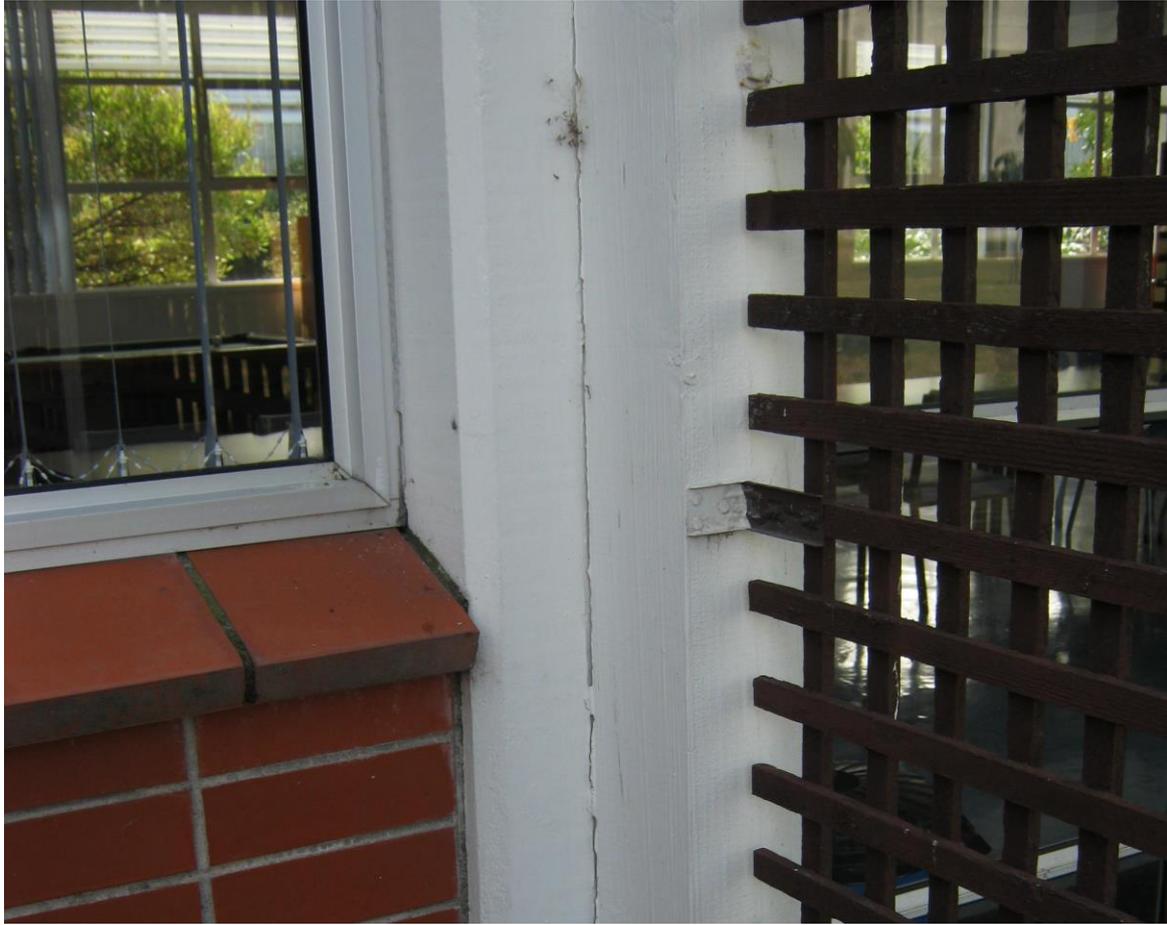
**Damage at location 9**

**Separation between timber column (canopy) and concrete column**

General damage description: Separation between timber column and concrete column.

Recommended repair: The separation should be repaired with a sealant.

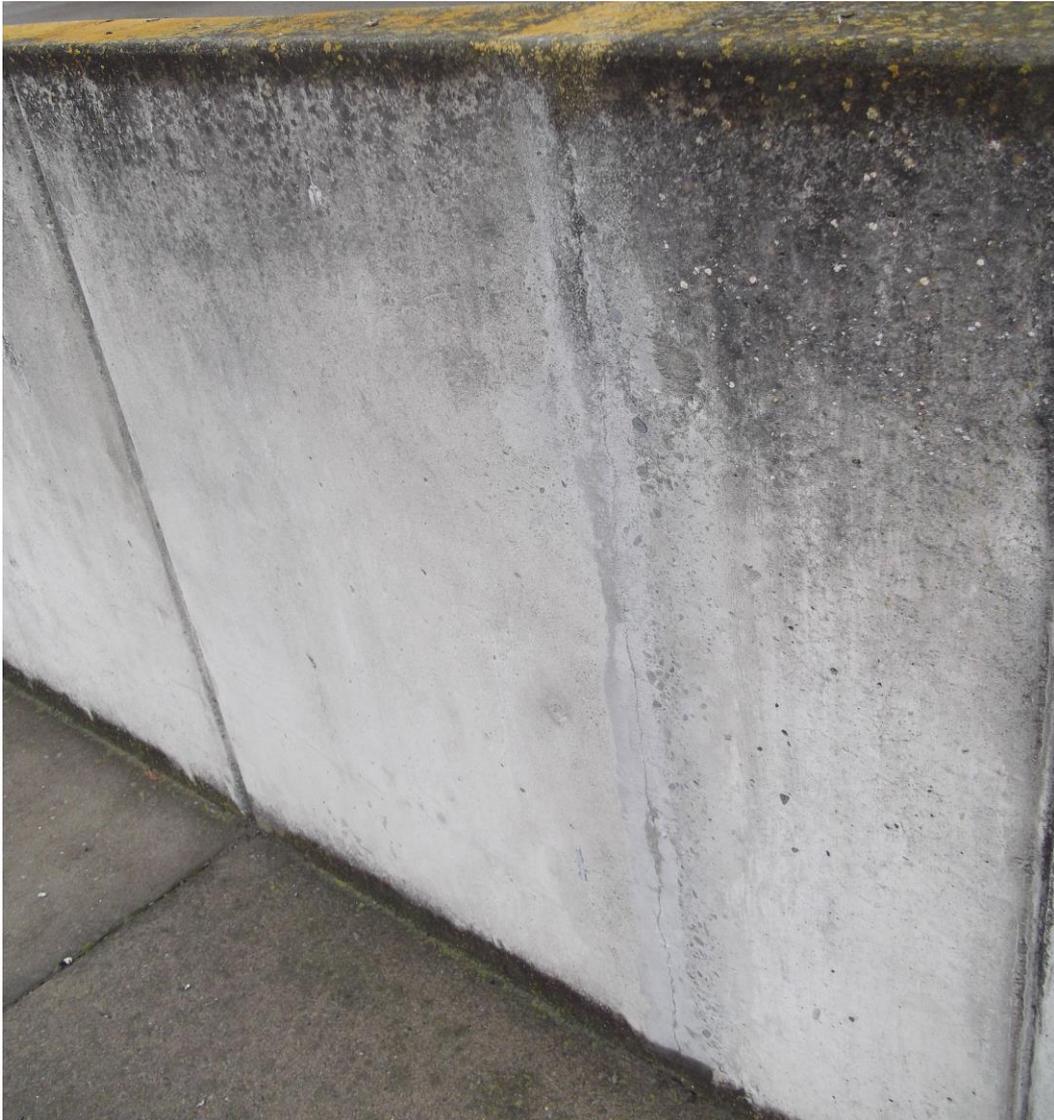
## Damage at location 10

There is a retaining wall located approximately 1m from the northern part of the building. There are widespread vertical cracks at the retaining wall. The failure of this retaining wall can affect to the building stability. Thus, intrusive investigation related to this retaining wall is required.

**Typical minor cracking at retaining wall**

General damage description: Vertical cracking to retaining wall.

Recommended repair: The cracks should be repaired with epoxy or grout injection system. Level survey is also required to confirm possible sign of ground movement and the tilt of the wall.

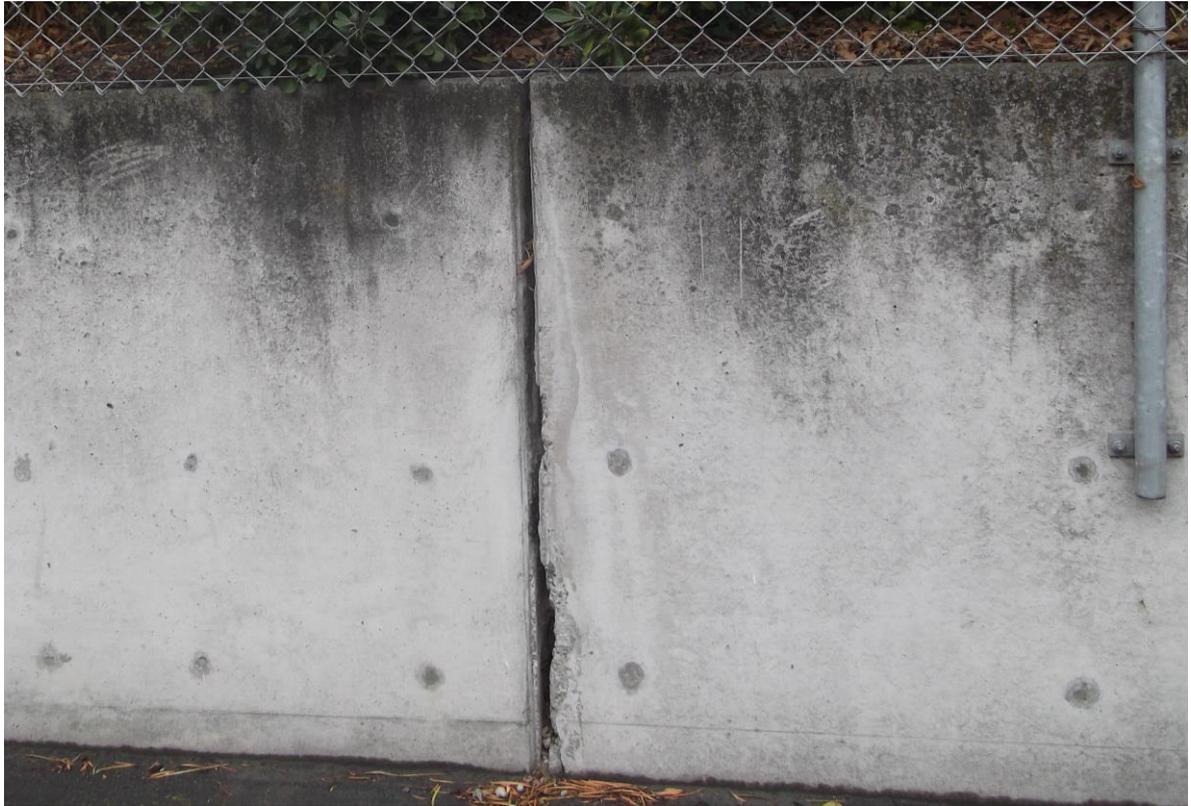
## Damage at location 11

### **Separation at retaining wall construction joint**

General damage description: Separation at retaining wall with crack widths that exceeds 1mm.

Recommended repair: Further investigation is required to confirm the extent of separation and damage. Level survey is required to confirm ground movement. Cracks in the retaining are to be repaired with an epoxy or grout injection system.
