# Vehicle Garage Building – Christchurch Wastewater Treatment Plant

## Detailed Engineering Evaluation

### BU 0879-019 EQ2

### Quantitative Report

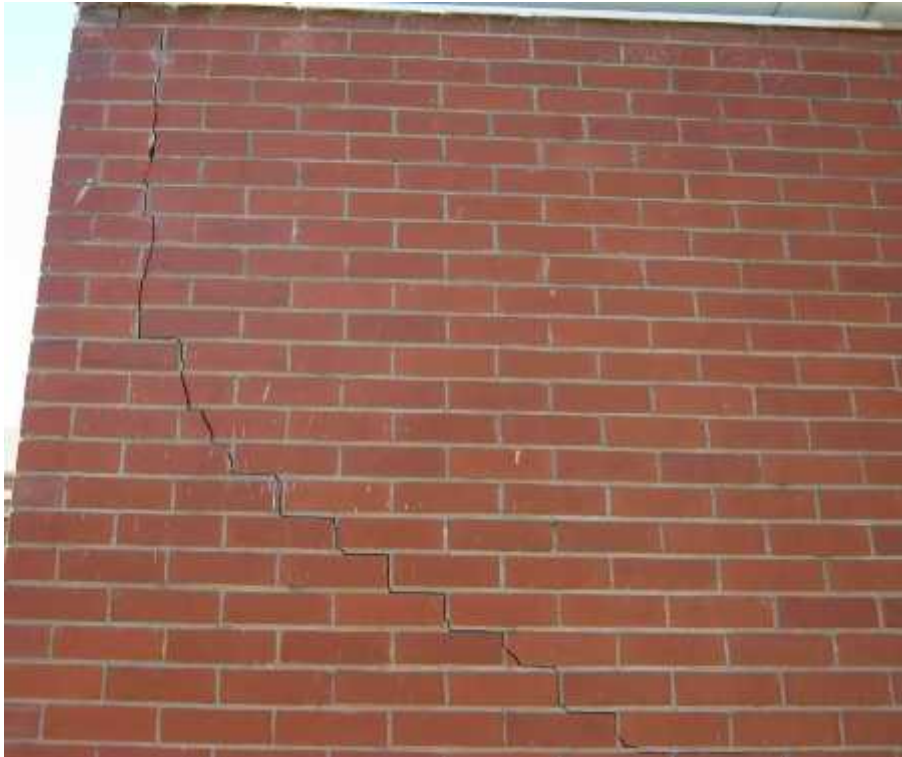
**Photo 6: Damage at location 1**

General damage description: Damage to brick veneer.

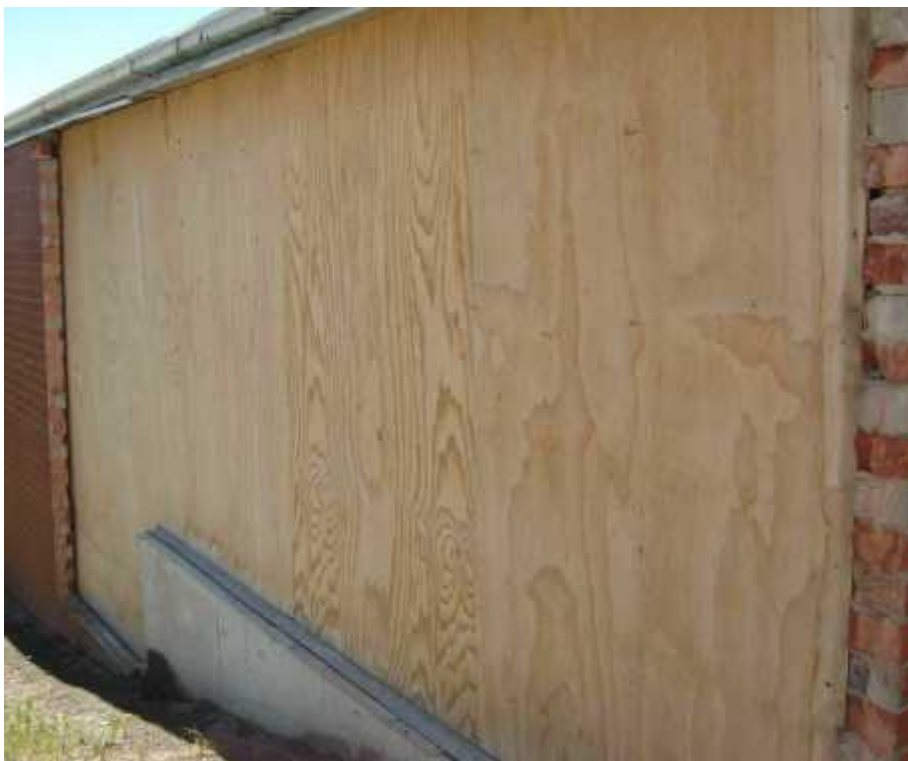
**Photo 7: Damage location 2**

General damage description: Cracked brick veneer (30mm crack width) - has been removed and replaced with plywood.

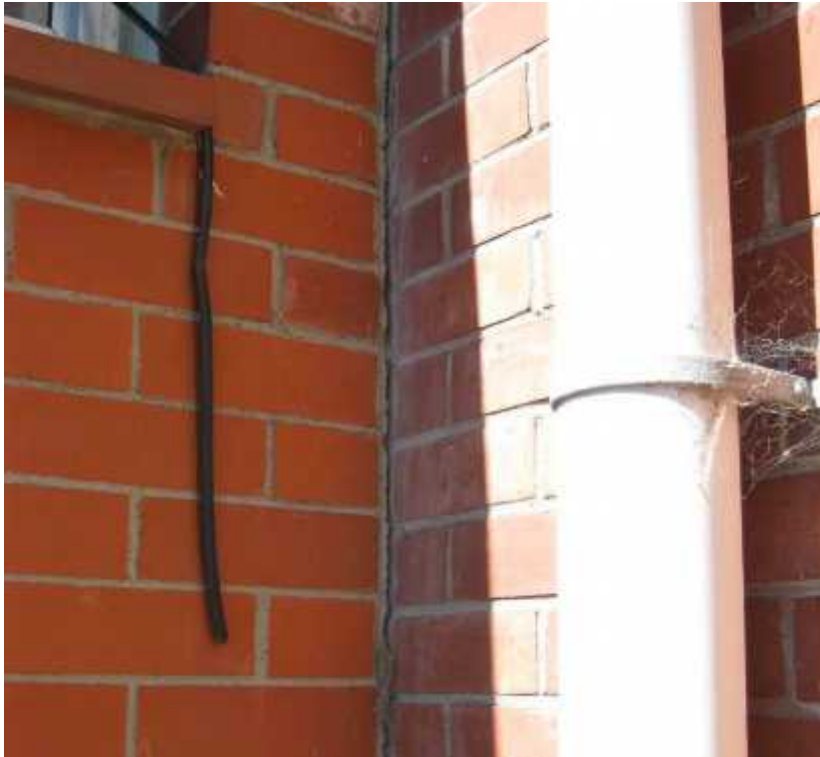
**Photo 8: Damage at location 3**

General damage description: Differential settlement between adjacent walls.

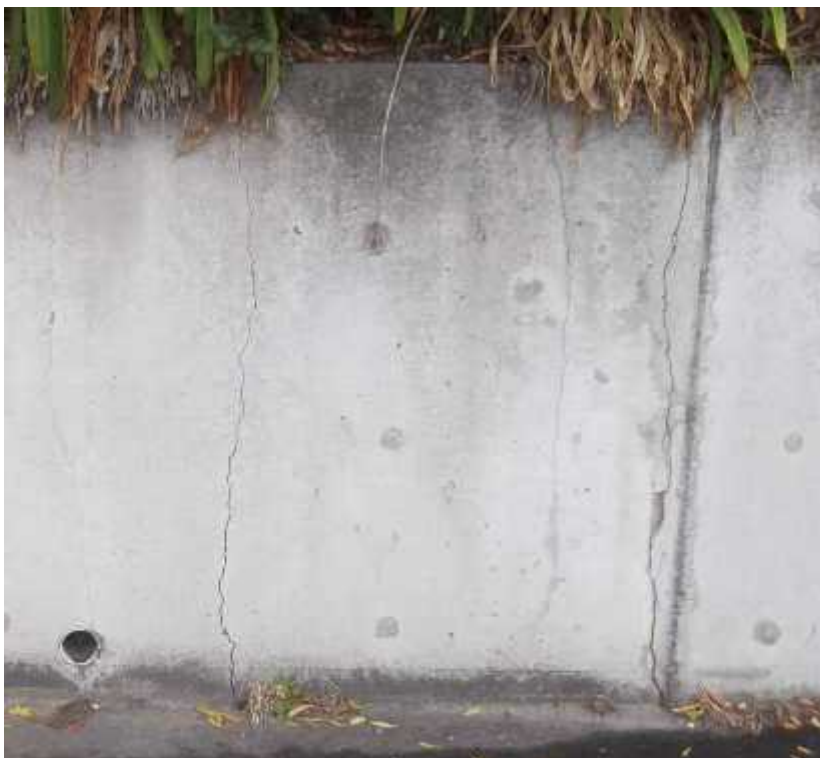
**Photo 9: Damage at location 4**

General damage description: Cracking in retaining wall.

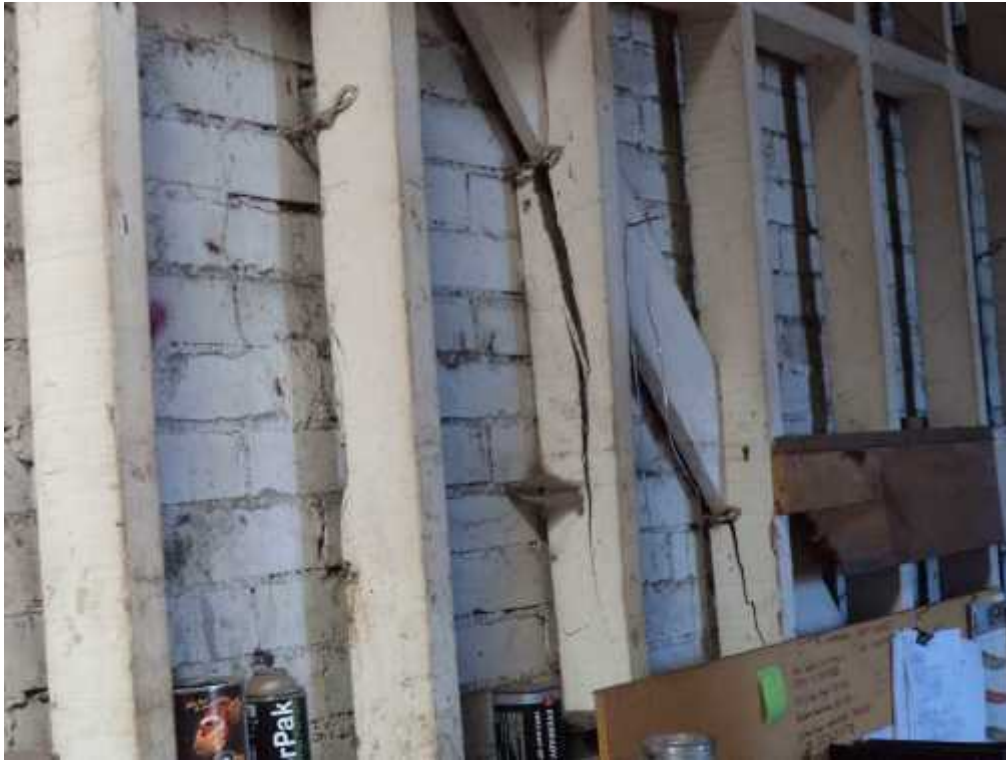
**Photo 10: Damage at location 5**

General damage description: Timber framed walls splitting of vertical stud members at brick veneer tie and bracing locations.

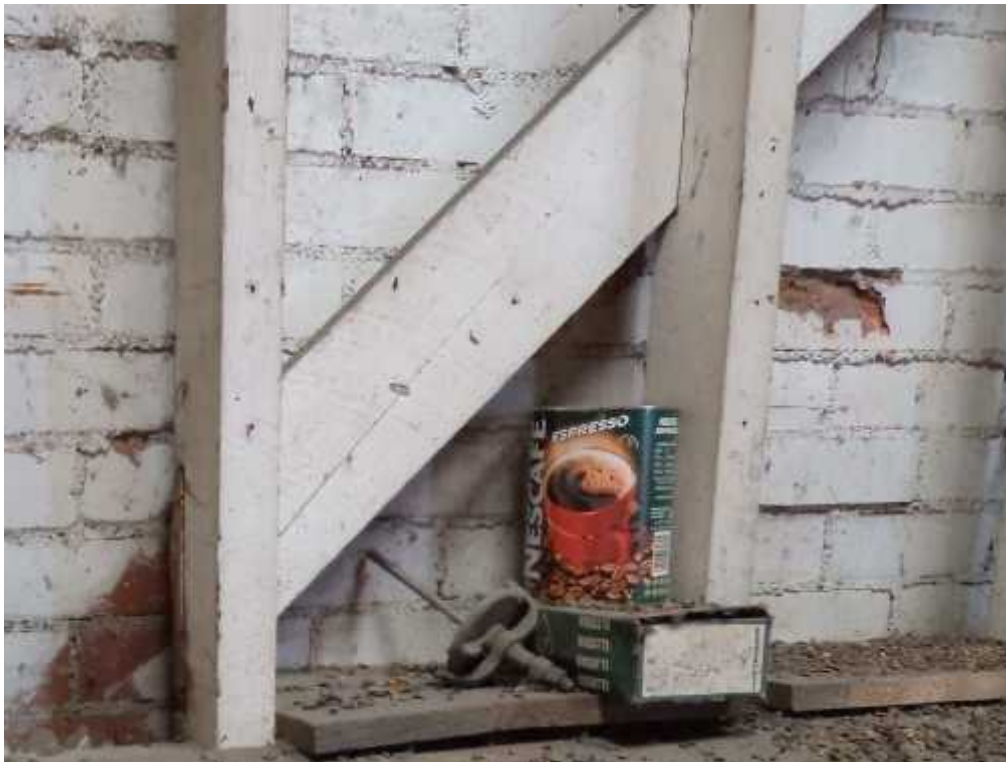
**Photo 11: Damage at location 5**

General damage description: Cracking and splitting of timber brace

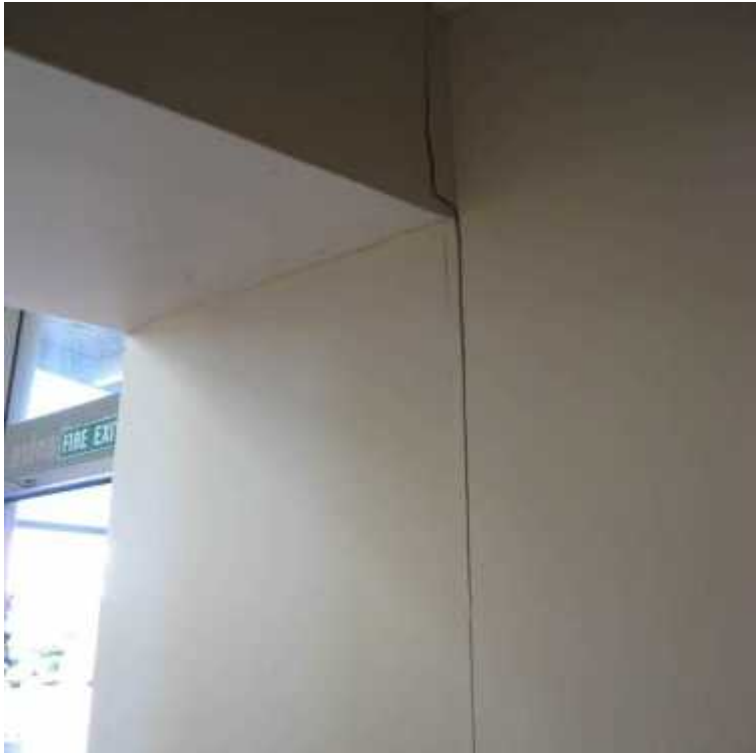
**Photo 12: Damage at location 7**

General damage description: Separation at plaster board joint.

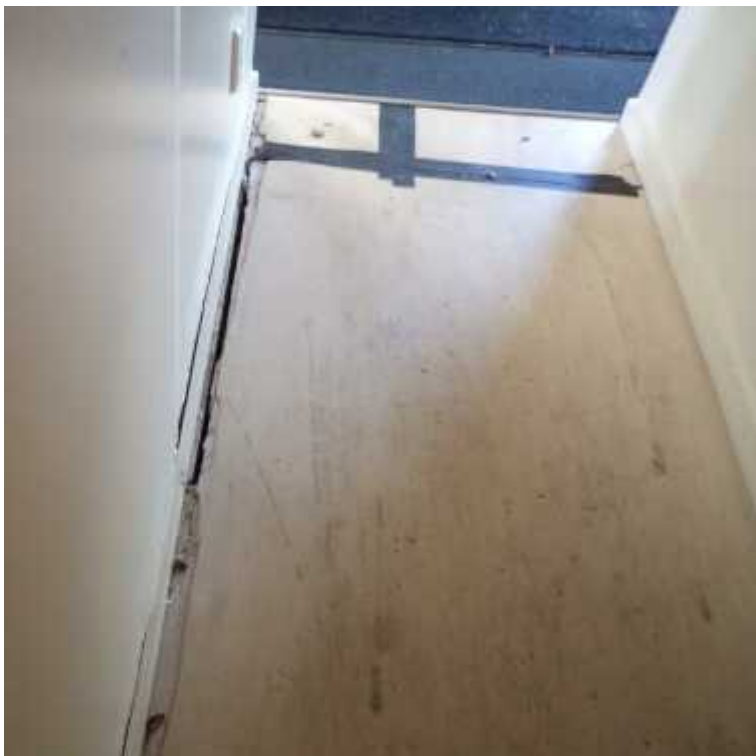
**Photo 13: Damage at location 8**

General damage description: Separation at slab joint.

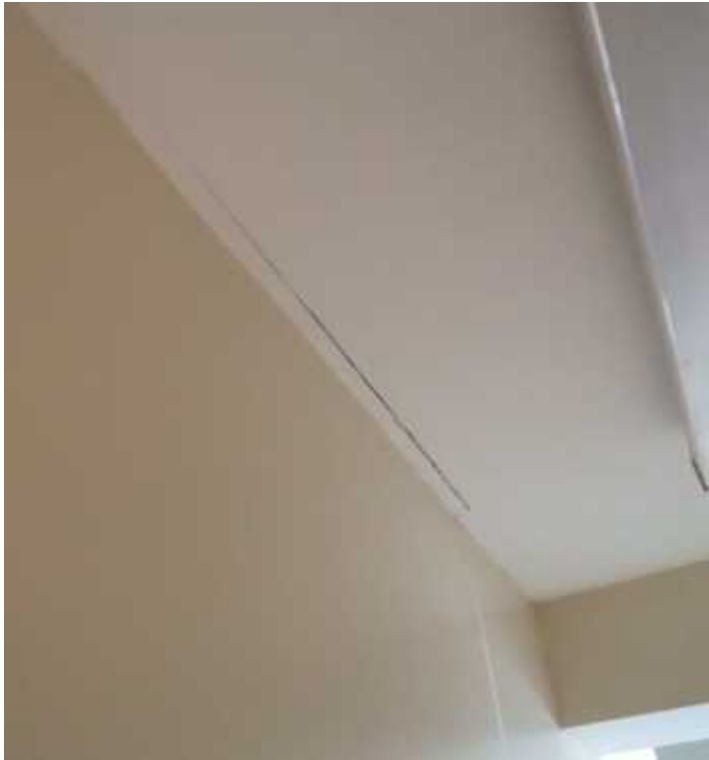
**Photo 14: Damage at location 8**

General damage description: Separation at plaster board ceiling.

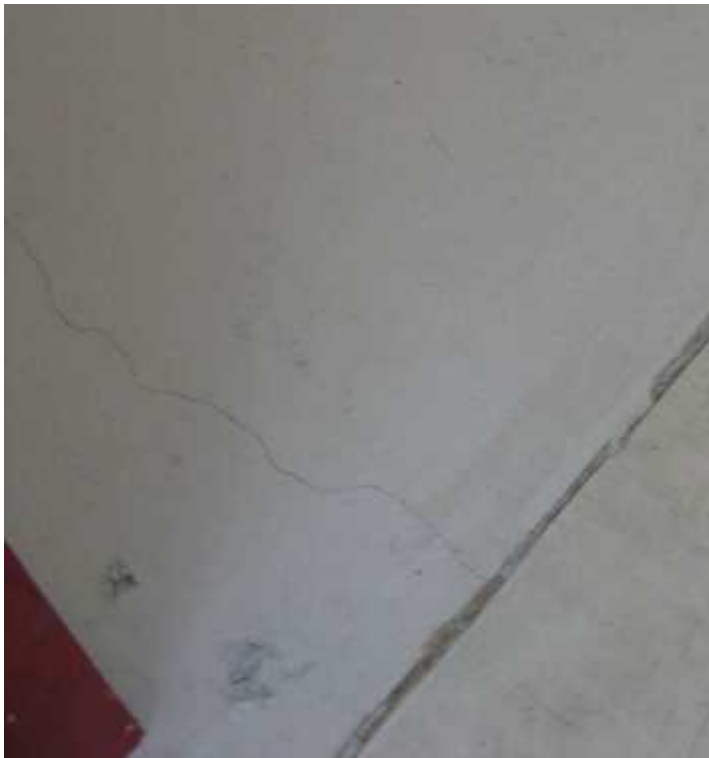
**Photo 15: Damage at location 9**

General damage description: Crack in concrete slab.

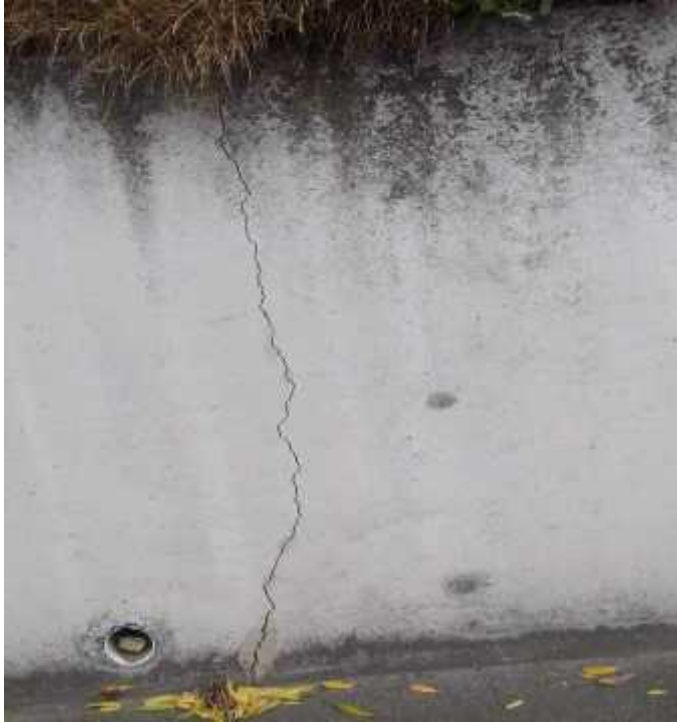
**Photo 16: Damage at location 10**

General damage description: Cracking in retaining wall.

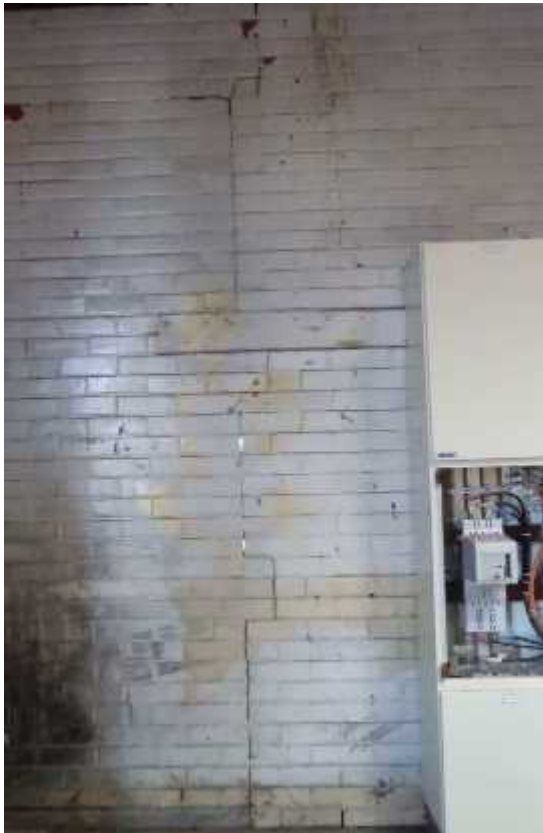
**Photo 17: Damage at location 11**

General damage description: Vertical crack in brick veneer between Part 1, Area 1 and Area 1 Extension.

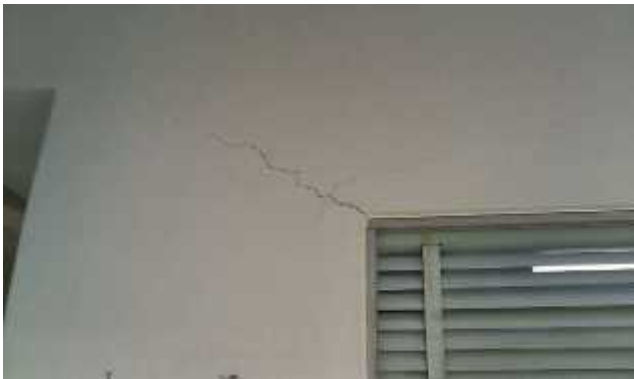
Diagonal cracking in wall next to opening near entrance to the Control Room (approx. 1 mm crack width).	Type 2.  Repair with an epoxy or grout injection system.

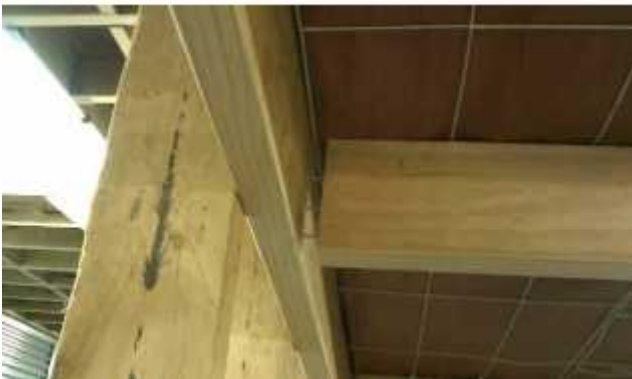
The timber purlins connecting to the western timber truss on the new roof structure have separated by approx 30 mm. (The roof structure was currently under construction).	Supply packers between purlins and truss. Install joist hangers.

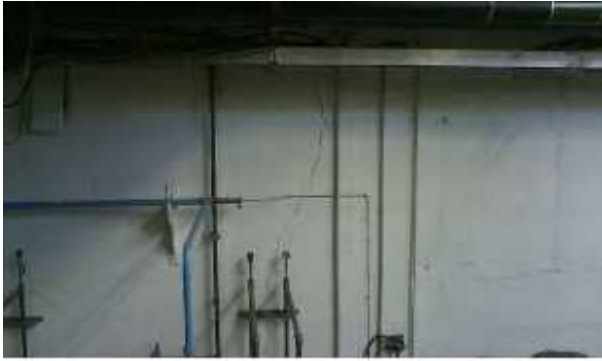
Large cracks in south basement wall (up to 5 mm crack width).	<i>Type 3.</i>  Repair with an epoxy or grout injection system.
S3.2a & S3.3

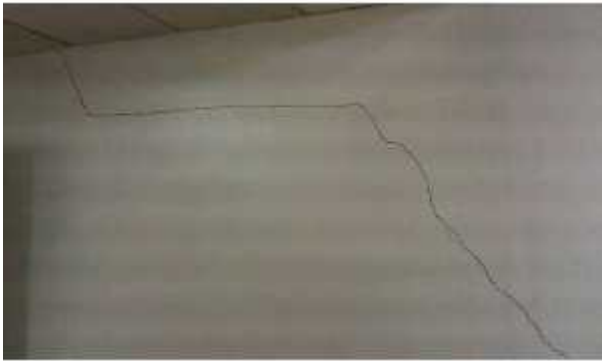
Large cracks to eastern ground level wall next to men's changing room (up to 3 mm crack width). View from mezzanine floor.	<i>Type 3.</i>  Repair with an epoxy or grout injection system.
S3.2b

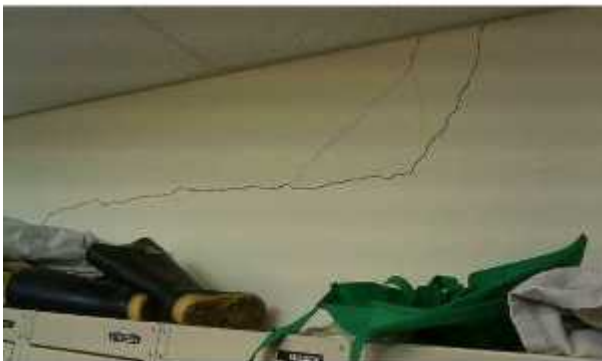
Large cracks to eastern ground level wall next to men's changing room. View from inside men's changing room.	<i>Type 3.</i>  Repair with an epoxy or grout injection system.
S3.2c

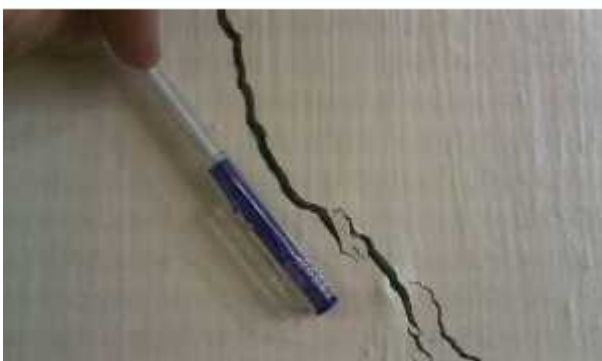
Close-up view of large cracks to eastern ground level wall next to men's changing room.	<i>Type 3.</i>  Repair with an epoxy or grout injection system.

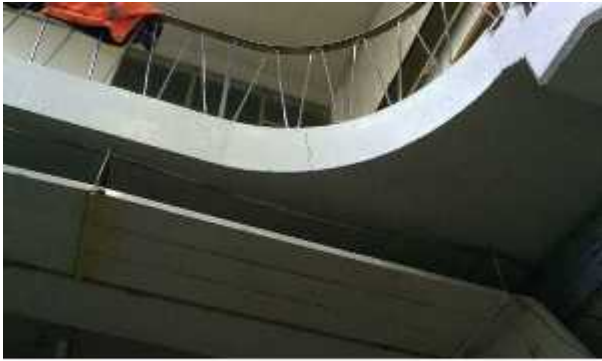
Cracking in mezzanine floor. The mezzanine floor is supported by a reinforced concrete beam spanning east-west. Therefore the cracks in the mezzanine floor do not compromise the vertical load capacity of the floor.	Type 2.  Repair with an epoxy or grout injection system.
S3.5

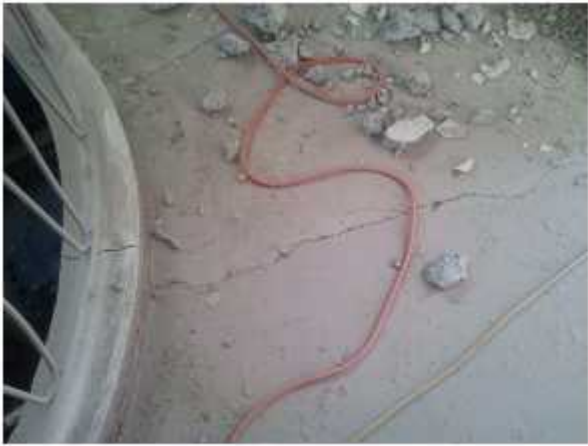
Cracking in mezzanine floor with covering removed.	Type 2.  Repair with an epoxy or grout injection system.
S3.5

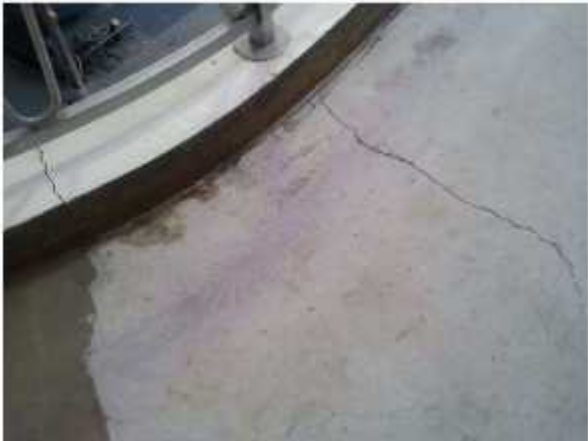
Cracking in mezzanine floor with crack propagating from edge.	Type 2.  Repair with an epoxy or grout injection system.

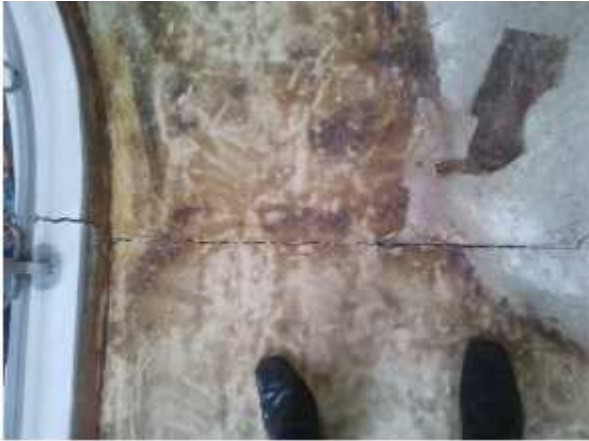
Cracking in mezzanine floor.	Type 2.  Repair with an epoxy or grout injection system.
S3.6	(no image)	Cracks in basement floor slab (up to approx 1 mm crack width).	Type 2.  Repair with an epoxy or grout injection system.
S3.7 & S3.8

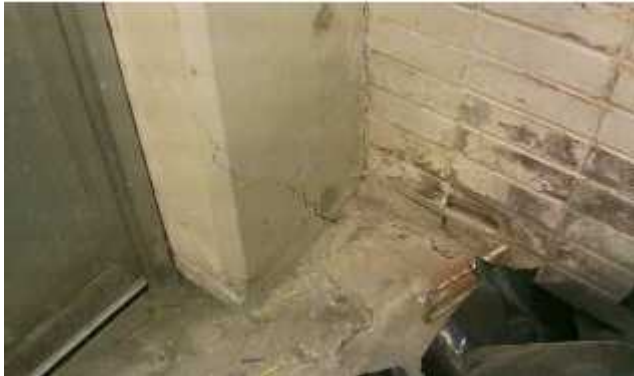
Cracks in southern column and cracks in reinforced concrete floor slab of 11 kV switchroom.	Type 2.  Repair with an epoxy or grout injection system.

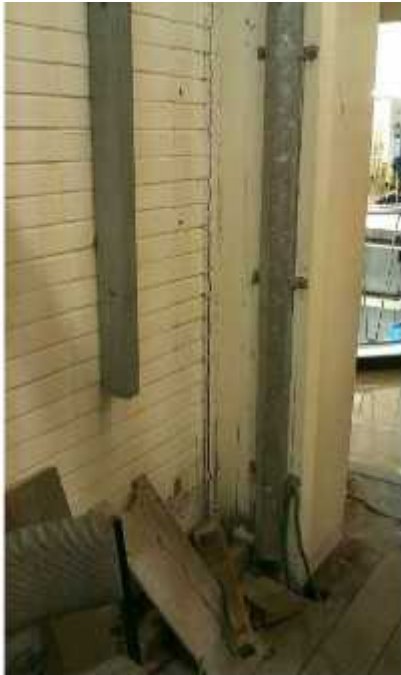
Gaps between the infill brickwork and the RC column in 11 kV switchroom.	<i>Type 5.</i>  Remove cracked mortar and repoint masonry
S3.10

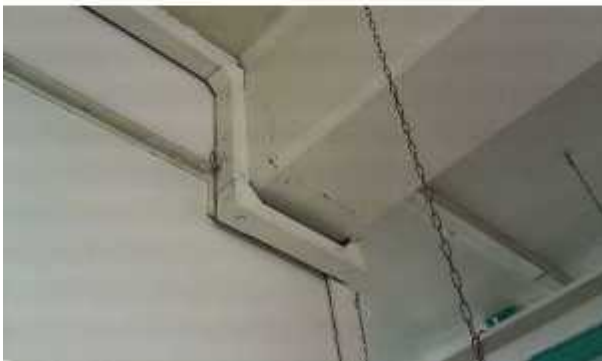
Cracking in beam at one location	<i>Type 2.</i>  Repair with an epoxy or grout injection system

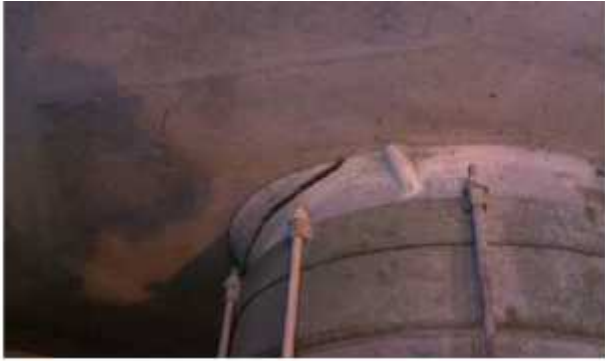
Large crack to concrete where pump station pipe passes through wall.	Break out and replace concrete. Carry out level survey to assess whether the cracked pipe is the result of differential settlement or seismic shaking.
S7.9

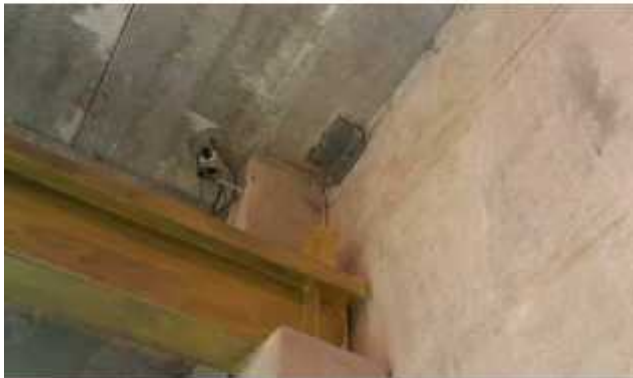
Spalling to top of column at south-east end next to wall	<i>Type 4.</i>  Repair with structural repair mortar system.
S7.10

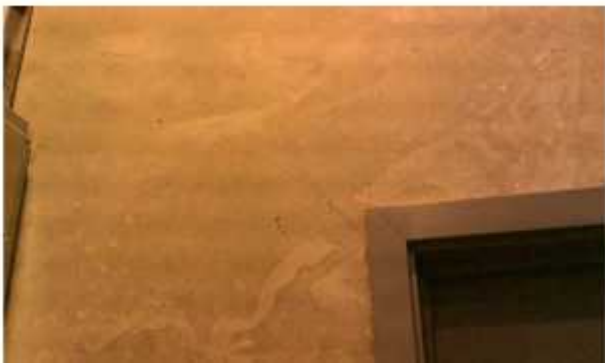
Cracking in wall above internal door to southern room (0.2-0.3mm crack width)	<i>Type 1.</i>  Repair with an epoxy or grout injection system.

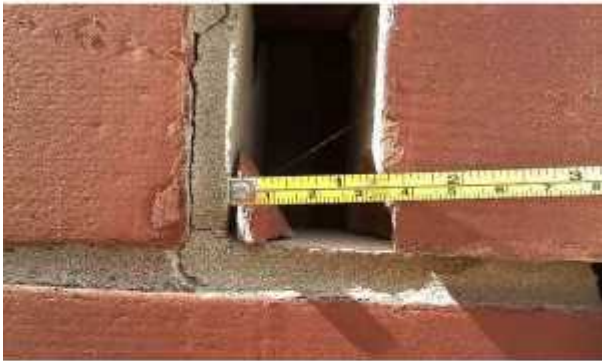
Close-up view of large cracks / gaps in brickwork on north-western wall.	As above.
S8.2

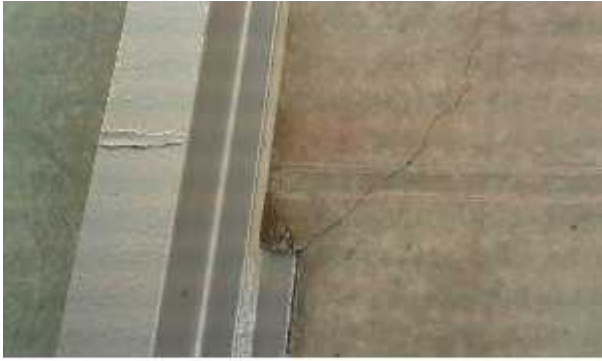
Cracks in walls at weld plate connections. This cracking was observed at several of the weld plate connections.	Type 2.  Repair with an epoxy or grout injection system

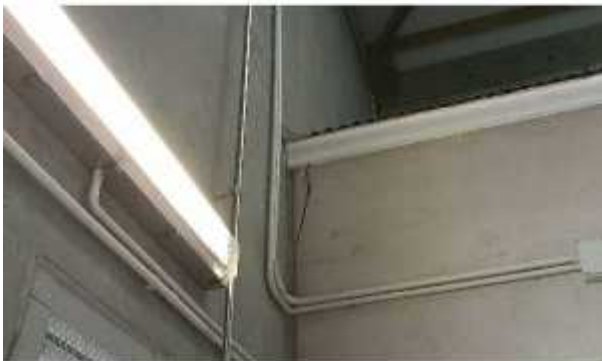
Spalling to top of interior wall panel on northern end of building.	Type 4.  Break out loose concrete and repair with structural repair mortar system.
S10.2

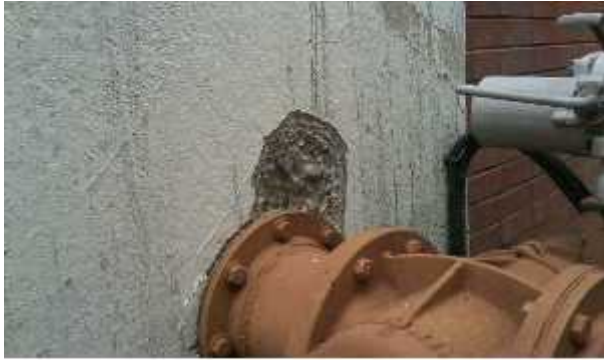
Spalled concrete at pipe on northern edge of Digester No. 3.	Type 4.  Breakout loose concrete and repair with structural repair mortar system
S18.1b

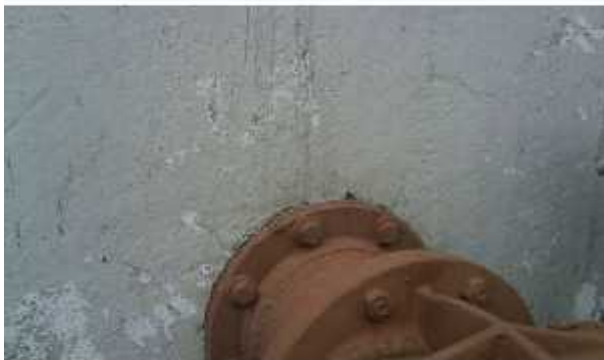
Cracked concrete at pipe locations. This cracked concrete was observed at two locations.	Type 4.  Breakout loose concrete and repair with structural repair mortar system
S18.2

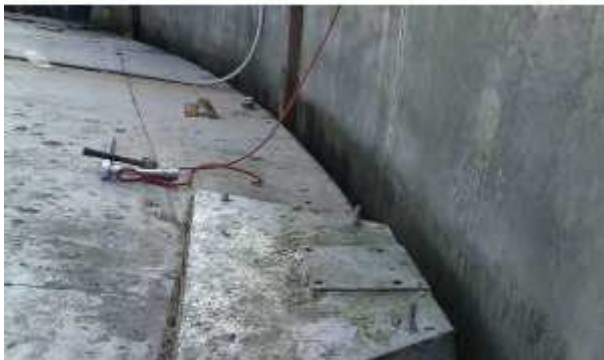
Guide wheels and guides have broken off at a number of locations on the floating roof structure.	Reinstate guide wheels and install timber packers to stop pounding of lid against the sides of the tank (this was currently being undertaken at the time of the inspection).

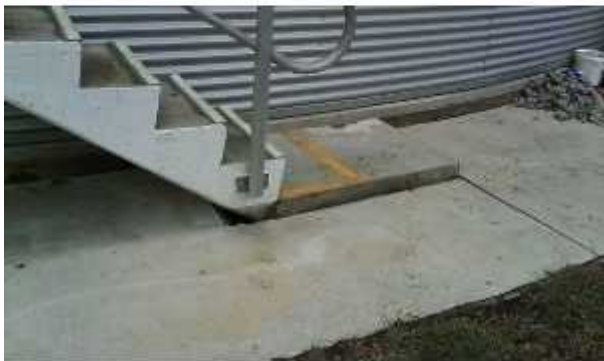
Ground settlement around perimeter of digester tanks resulting in a trip hazard at the step foundation.	Provide inclines to step footing.
S18.4b

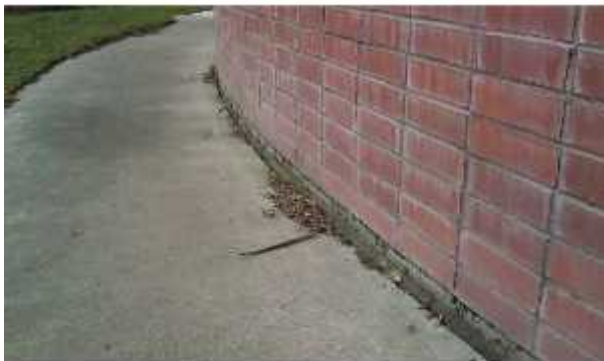
Ground settlement around perimeter of digester tanks.	Re-grade as necessary.
S18.4c

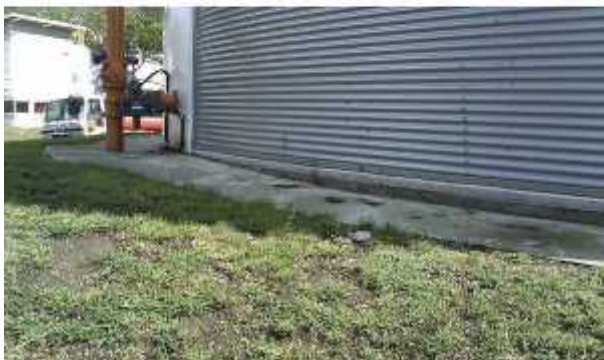
Ground settlement around perimeter of digester tanks.	Re-grade as necessary.

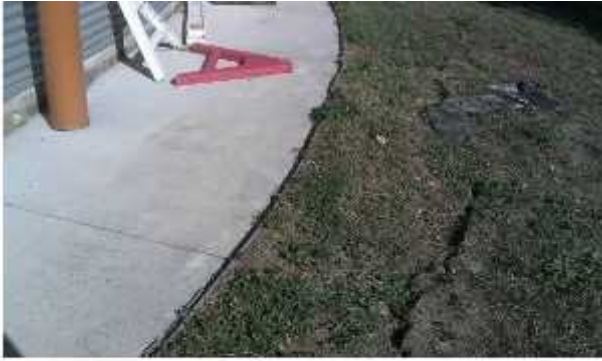
Tension cracks indicating slope instability next to Digester No. 4	Infill the tension cracks and re-grade as necessary.
S18.4e

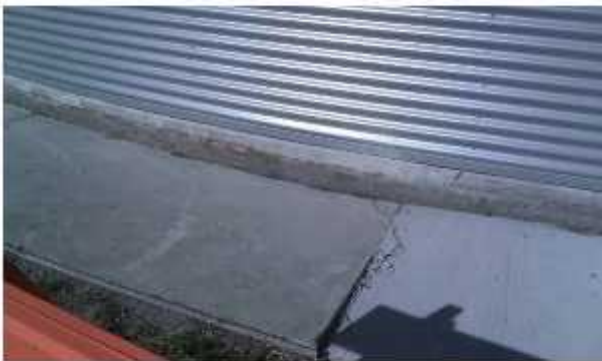
Ground settlement around perimeter of digester tanks.	Re-grade as necessary.

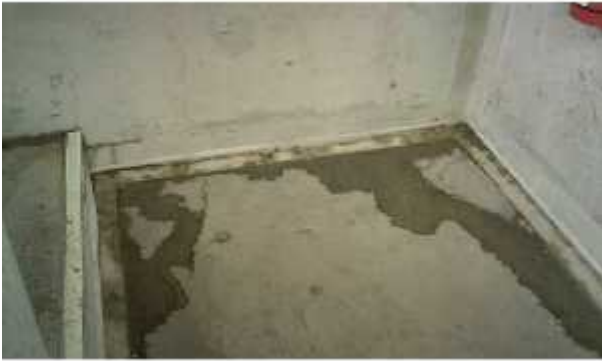
Some leakages were observed at the base of the gallery walls.	Type 2.  Repair cracks with an epoxy or grout injection system and provide sealant
S20.3a

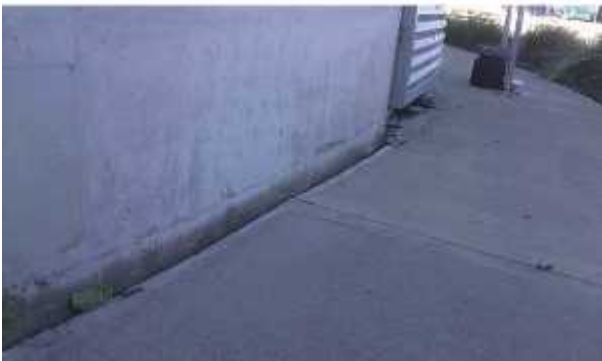
Evidence of ground settlement around perimeter of digester tanks up to 80 mm.	Repair pavement slab and re-grade as necessary.

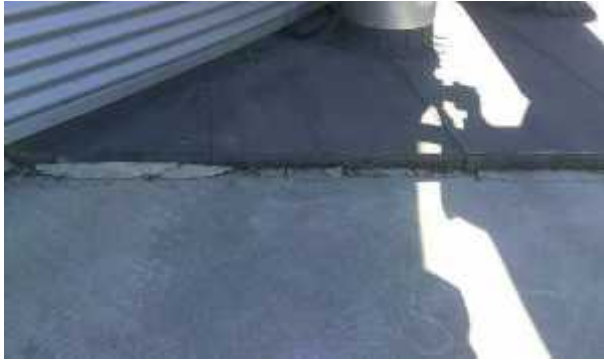
Evidence of ground settlement around perimeter of digester tanks up to 80 mm.	Repair pavement slab and re-grade as necessary.

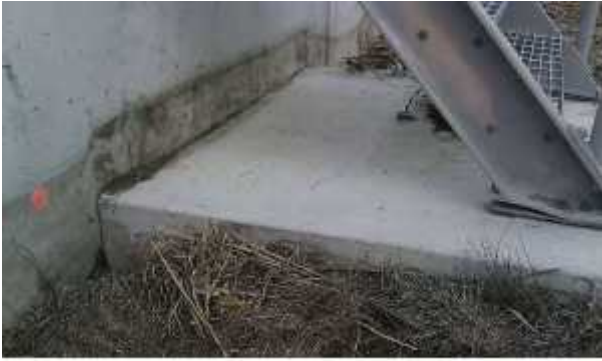
Steelwork to walkway stair landing is deformed due to differential settlement of the stair foundation.	Repair steelwork and provide packers.
S22.3a

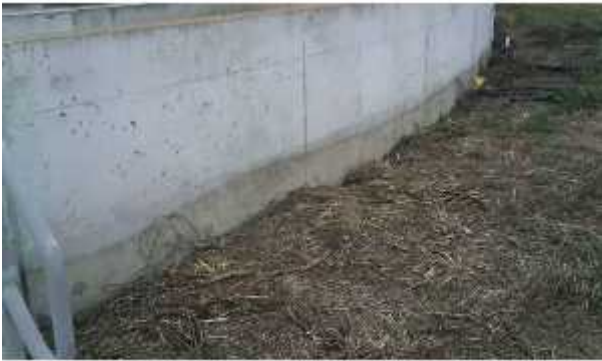
There is general settlement around the clarifiers of between 100 and 300 mm. Local slumping was observed around clarifier number 4.	Backfill and re-grade as necessary.
S22.3b

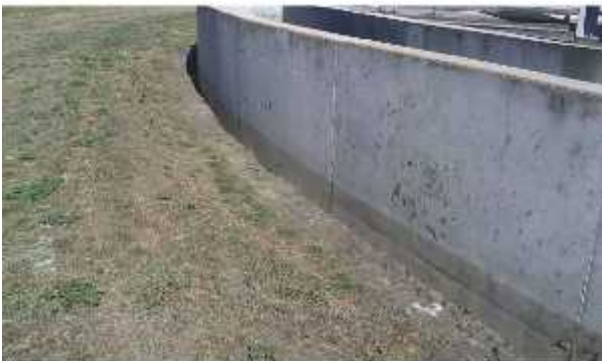
There is general settlement around the clarifiers of between 100 and 300 mm.	Backfill and re-grade as necessary.
S22.3c

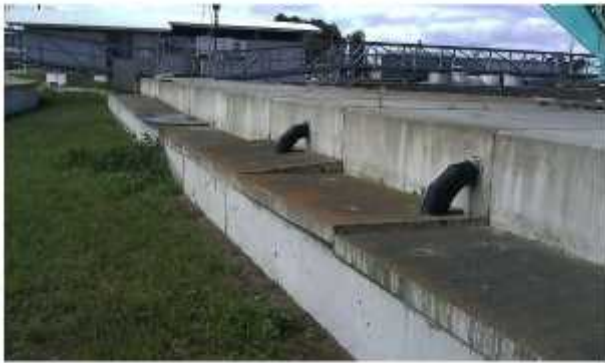
There is cracking to the trench structure from the pump station to the clarifiers due to the differential settlement.	Epoxy crack injection and replace seals between adjacent precast units.
S22.4b

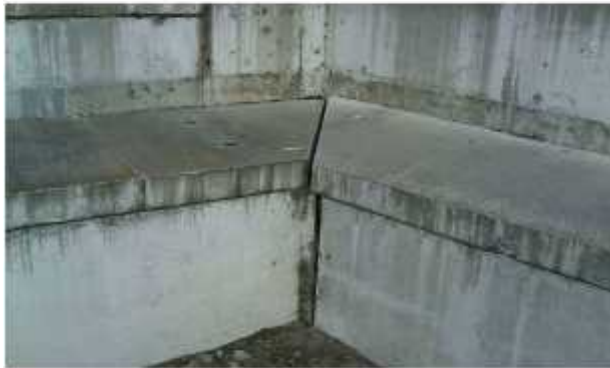
Differential movement between adjacent precast concrete sections resulting in damage to the seals.	Replace and repair seals.
S22.4c

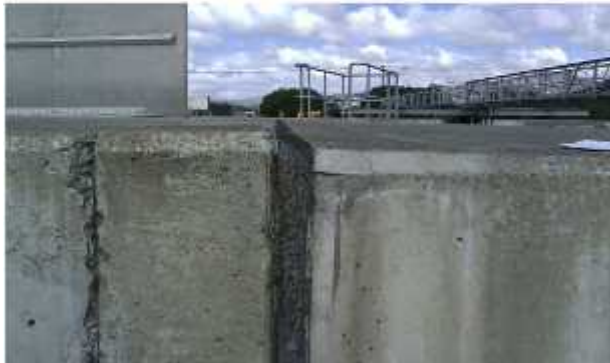
Differential movement between adjacent precast concrete sections resulting in damage to the seals.	Replace and repair seals.
