Canterbury Agricultural Park
Toilets
Qualitative Engineering Evaluation

Reference: 231550
Prepared for:
Christchurch City Council

Functional Location ID: PRK 2412 BLDG 002

Date: 5 July 2013

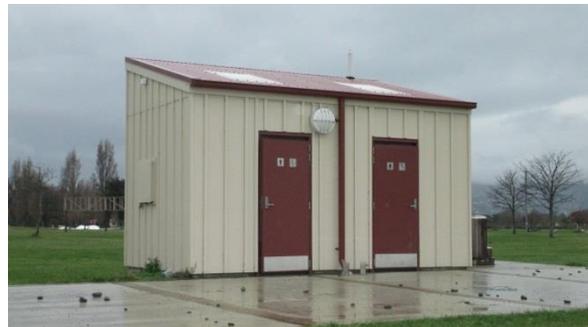
Eastern (front oblique) elevation of the Canterbury Agricultural Park Toilets.

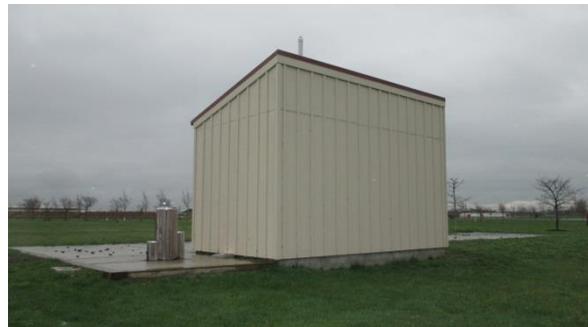
Western (end oblique) elevation of the Canterbury Agricultural Park Toilets.

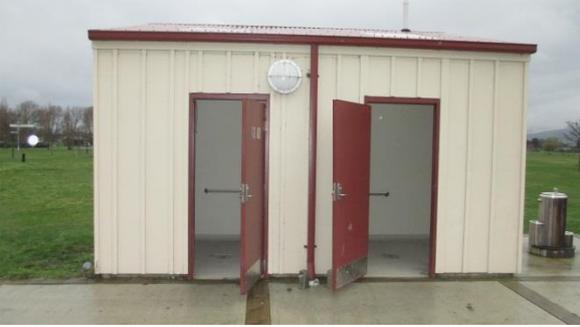
<p>Front view of the Canterbury Agricultural Park Toilets.</p>

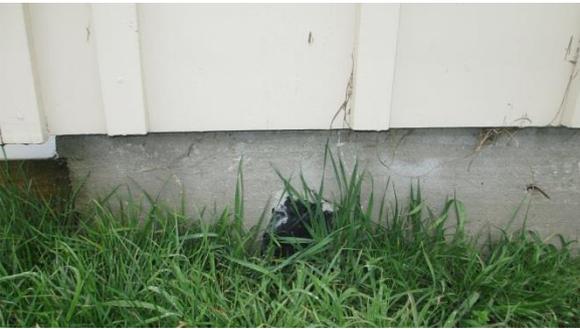
The Canterbury Agricultural Park Toilets are founded on a concrete slab on grade foundation.

<p>Canterbury Agricultural Park Toilets foundations.</p>

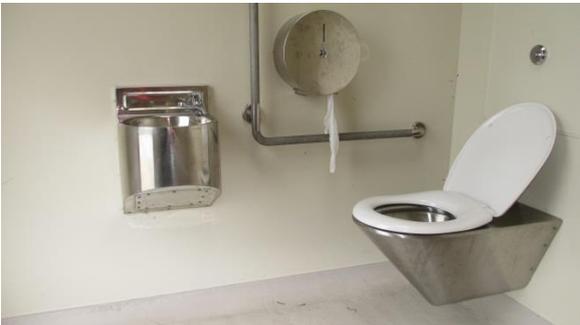
<p>Interior view of the Canterbury Agricultural Park Toilets.</p>

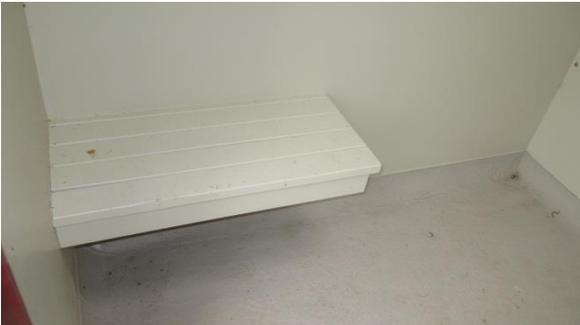
<p>Interior view of the Canterbury Agricultural Park Toilets.</p>

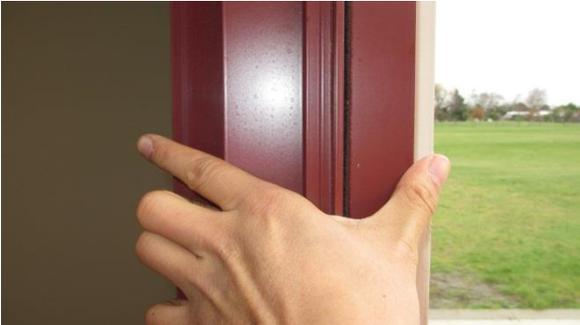
<p>Wall thickness approximately 120mm thick.</p>
