Christchurch City Council
PRK_3537_BLDG_001 EQ2
Cass Bay Toilets
Cnr Bay View Pl, Harbour View Tce

QUALITATIVE ASSESSMENT REPORT
FINAL

- Rev B
- 24 September 2012

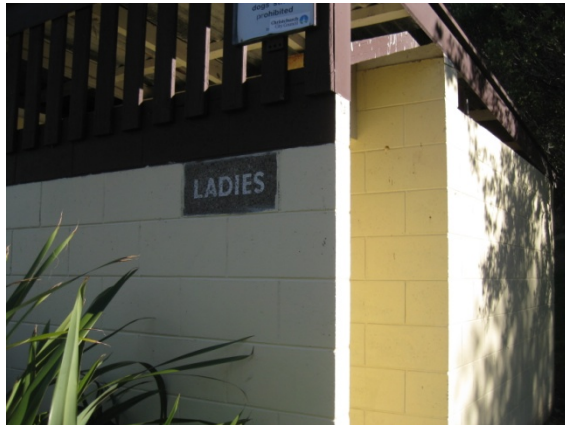
Photo 7: Damage Observed in Ladies

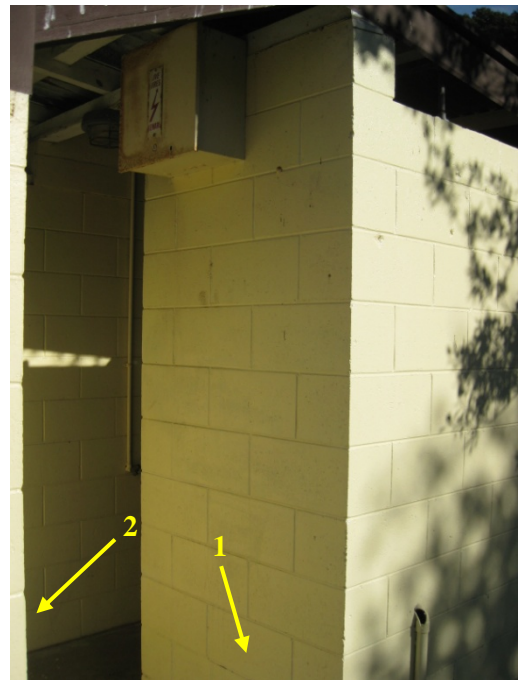
- 1) Hairline cracking along block wall mortar joints. Occurs in various locations refer to PHOTOS 8-27.
- 2) Differential movement between the concrete floor slab and concrete path at the entrance to the ladies. Differential movement approximately 10mm-15mm. Refer to PHOTOS 28 & 29.

Photo 8: Hairline Cracking along Mortar Joints

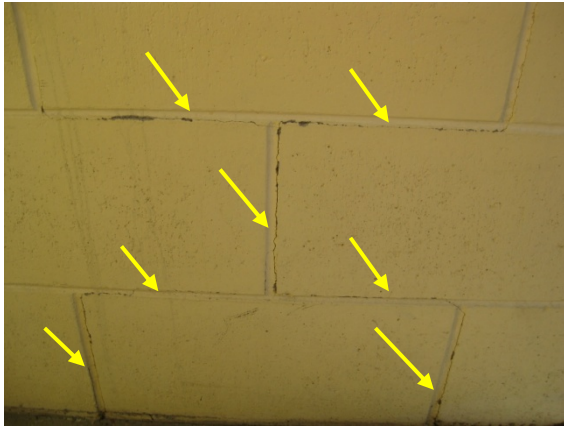
Photo 9: Close up of Photo 8 (Eastern Return Wall - 1)

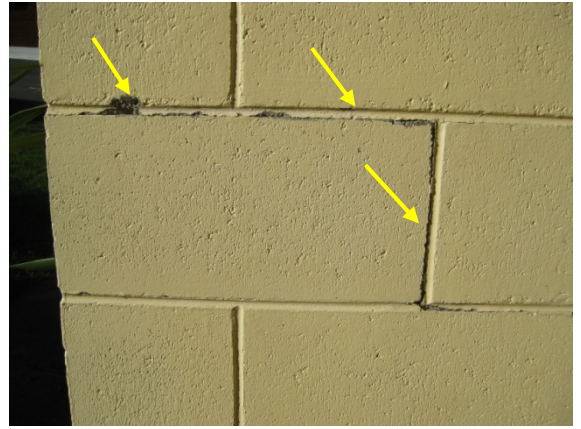
Photo 10: Close up of Photo 8 (Eastern Front Wall - 2)

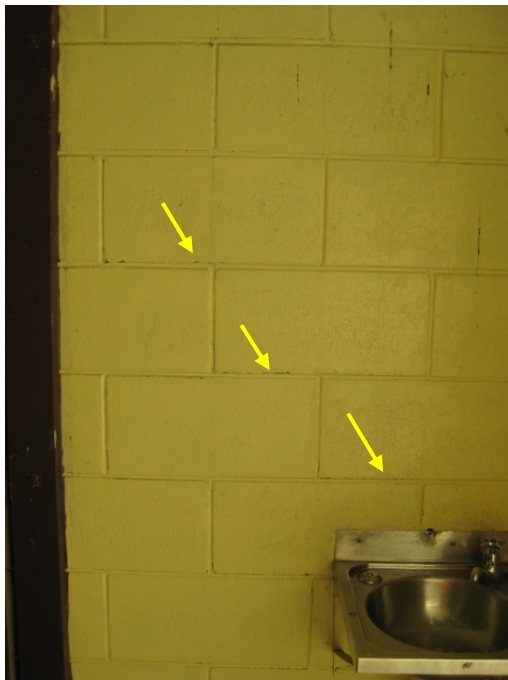
Photo 11: Hairline cracking along Mortar Joints on North Wall inside Ladies

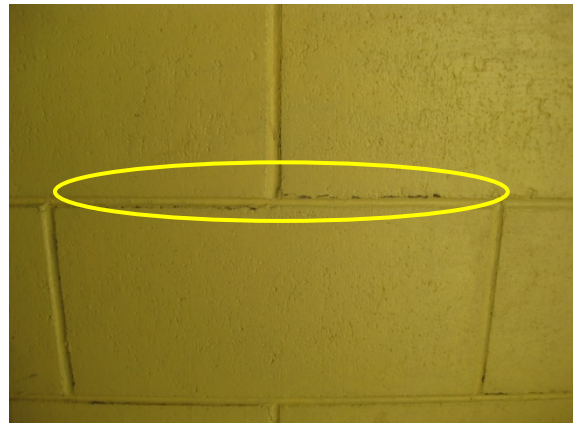
Photo 12: Close up of Photo 11

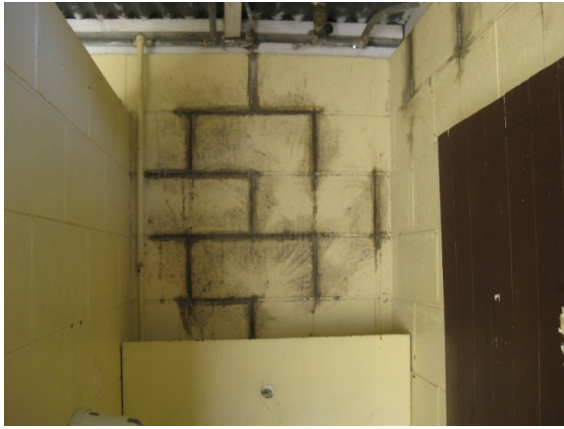
Photo 13: West Wall in Ladies – Mortar Joints appear to have been Re-pointed

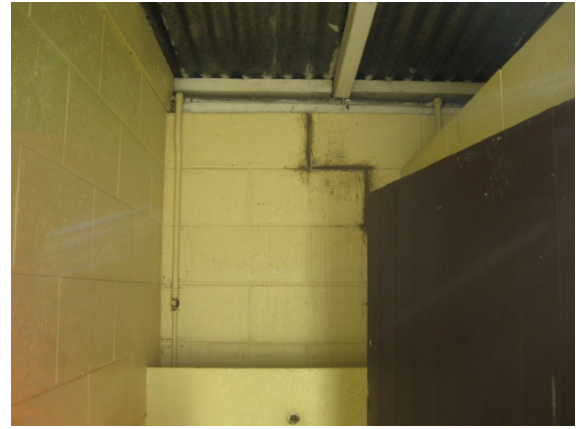
Photo 14: Continuation of Photo 13

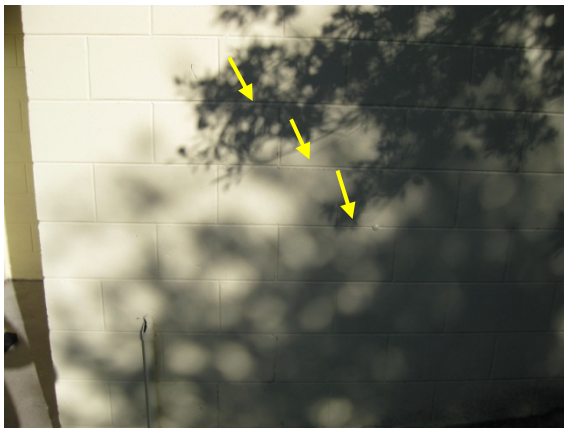
Photo 15: Hairline Cracking along Mortar Joints on West Wall – External View

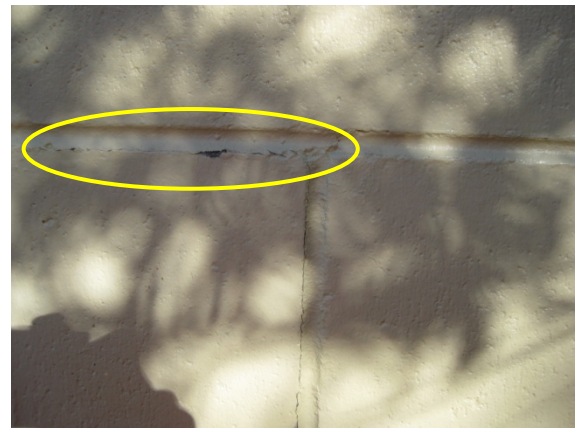
Photo 16: Close up of Photo 15

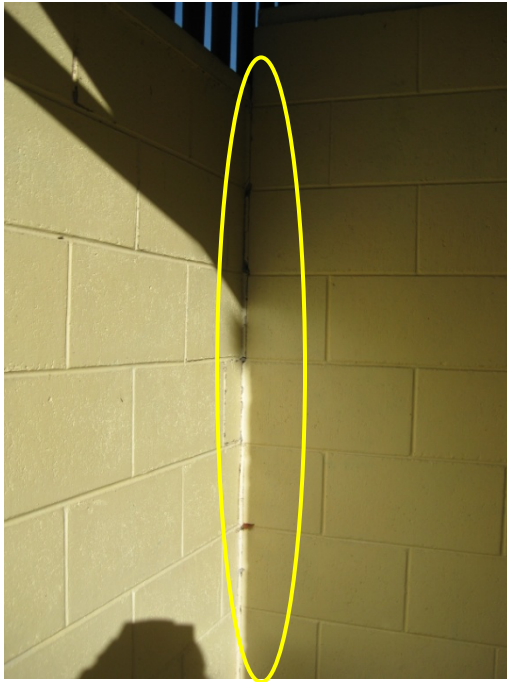
Photo 17: Cracking along Mortar Joint in SE Corner of Ladies

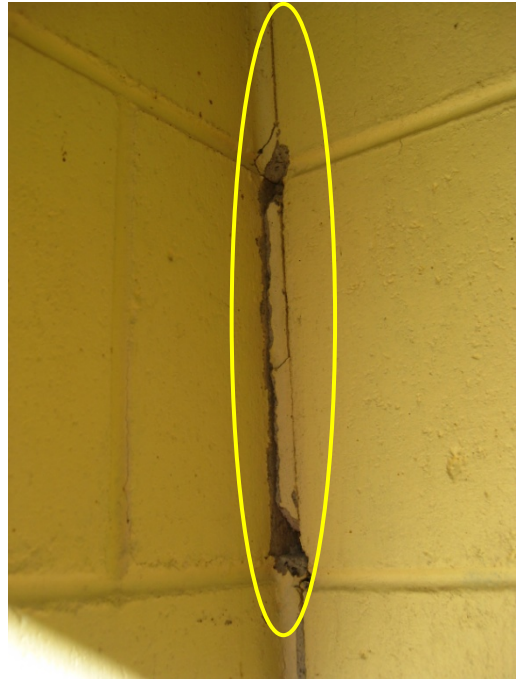
Photo 18: Close up of Photo 17

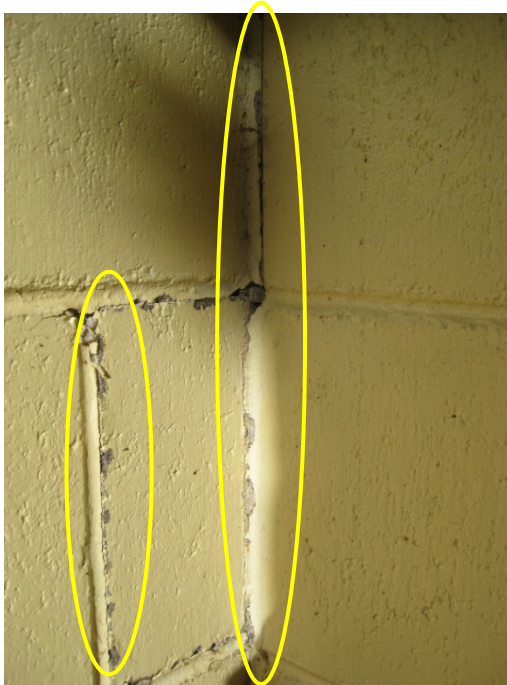
Photo 19: Close up of Photo 17

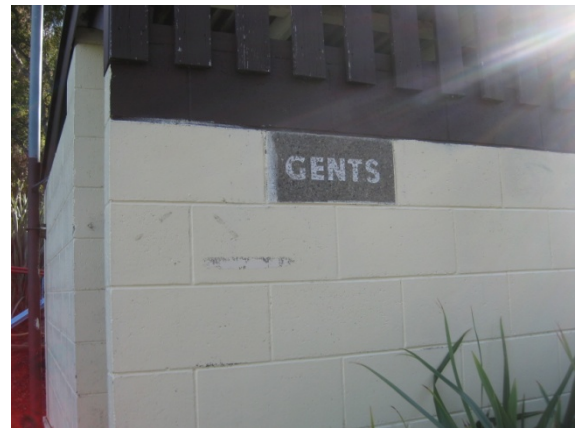
Photo 20: Damage to Gents

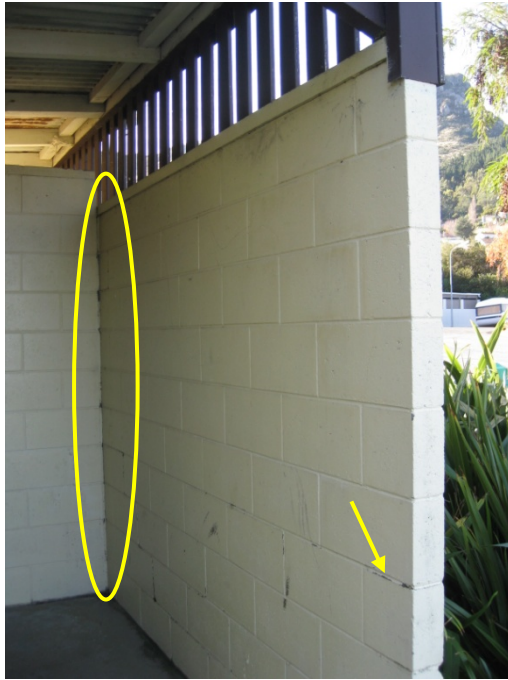
Photo 21: Hairline Cracking along Mortar Joints on East Wall of Gents

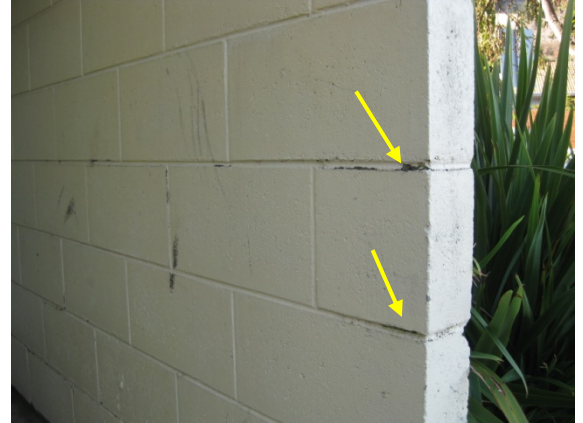
Photo 22: Close up of Photo 21

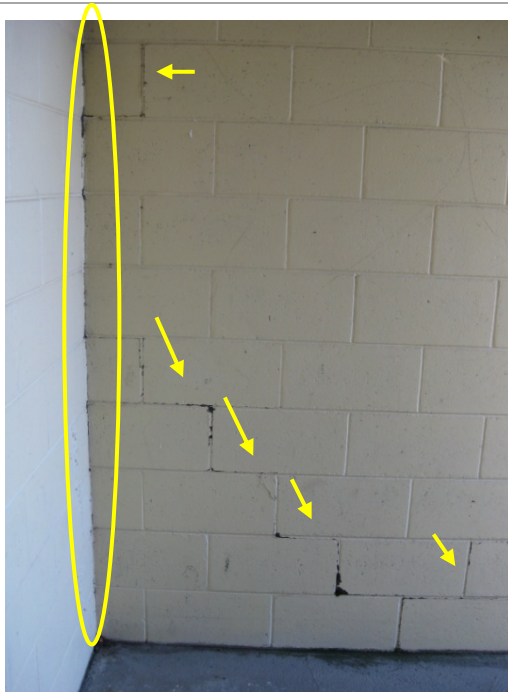
Photo 23: Hairline Cracking along the Mortar Joints on the North Wall of the Gents

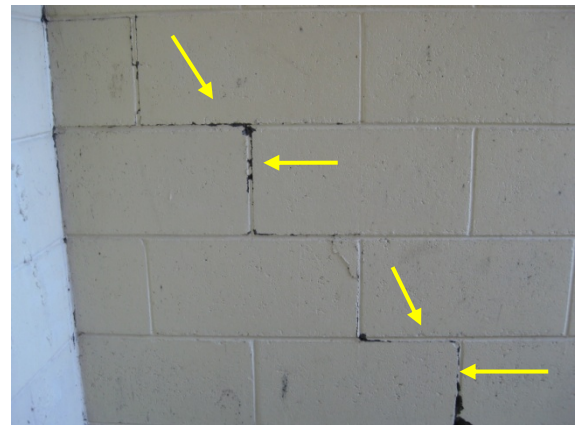
Photo 24: Close up of Photo 23

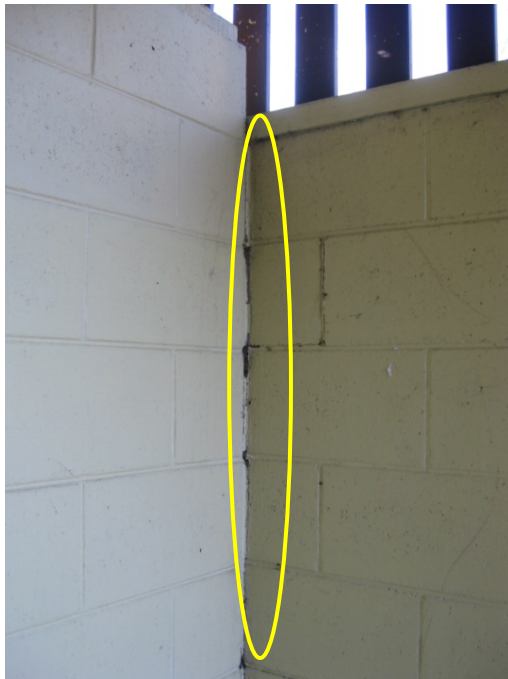
Photo 25: Cracking along the Mortar Joint in the NE Corner of the Joint

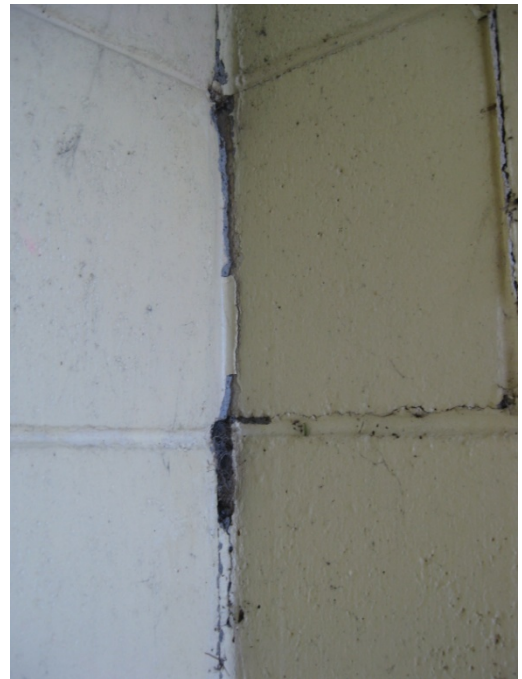
Photo 26: Close up of Photo 25

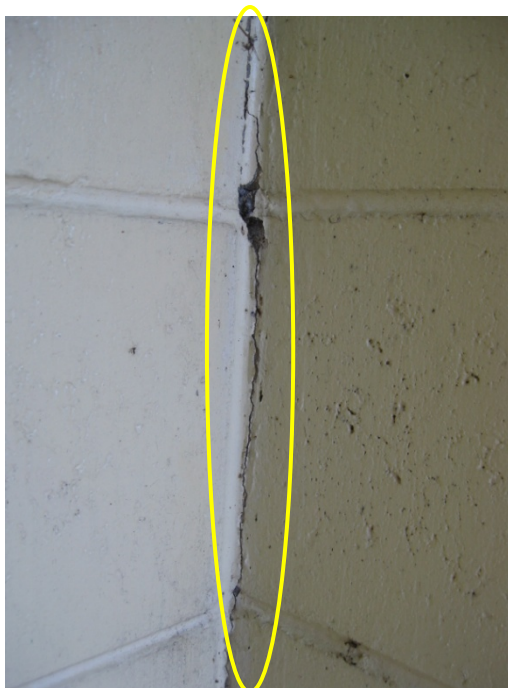
Photo 27: Close up of Photo 25

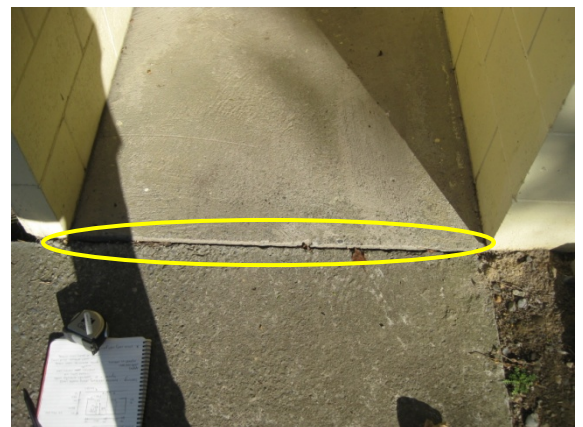
Photo 28: Differential Movement between the Concrete Floor Slab and Concrete Path outside Ladies

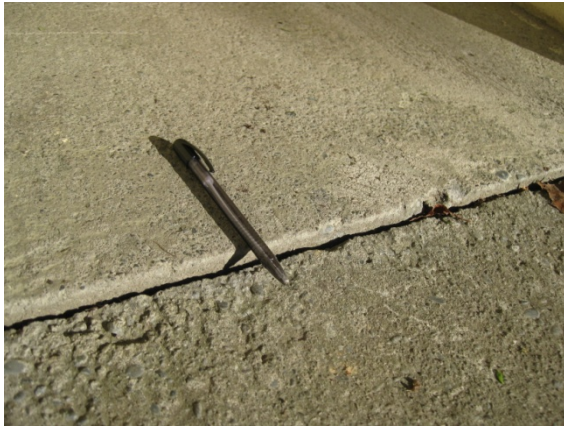
Photo 29: Close up of Photo 28

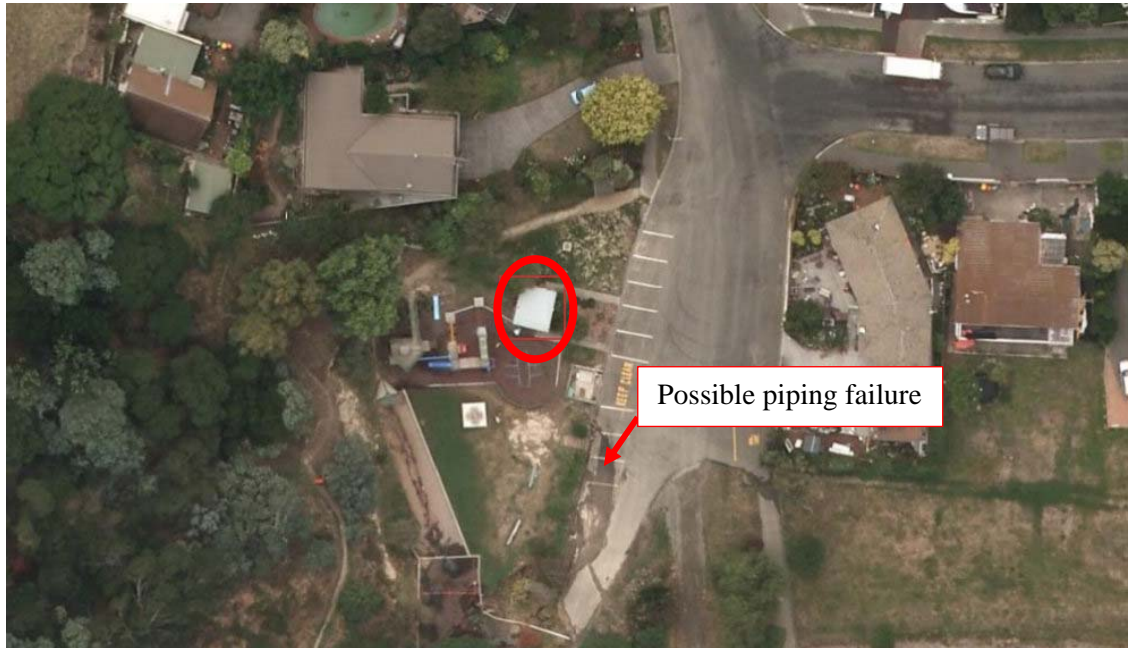
- **Figure 3 – Aerial photography from 24 Feb 2011 (<http://viewers.geospatial.govt.nz/>)**

Aerial photography shows no evidence of liquefaction but some dark grey patches to the south of the building which indicate a possible evidence of water piping failure. This piping failure was observed from the site walkover.

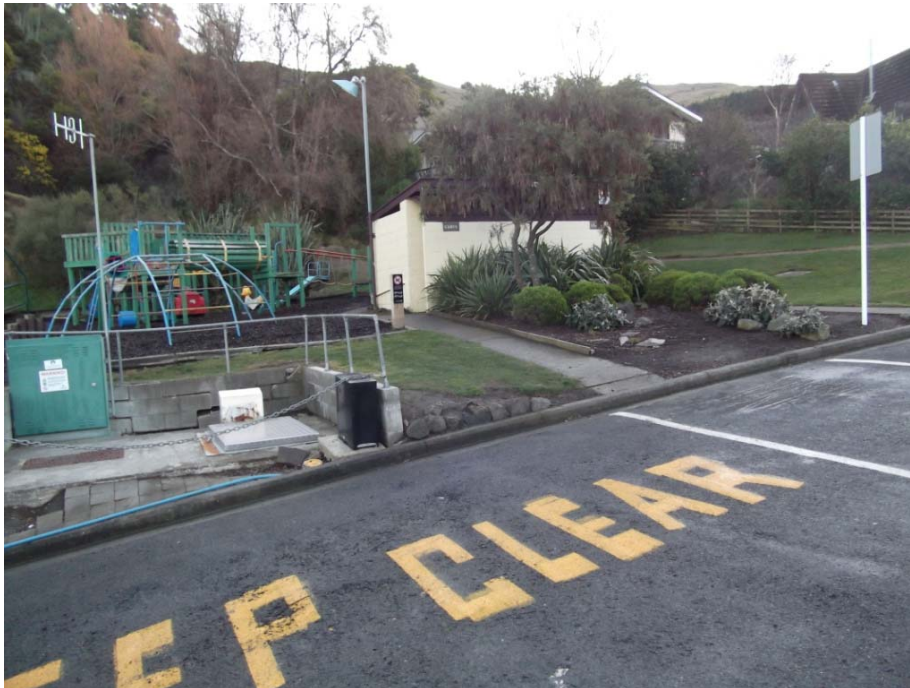
Some slumping and depressions were noted around the pump station approximately 5m southeast of the toilet building. Collapse of the concrete was noted at the back of the pump station structure. The depressions noted here may have been caused by poorly compacted fill settling around the structure or damaged pipe work may have allowed uncontrolled water/sewerage flow which tends to cause erosion and piping failure of the loess material.

- **Figure 5 Overview of structures (eastern wall) and damaged pump station in the foreground**

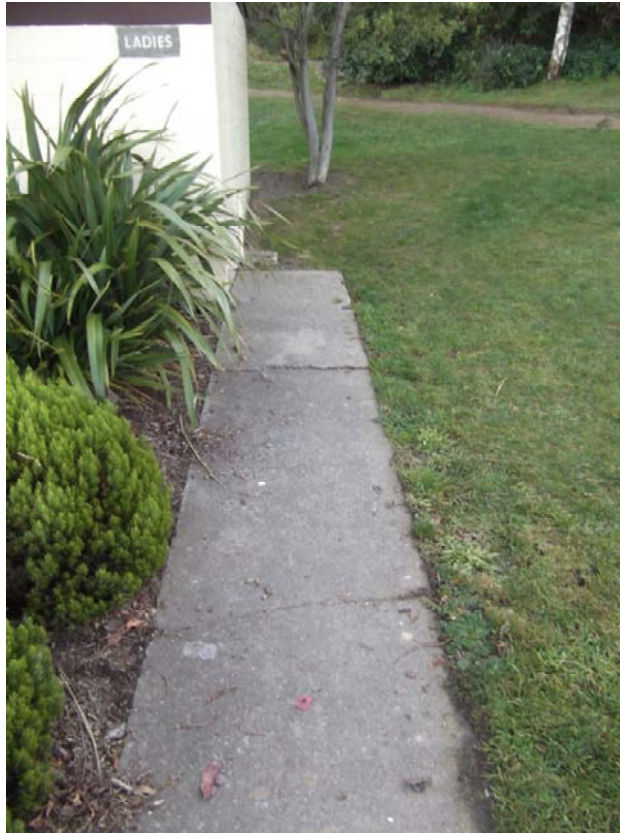
- **Figure 6 Cracking and settlement noted in concrete path northeast of building**

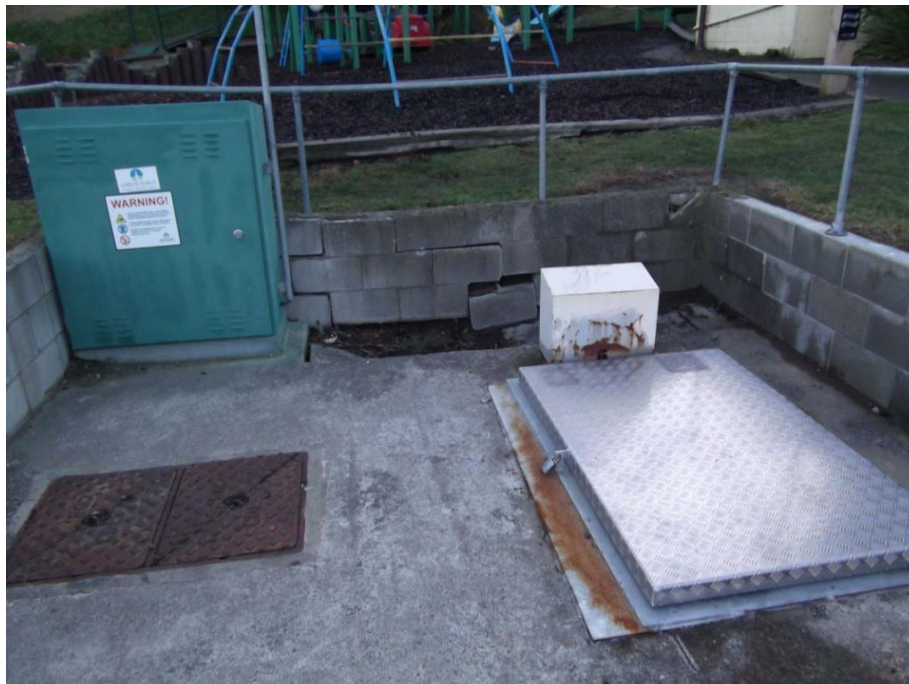
- **Figure 7 cracking and settlement of block work and concrete at the back of the pump station**

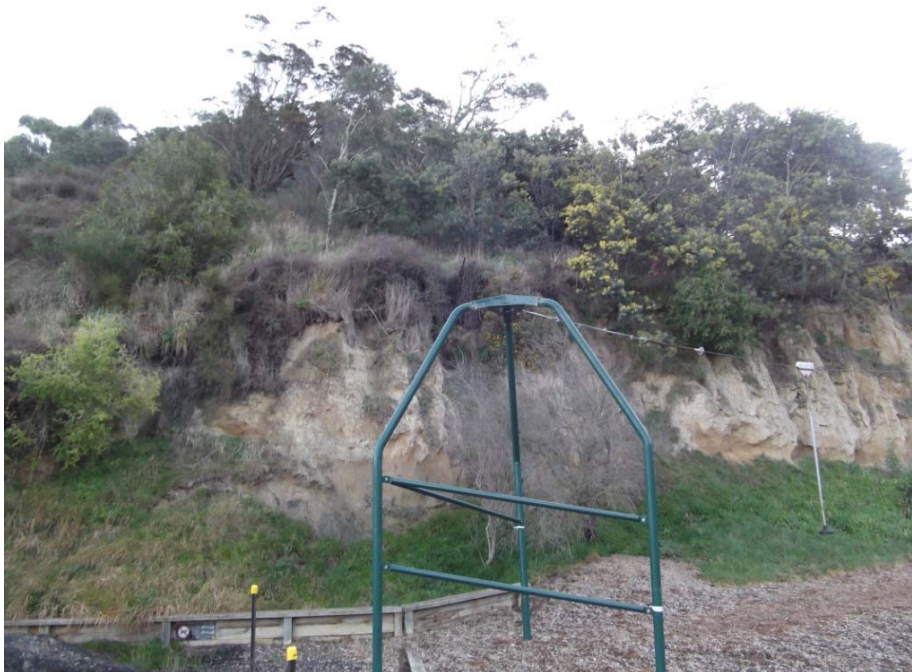
■ **Figure 8 Loess cut faces behind the building standing near vertical and stable**
