**Chaney's Plantation  
Shed/Open Garage  
PRK 0388 BLDG 002 EQ2**

**Detailed Engineering Evaluation**

**Quantitative Assessment Report**

# **Chaney's Plantation Shed/Open Garage Quantitative Assessment Report**

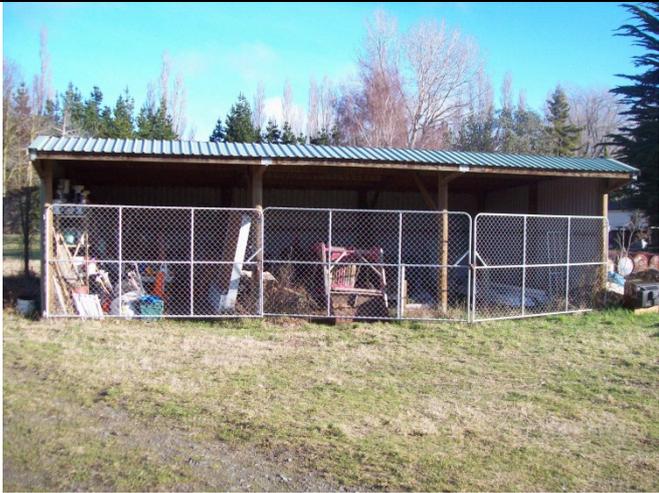
Chaney's Plantation Shed/Open Garage		
No.	Item description	Photo
1.	Front View

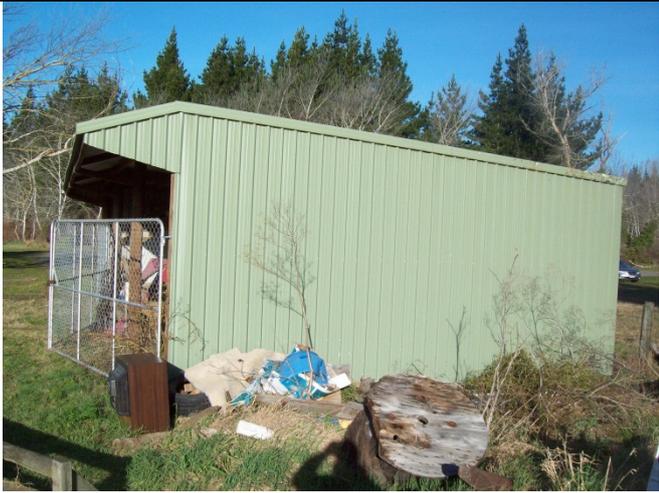
2.	Side View

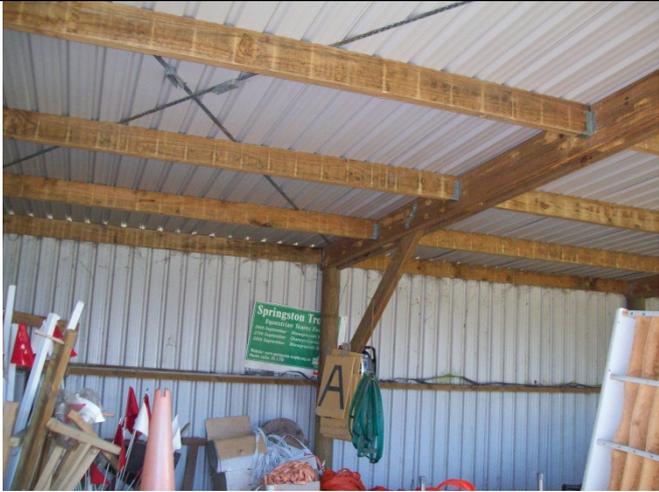
3.	Diagonal Roof Straps

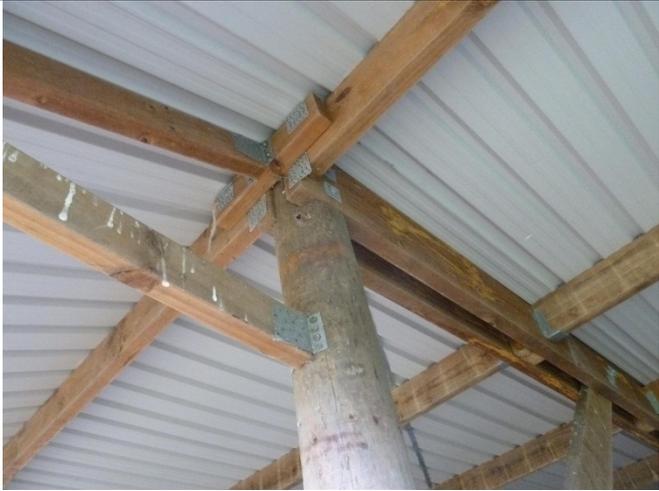
<p>4.</p>	<p>Fixing details at open end of roof rafters</p>

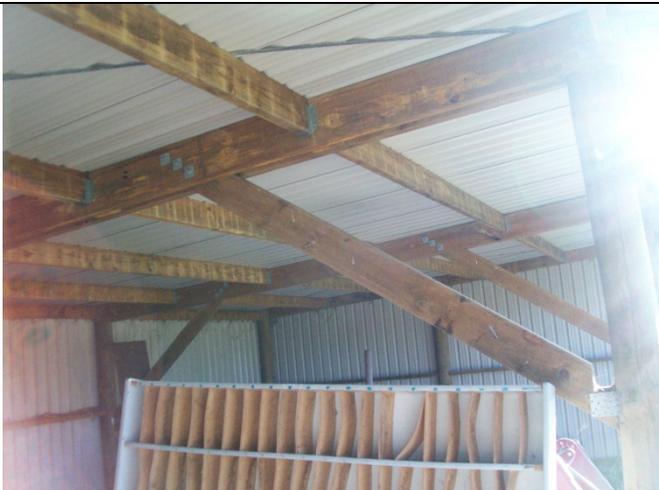
<p>5.</p>	<p>Knee brace at corners of internal timber frames</p>

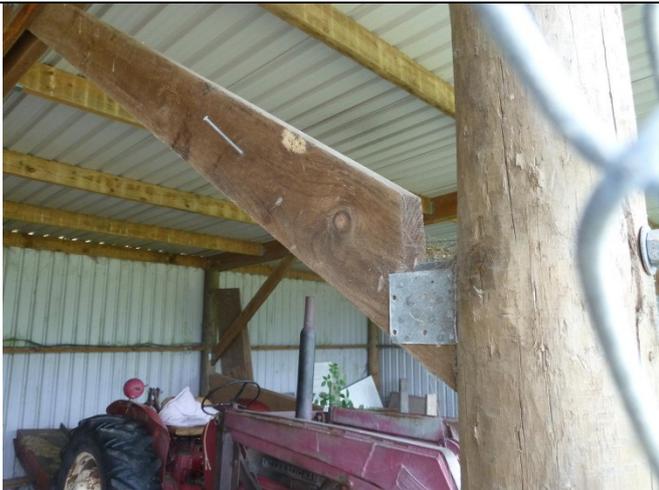
<p>6.</p>	<p>Fixing of knee brace to post</p>

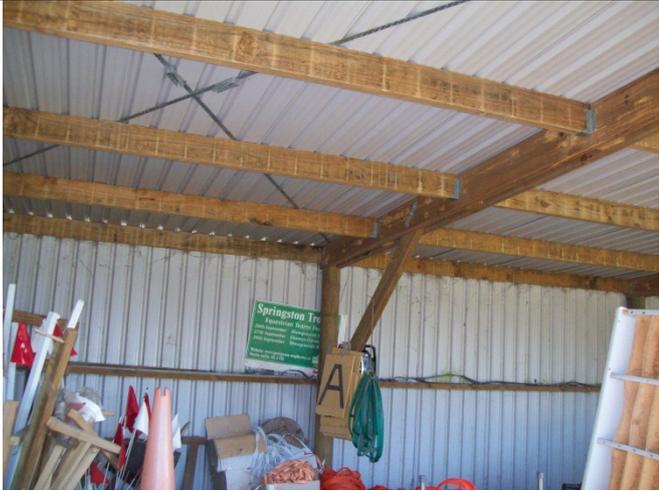
7.	Timber Roof Purlins

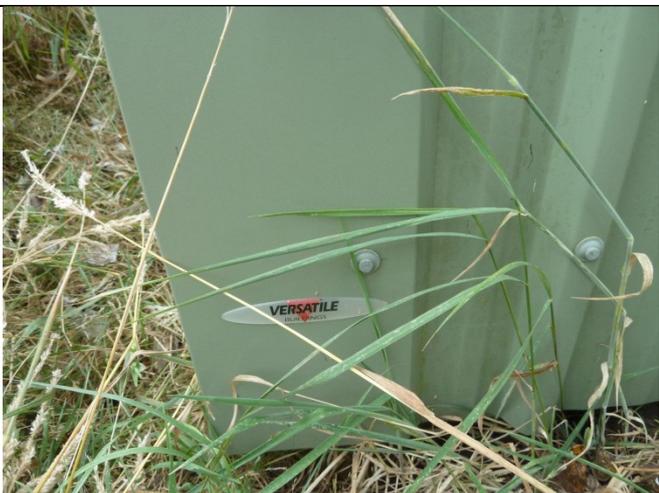
8.	Versatile manufacturer logo on buildings
