**Clent Lane  
Housing Complex  
PRO 1091**

**Detailed Engineering Evaluation  
Quantitative Assessment Report**

**32 Cobham Street, Spreydon,**

Date: April 2014

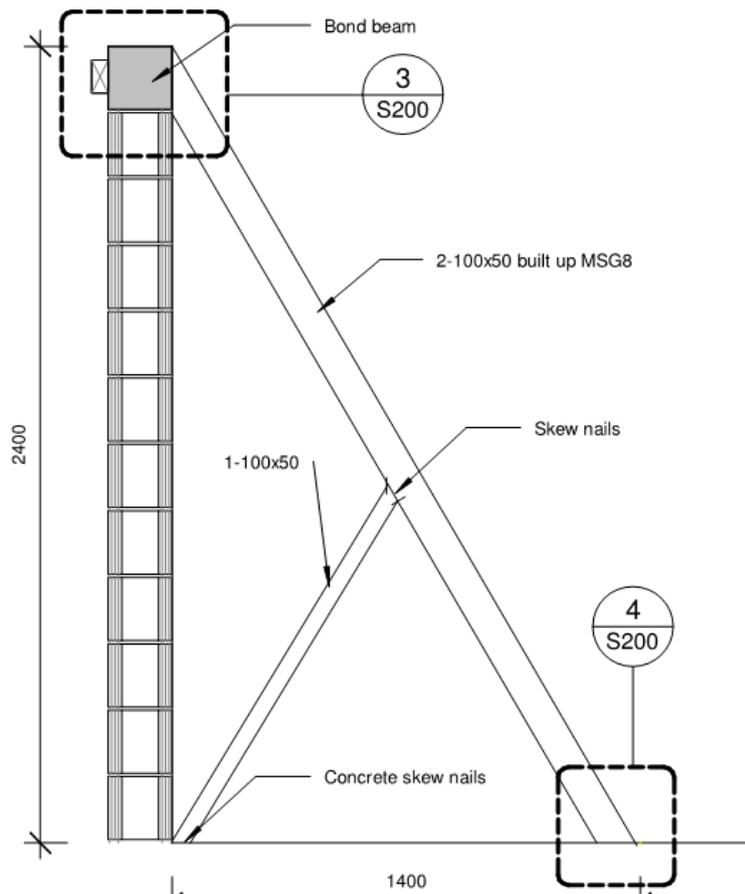
The Residents Lounge has been converted from two adjacent units in Block E. After initial investigations by Opus International Consultants, temporary braces (Figure 6 and Photos 20 and 21) were installed on 20 March 2014 so that the units in this block could remain occupied.

Figure 6: Braces used in residents lounge

- Strengthening schemes be developed to bring the capacities of the structures to at least 67%NBS.
- Cracking in the concrete bond beam and block firewall be repaired.
- Replace temporary propping with permanent strengthening solution.
- Cosmetic repairs be undertaken as required.

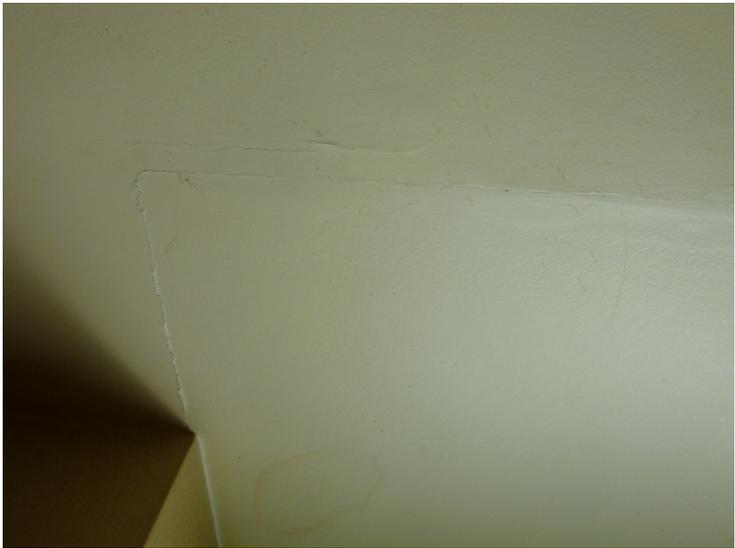
The residential units have suffered minor damage to non-structural elements. This included cracking of the internal wall linings and ceiling diaphragms. There is minor cracking to the concrete bond beam and firewall. This damage was deemed low enough to not affect the capacities of the buildings.

10.	Typical cracking to ceiling diaphragm

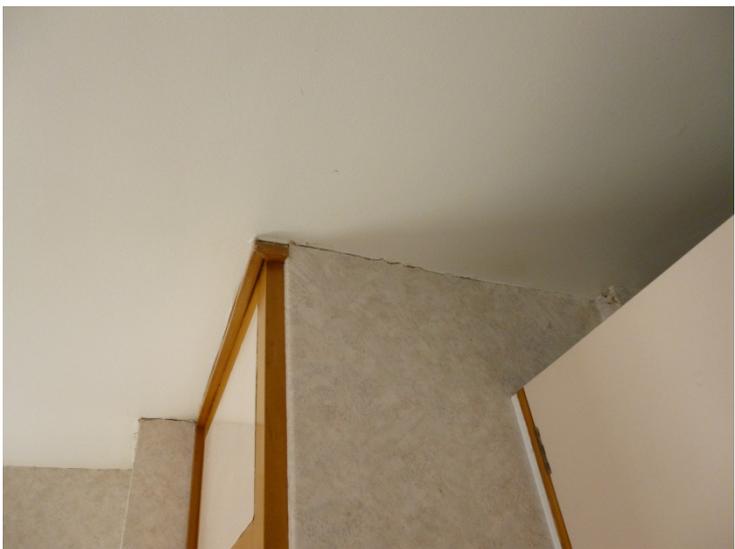
Minor to moderate damage to non-structural elements was observed. This included cracking to plasterboard wall linings where they join at corners (photos 11 and 14).

11.	Typical cracking where wall and ceiling linings meet

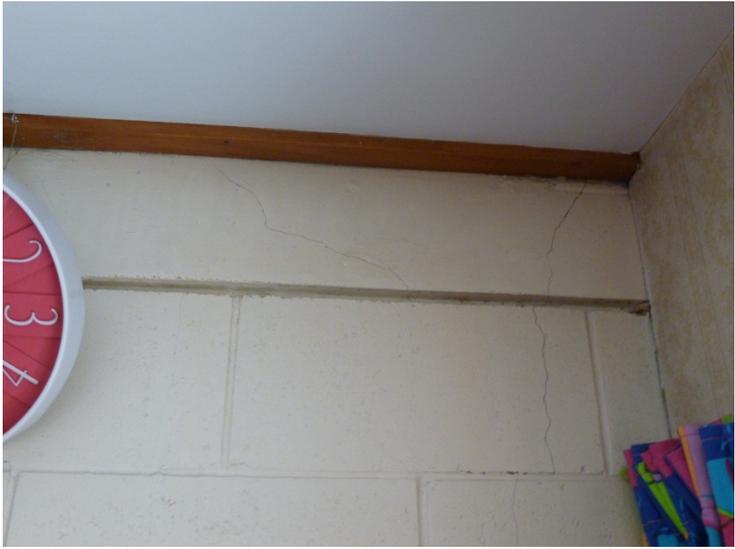
Minor damage was observed to the primary lateral resistance structure in the form of cracking to wall and ceiling linings. Cracking was also observed to the bond beam at the top of the fire walls in most units (photo 12). Similar cracks were also observed from the exterior of the bond beams (photo 15) which have been patched between the time of the damage and the site inspection. Stepped cracking was also observed in the fire wall of Unit 19 (photo 13).

<p>12.</p>	<p>Cracking in bond beam</p>

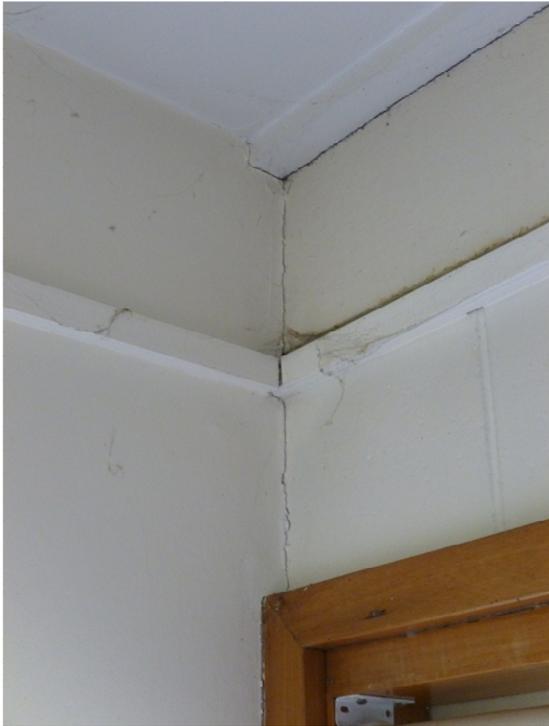
<p>14.</p>	<p>Typical separation of interior wall linings from fire wall</p>

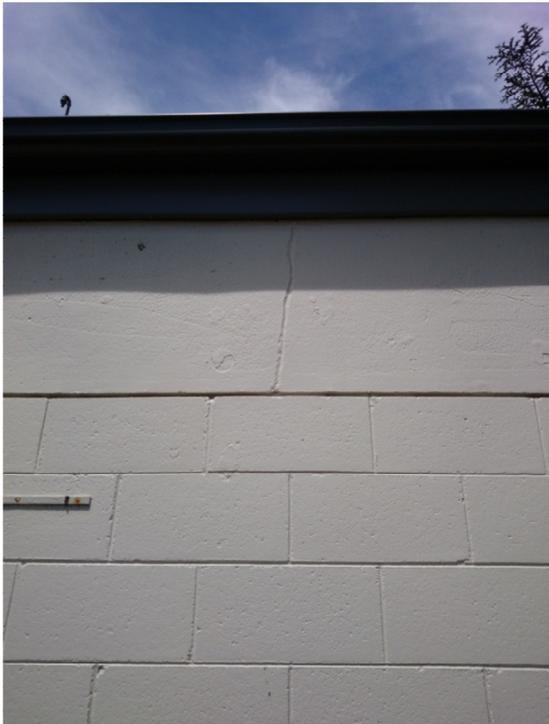
A photograph showing the interior corner of a room. The walls are white, and there is a significant vertical crack running down the corner where the wall meets the ceiling. The crack appears to be a separation between the interior wall lining and the underlying fire wall. A wooden door frame is visible in the lower right corner.
<p>15.</p>	<p>Exterior crack in bond beam</p>

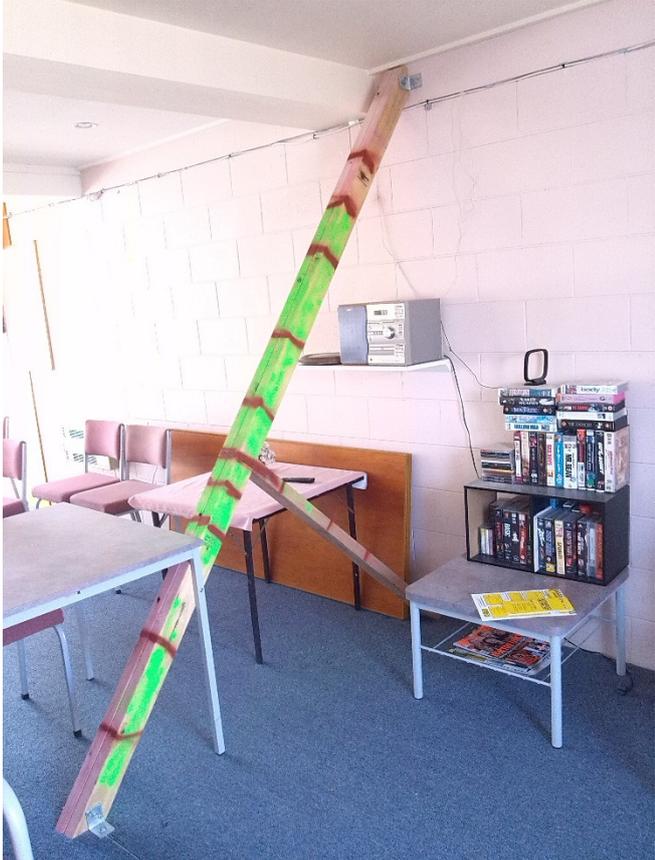
A photograph showing a large, open-plan living and dining area. In the foreground, a long table is covered with a brown cloth. The middle ground features a dining table with several chairs. In the background, a person in a high-visibility vest stands near a window, and other people are seated at a table. Large windows with sheer curtains allow natural light into the room.
<p>20.</p>	<p>Temporary braces installed in Residents Lounge</p>

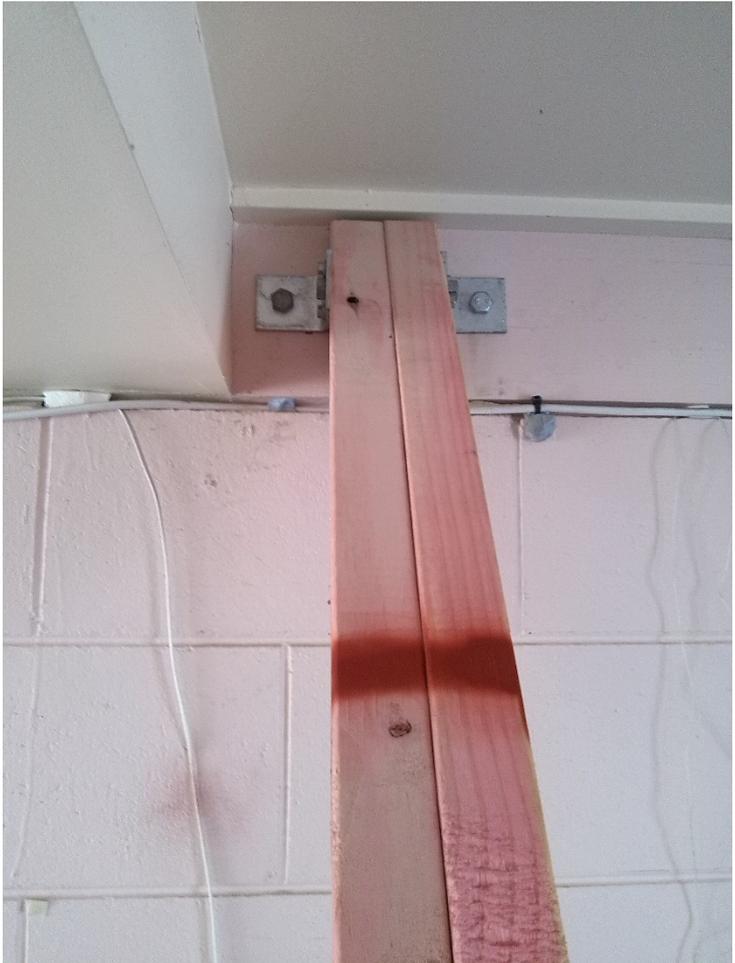
<p>21.</p>	<p>Temporary braces installed in Residents Lounge</p>

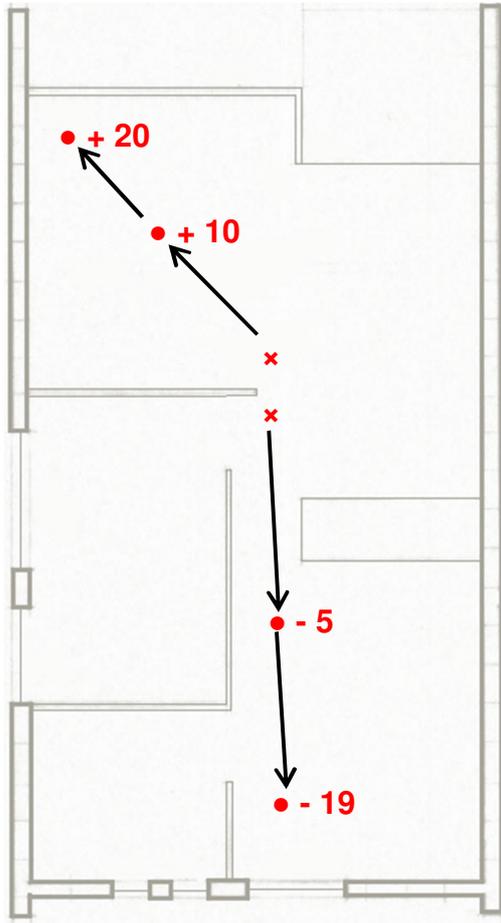
Unit 25

Block	Unit No.	Comment	Maximum Fall*
A	1	Pass	-
	2	Pass	-
	3	Pass	-
	4	Pass	-
B	5	Pass	-
	6	Pass	-
	7	Pass	-
	8	Pass	-
	9	Pass	-
	10	Pass	-
C	11	Pass	-
	12	Pass	-
	14	Pass	-
	15	Pass	-
	16	Pass	-
D	17	Pass	-
	18	Pass	-
	19	Pass	-
	20	Pass	-
E	Residents Lounge	Pass	-
	23	Pass	-
	24	Pass	-
F	25	Fail	5 mm/m
	26	Pass	-
	27	Pass	-
	28	Pass	-
	29	Pass	-
	30	Pass	-
	31	Pass	-
	32	Pass	-
G	33	Fail	6 mm/m
	34	Pass	-
	35	Pass	-
H	36	Pass	-
	37	Pass	-
	38	Pass	-

Only minor displacements were observed in all units inspected. Two units exhibited levels which exceeded the 5mm/m MBIE guideline.
