CHRISTCHURCH CITY COUNCIL  
PRK\_3554\_BLDG\_001 EQ2  
Coastal Cliff Reserve Toilets  
21 Marine Drive, Diamond Harbour

QUALITATIVE ASSESSMENT REPORT

FINAL

- Rev B
- 23 May 2013

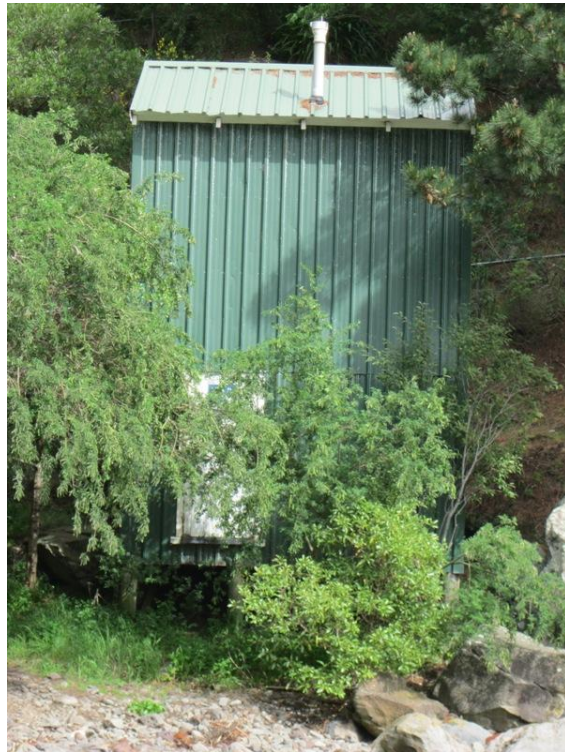
Photo 1: North elevation

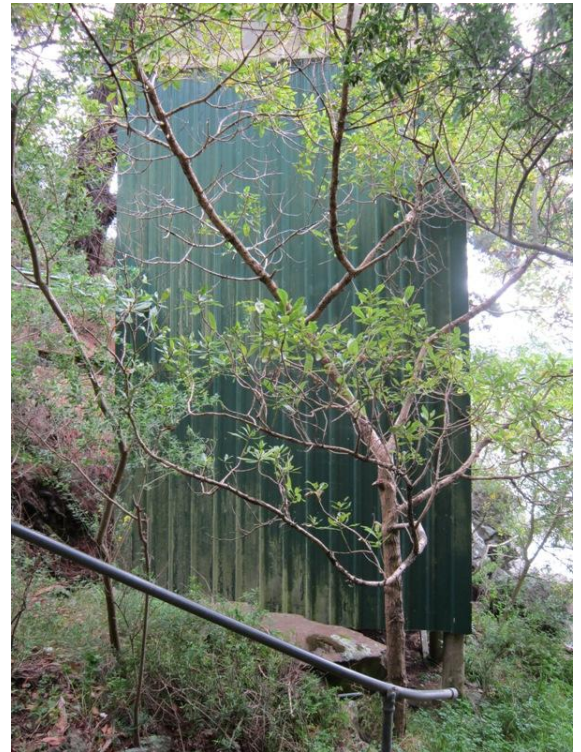
Photo 2: East elevation

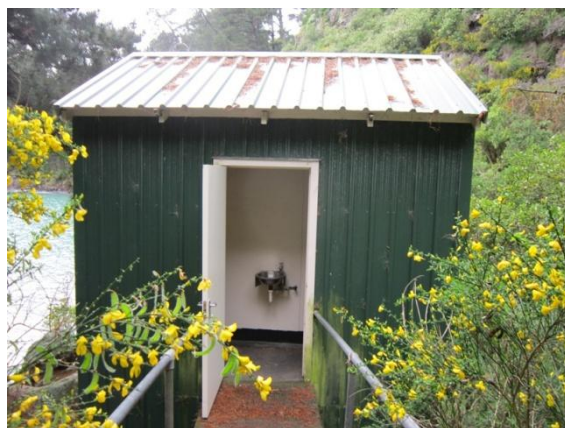
Photo 3: South elevation

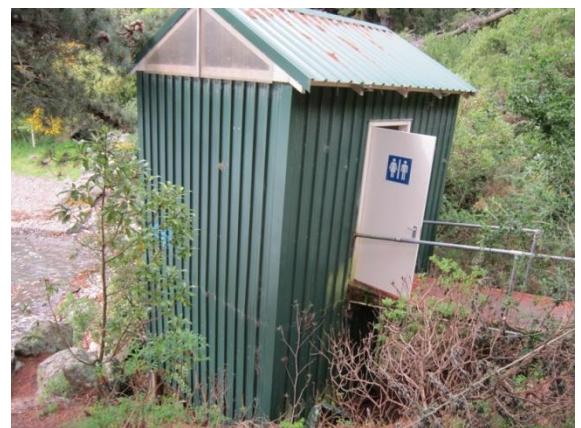
Photo 4: West elevation

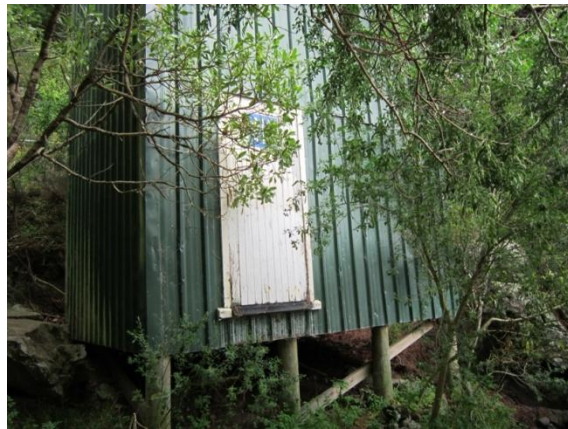
Photo 5: Entrance to ground floor (inaccessible), also showing diagonal timber brace at foundation level

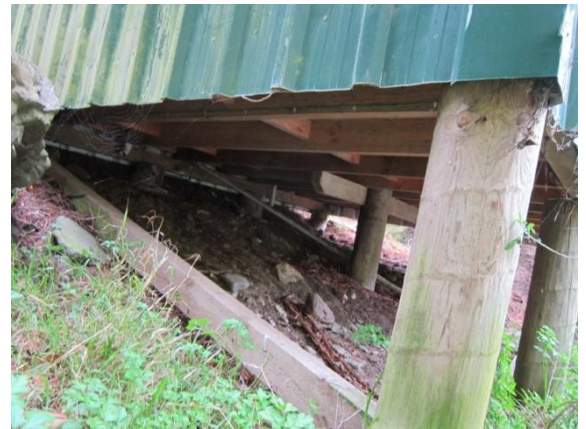
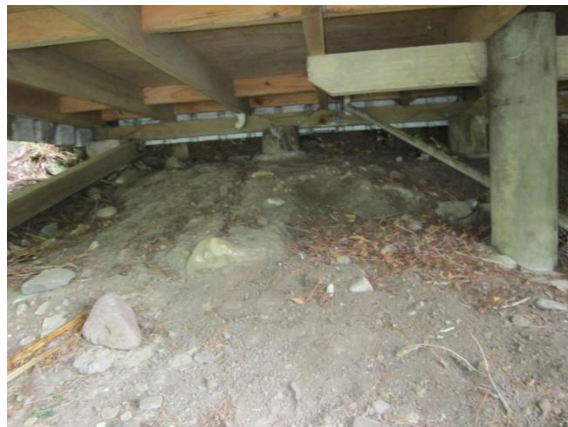
Photo 6: Timber joists, piles and diagonal bracing shown at foundation level (sloping ground)

Photo 7: Timber joists, piles and diagonal bracing shown at foundation level (sloping ground)

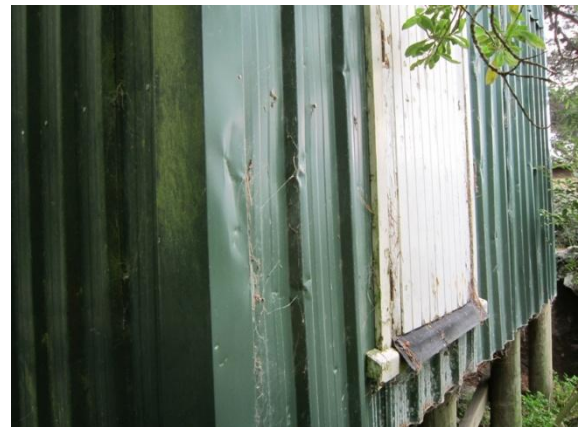
- 1) Corrosion of corrugated wall sheeting at the base of the walls. This is not earthquake-related damage.
- 2) Cracking along the grain of timber piles. This is due to age and is not earthquake-related damage.
- 3) Suspected impact damage to the corrugated wall sheeting on the ground floor. This is not earthquake-related damage.

Photo 8: Suspected impact damage to corrugated external wall cladding

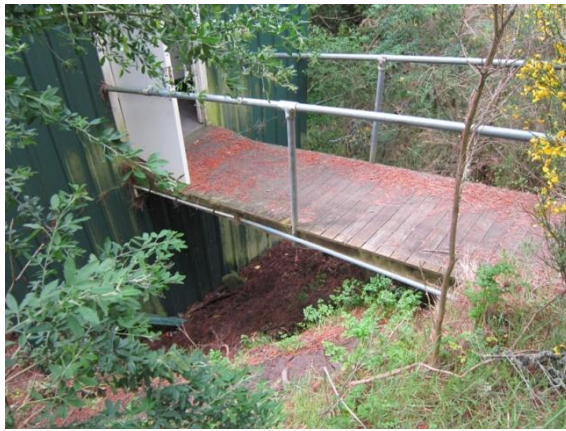
Photo 9: Ramp leading to first floor on the south side of the building

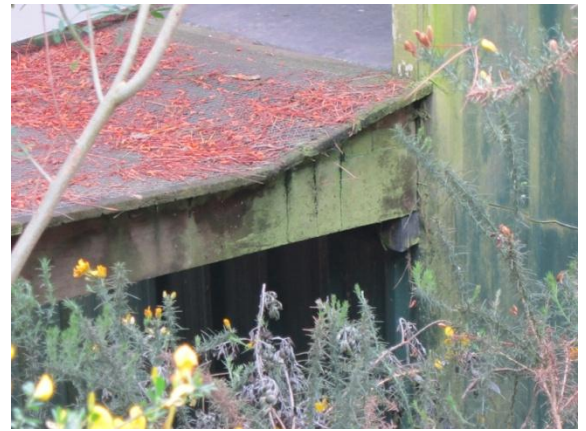
Photo 10: Ramp support at the entrance to the first floor

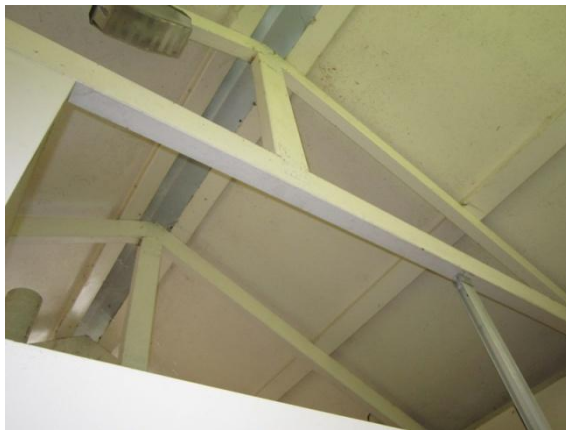
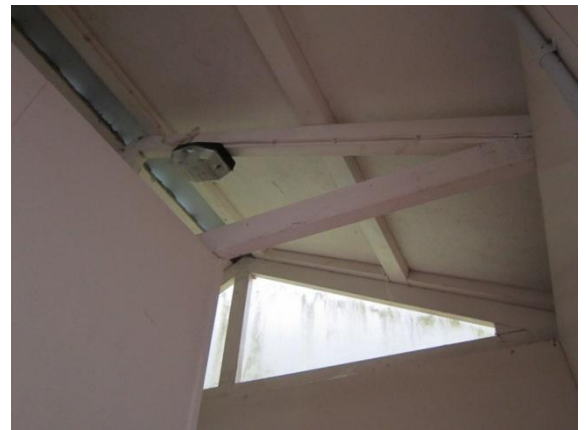
Photo 11: Timber roof trusses at 850mm centres

Photo 12: Timber roof trusses at 850mm centres
