**Coles Place  
Housing Complex  
PRO 0616**

**Detailed Engineering Evaluation  
Quantitative Assessment Report**

**21-49 Coles Place, St Albans, 8014**

Date: January 2014  
Reference: 6-QC332.00  
Status: Final

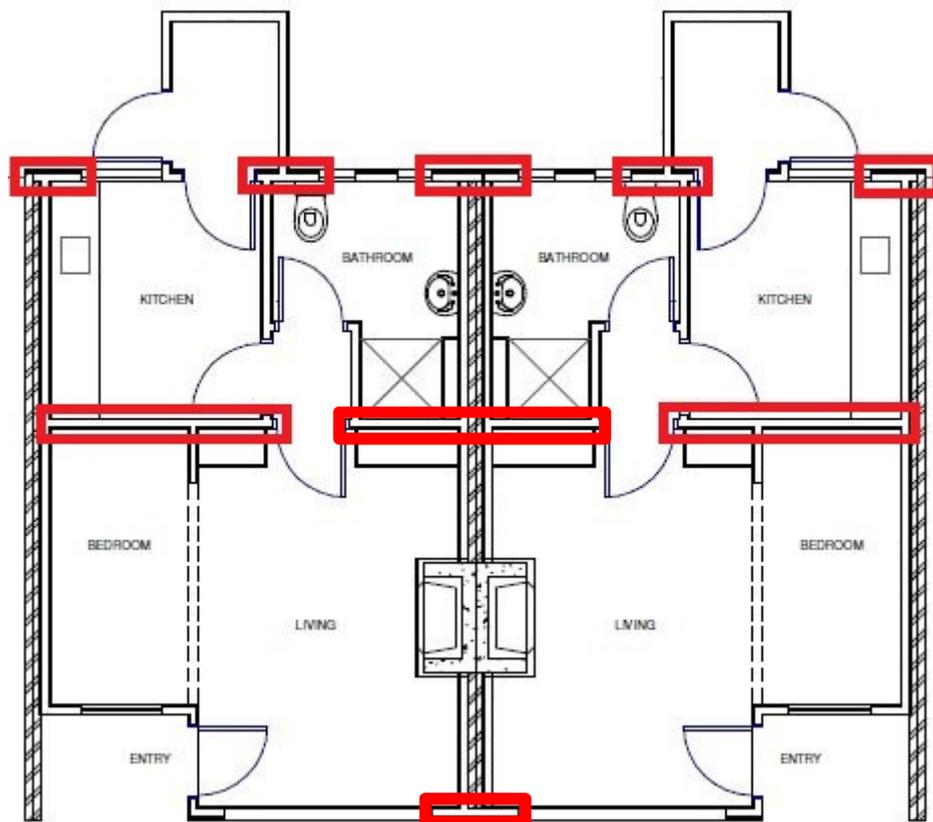
Figure 6: Walls used for bracing in the longitudinal direction.

The residential units have a capacity of 44% NBS as limited by the in-plane shear capacity of the timber-framed shear walls in the longitudinal direction. They are deemed to be a 'moderate risk' in a design seismic event according to NZSEE guidelines.

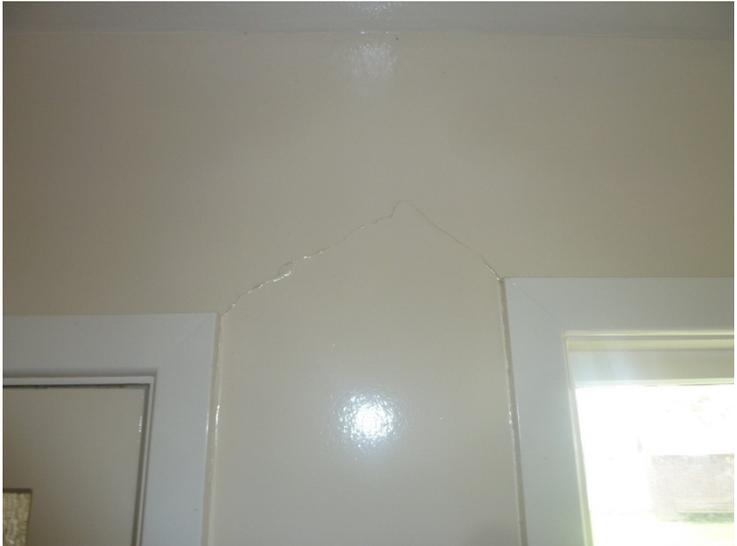
Minimal cracking of ceiling and wall linings was observed in the units. This form of damage is common throughout the units, particularly surrounding doors and windows.

| 9. | Typical cracking of interior lining | A photograph of a white interior wall. A prominent, jagged crack runs vertically down the center of the wall, starting from the ceiling and extending towards the bottom. The crack is irregular in shape, with several sharp points and turns. The wall surface is otherwise smooth and glossy. |

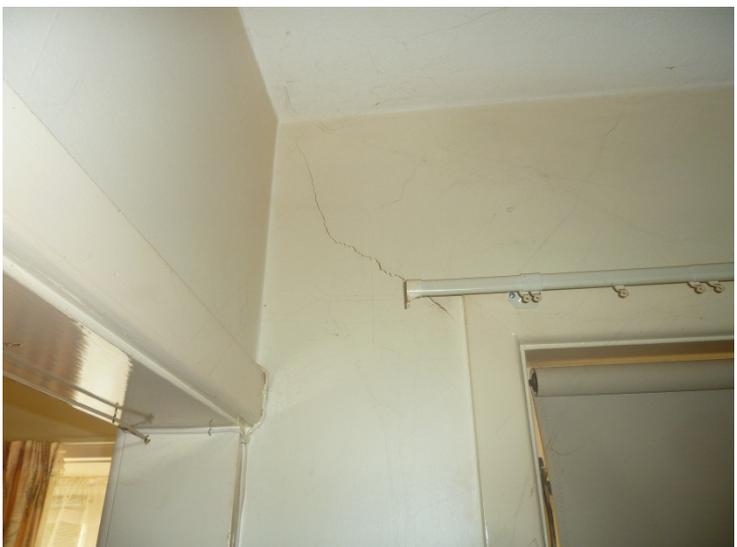
| 10. | Typical cracking of interior lining | A photograph showing a different view of a white interior wall. A crack runs diagonally across the wall, starting from the ceiling and extending towards the right. The crack is jagged and irregular. A metal handrail is visible on the right side of the wall, and a doorway is partially visible in the background. |

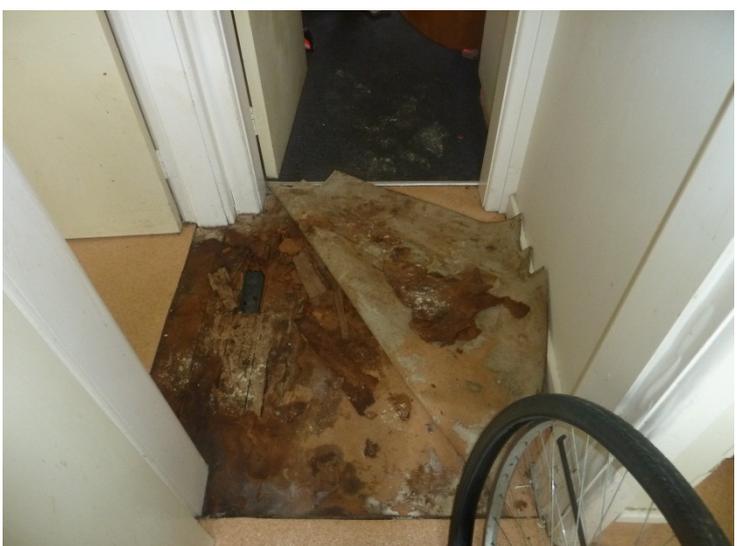
It is noticeable that none of the residential unit blocks, and individual units, have suffered any significant earthquake damage. It is noted that units 29, 37, 42 have areas where rotten floor boards are present.

| 11. | Rotten floor boards located in unit 29 (not earthquake related) | A photograph of a hallway floor. The floorboards are severely damaged, showing significant rot and discoloration. The wood is dark brown and crumbling. A bicycle wheel is visible in the foreground, partially obscuring the floor. The walls are white and appear to be in good condition. |

- The concrete perimeter footings be repaired on blocks where cracking occurs.
- A site specific geotechnical site investigation be carried out to determine the liquefaction potential of the site and the shallow bearing capacities of the soils if this information is required for future construction on the site.
- Cosmetic repairs be undertaken as required.
- Veneer at height (gable ends) have their veneer ties checked.
- All buildings be strengthened to at least 67% NBS.
- Repairs be undertaken to replace rotten floor boards.

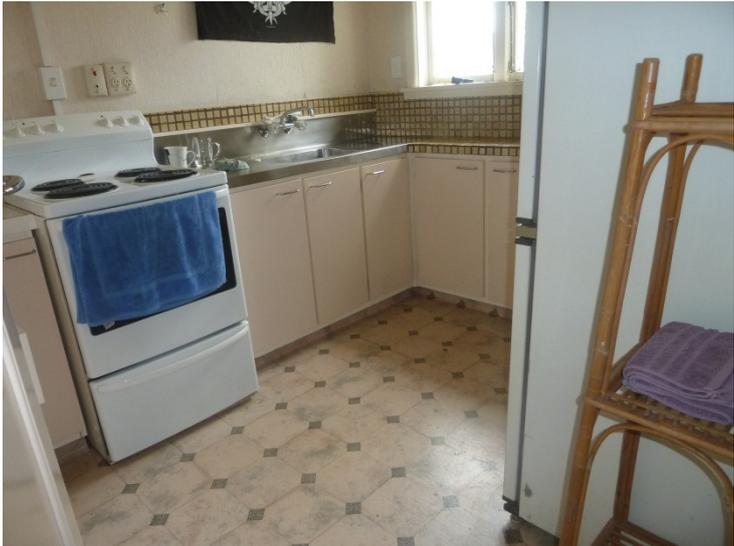
Only Unit 44 had floor slopes that were greater than the 5mm/m limitation set out in the MBIE guidelines [6].

A full level survey was not deemed to be necessary at Coles Place as it is located in a TC2 zone. Properties in TC2 zones suffered moderate damage due to liquefaction and/or settlement. In lieu of a full level survey, a laser level was placed in each unit so that differentials in vertical levels could be measured at the extreme ends of the unit. These values could then be used to determine the floor slope of the entire unit. For this site, the maximum slope in a unit was 11mm/m, which exceeds the 5mm/m limitation set out in the MBIE guidelines.

| <p>12.</p> | <p>Levels beyond 5mm/m limitation in kitchen area of Unit 44</p> | |

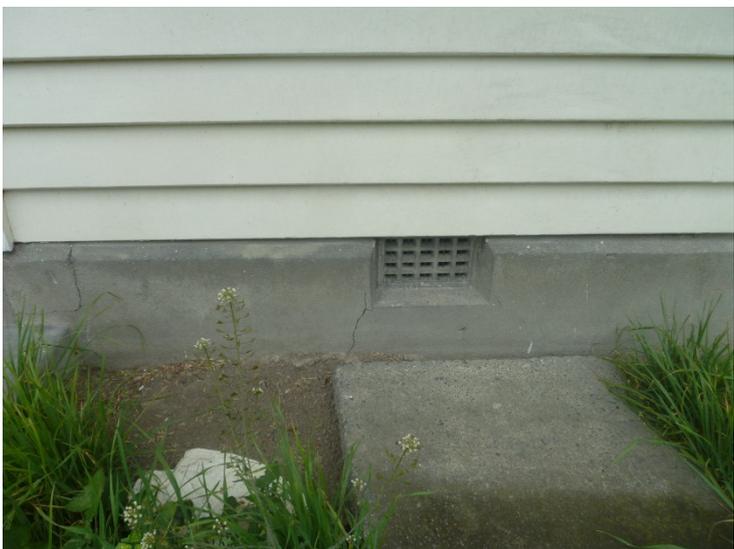
Foundation damage was limited to minimal cracking in the concrete perimeter foundation. This occurs particularly around the ventilation grids.

| <p>13.</p> | <p>Typical cracking of concrete perimeter footing</p> | |
