**Christchurch City Council**  
PRK\_3534\_BLDG\_006 EQ2  
Corsair Bay Changing Sheds and Toilets  
5 Park Terrace, Corsair Bay

QUALITATIVE ASSESSMENT REPORT  
FINAL

- Rev B
- 17 January 2013

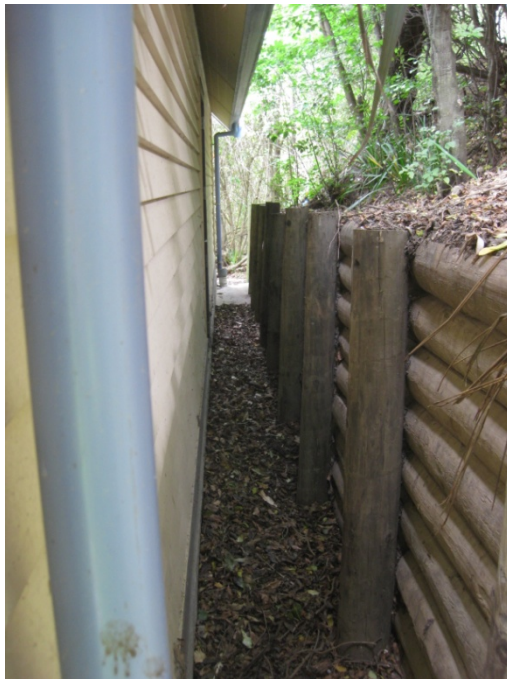
Photo 3: View along the Northwest elevation showing the timber retaining post retaining wall

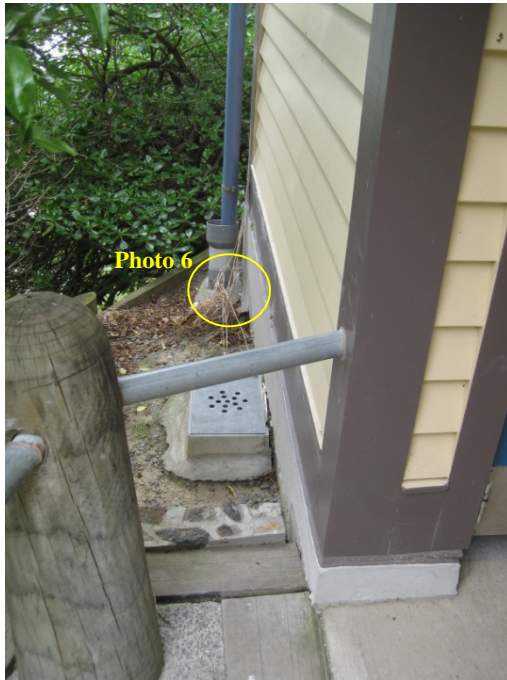
- Grout material between the building and external drainage on the south corner of the building has separated and cracked.

- 1) Grout material between the building and external drainage on the south corner of the building has separated and cracked. (photo 5 and 6)
- 2) Vertical 1.5 mm crack at the foundation on the east corner of the building. (photo 11 and 12)
- 3) External landscaping including the small footpath stone retaining wall and the fence posts have moved away from their original position exposing cracks and damaging the horizontal steel rail on the south corner of the building. (photo 7)

Photo 5: View of the south corner of the building showing cracks between the drains and the building

<b>Recommendations</b>		Level of repair/strengthening required: minor non-structural	Describe: re grouting around areas of the damage around drain
Building Consent required: no		Describe:	
Interim occupancy recommendations: full occupancy		Describe:	
Along	Assessed %NBS before: 100%	%NBS from IEP below	Qualitative Assessment carried out, this includes the NZSEE IEP - refer to SKM report
Assessed %NBS after: 100%			
Across	Assessed %NBS before: 100%	%NBS from IEP below	If IEP not used, please detail assessment methodology:
Assessed %NBS after: 100%

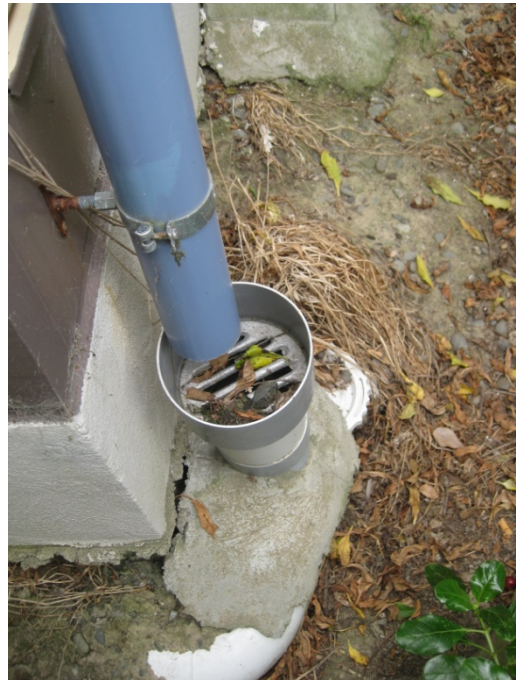
Photo 6: Close up view of one of the roof drains

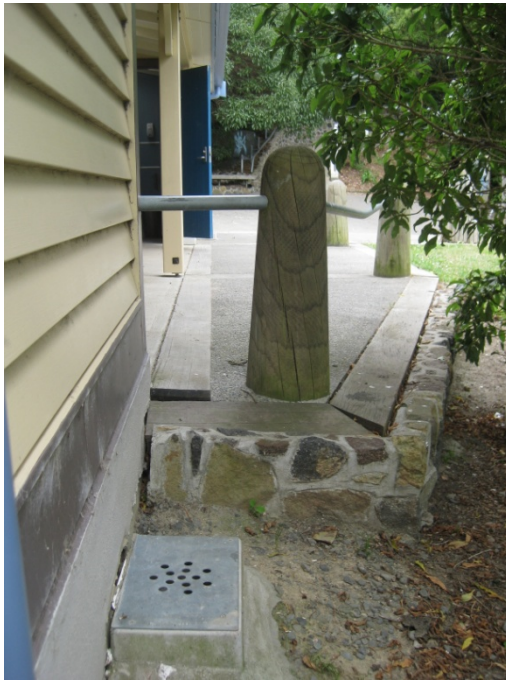
- External landscaping including the small footpath stone retaining wall and the fence posts have moved away from their original position exposing cracks and damaging the horizontal steel rail on the south corner of the building.
- Vertical 1.5mm crack at the foundation on the east corner of the building.

Photo 7: View of south corner in the opposite direction to photo 5, showing the damaged external landscaping

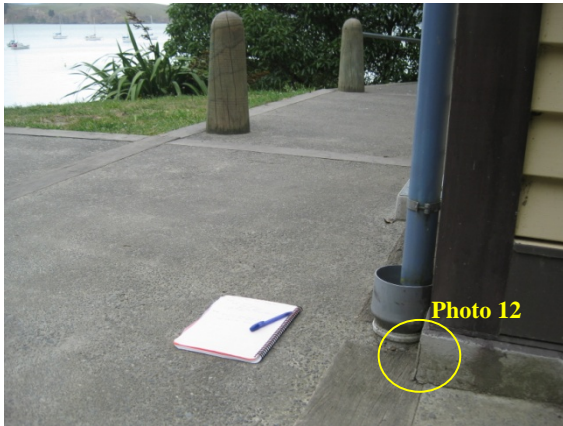
Photo 12

Photo 12: Close up view from photo 11

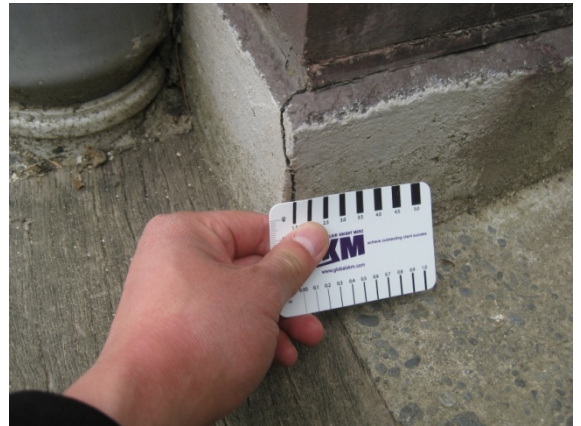
Photo 11: View of the east corner of the building
