Cowles Stadium, Wainoni, Christchurch

QUANTITATIVE ASSESSMENT OF STRUCTURE

- Report 3
- 20 December 2011

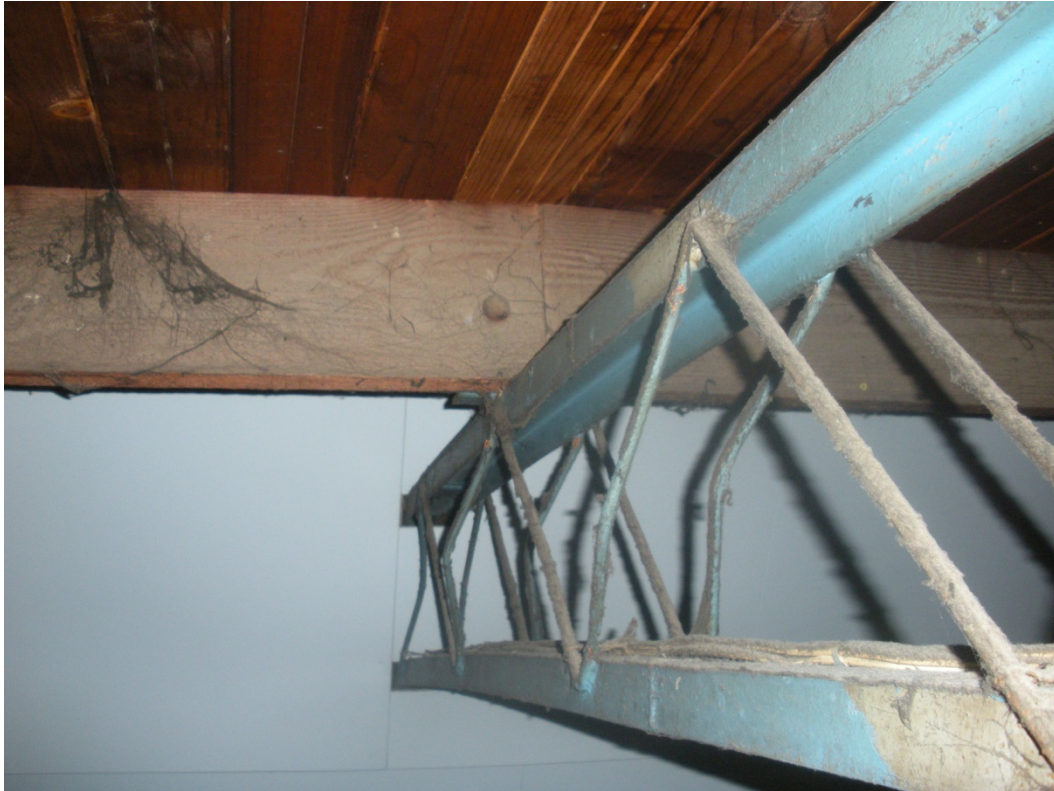
The damage of principle concern, that triggered the need for this investigation, is that a significant number of trussed-arch diagonals, primarily at the south-east ends of the arches have buckled substantially (Photos 3 and 4). Displacement of a previous build-up of dust on these diagonals suggests that this is recent, hence earthquake related, damage rather than as a result of some earlier demand. Generally this damage occurs only on the S-E side of the hall but it is understood that the diagonals on the N-W ends have been upgraded to heavier sections at some time in the past. The reason for this is not known but it seems likely that the building may have suffered similar distress in the past to have triggered this upgrading.

Photo 3 – Buckled web members and bent lower chord

- Remove the following web members: all webs over the first three purlin spacings (approx 3.6m) whether buckled or not; all buckled members beyond this region, including any straight members that are between buckled members.

- The removed webs should be replaced using 16mm diameter grade 300 steel rod.
- Web members should be laced by welding a longitudinal 12mm rod to each web at mid-height of the truss.

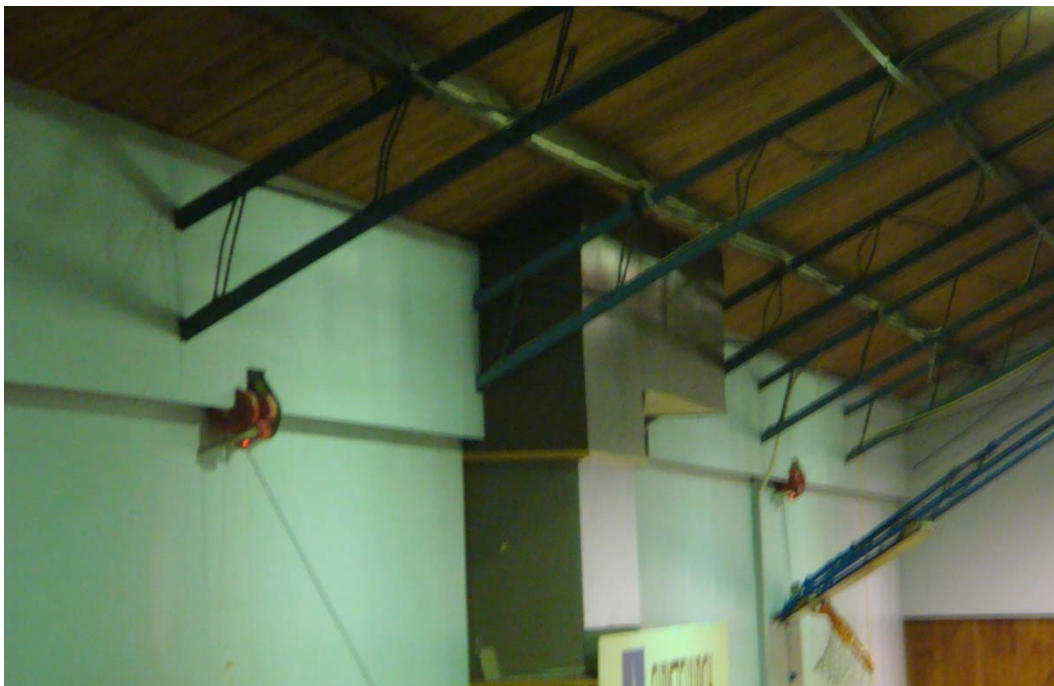
Photo 4 Buckled web members

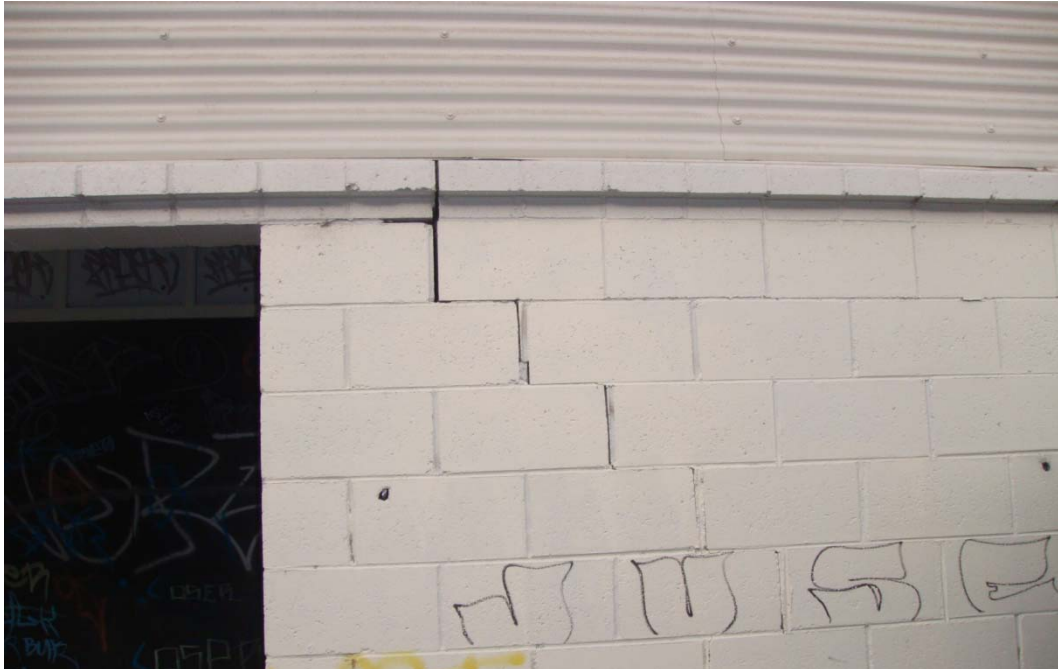
The block walls to the perimeter show numerous cases of diagonal herring-bone cracking of minor nature (Photo 5).

Photo 5 – Typical external wall cracking

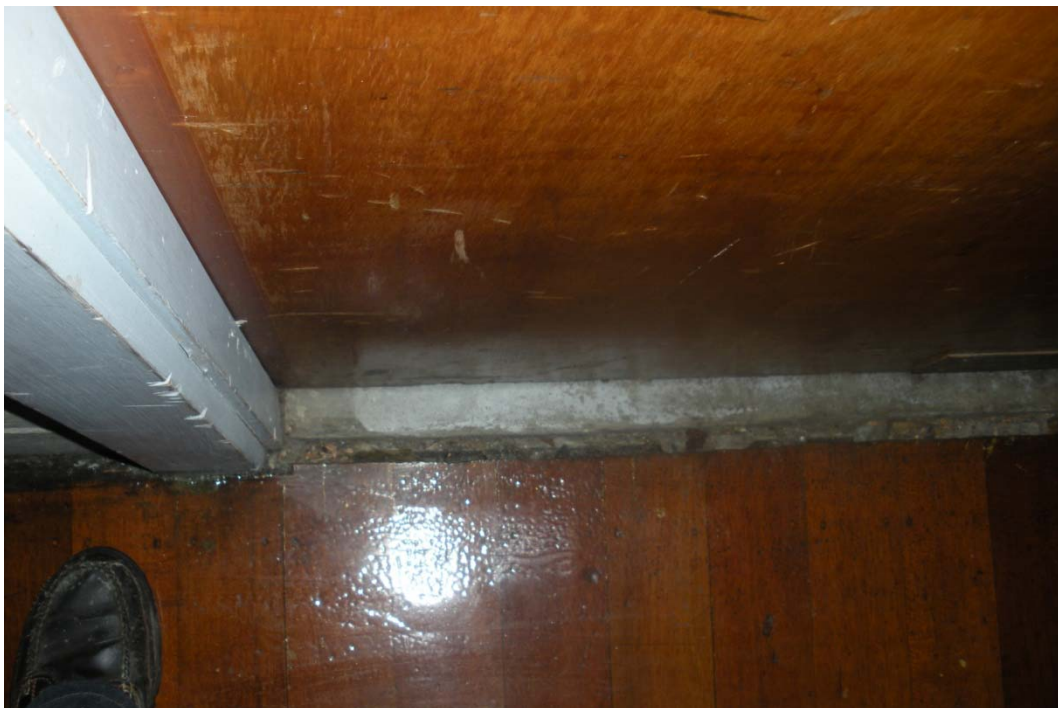
The S-E lean-to extension has separated from its adjacent structure by about 30 – 40 mm and similar (but slightly less) movement is exhibited by the S-W wall of the hall relative to the hall floor (Photo 6).

Photo 6 – Movement of South-West wall

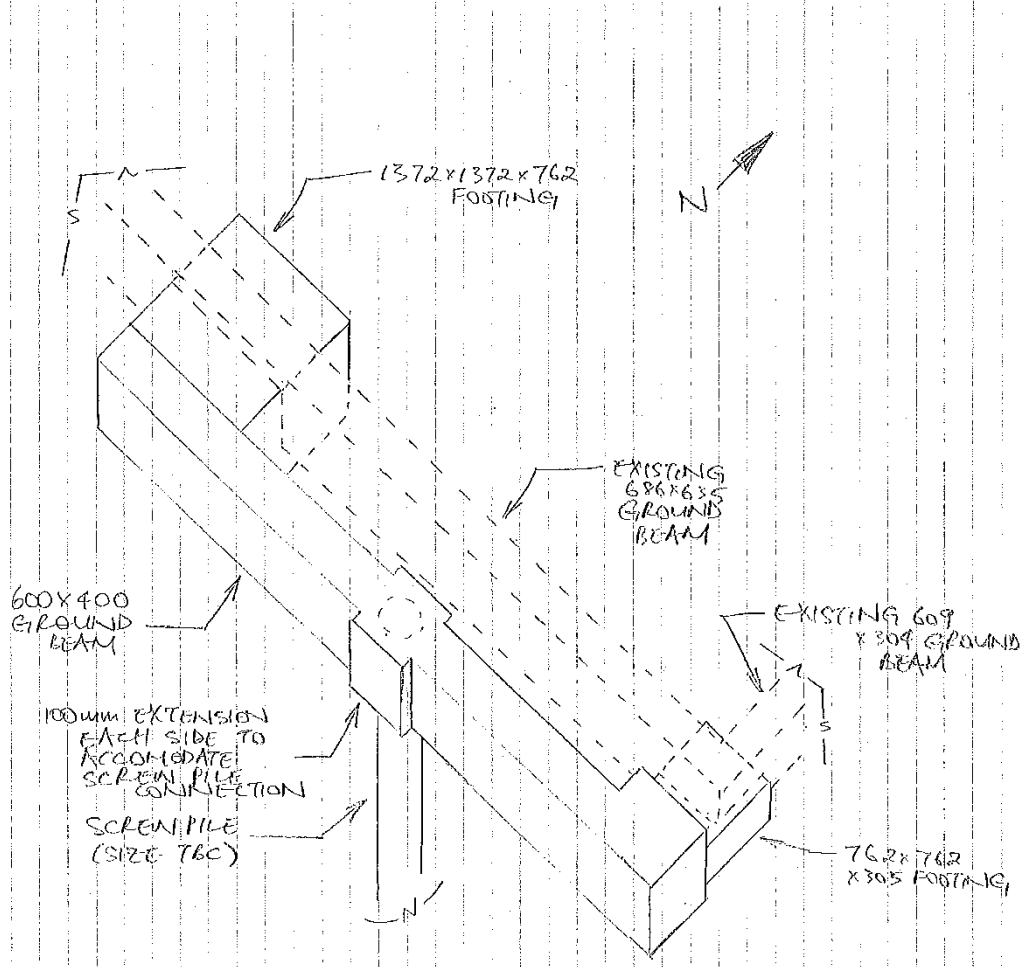
3D VIEW OF EXTERIOR CORNER OF FOUNDATIONS:

The foundation pads do not have sufficient mass to withstand the seismic uplift loads generated in all locations. Two scenarios were considered. These two scenarios were:

Generally the foundations associated with the longitudinal bracing do not have sufficient mass to resist these combined forces and consequently avoidance of foundation uplift tends to be the controlling strength limitation. The lift load is variable as indicated in the table below.

If screw piles are to be used for hold-down then they need to have a capacity of 225 kN. A total of 6 are required by calculation (one near each corner plus 1 each side for the additional braced bay for the 100% solution) however the presence of a transformer in one corner necessitates one pile either side of it, hence 7 total. For the typical corner these would be installed between the last two lean-to footings at each corner and slightly outside the line of the external wall. They would then be connected to the foundation pads either side by means of a new 6m long concrete beam per corner. This solution is shown in sketch format in Appendix B.

NB: EXISTING GROUND BEAMS SHOWN FOLLOW LINE OF EXTERIOR WALL OF STADIUM
 STEEL REINFORCING WEIGHT APPROXIMATELY 280 kg
