Cracroft Hill Reserve Toilets
PRK_1080_BLDG_001
Detailed Engineering Evaluation
Qualitative Report
Version Final

176 Hackthorne Road, Cashmere

Christchurch City Council

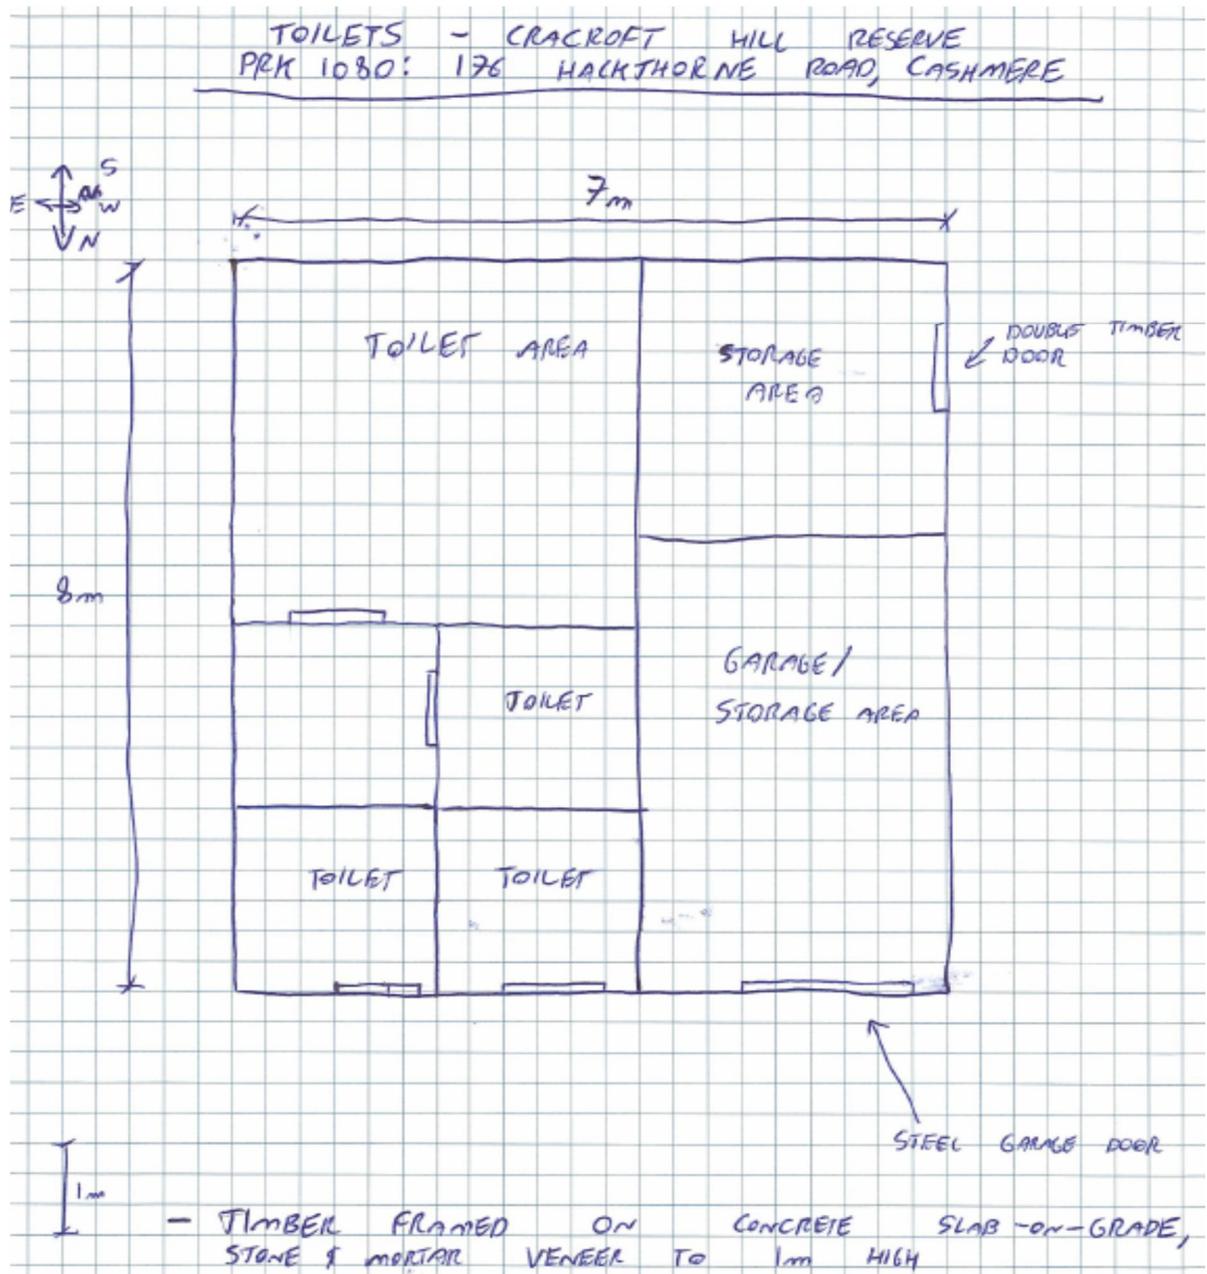
Figure 2 Sketch Showing Key Structural Elements

The building is light timber framed structure. The external walls have stone and mortar veneer up to 1m high and timber panels above. The internal walls are lined with compressed sheets, tiles, and plaster board. The single storey construction has a concrete slab on grade floor.

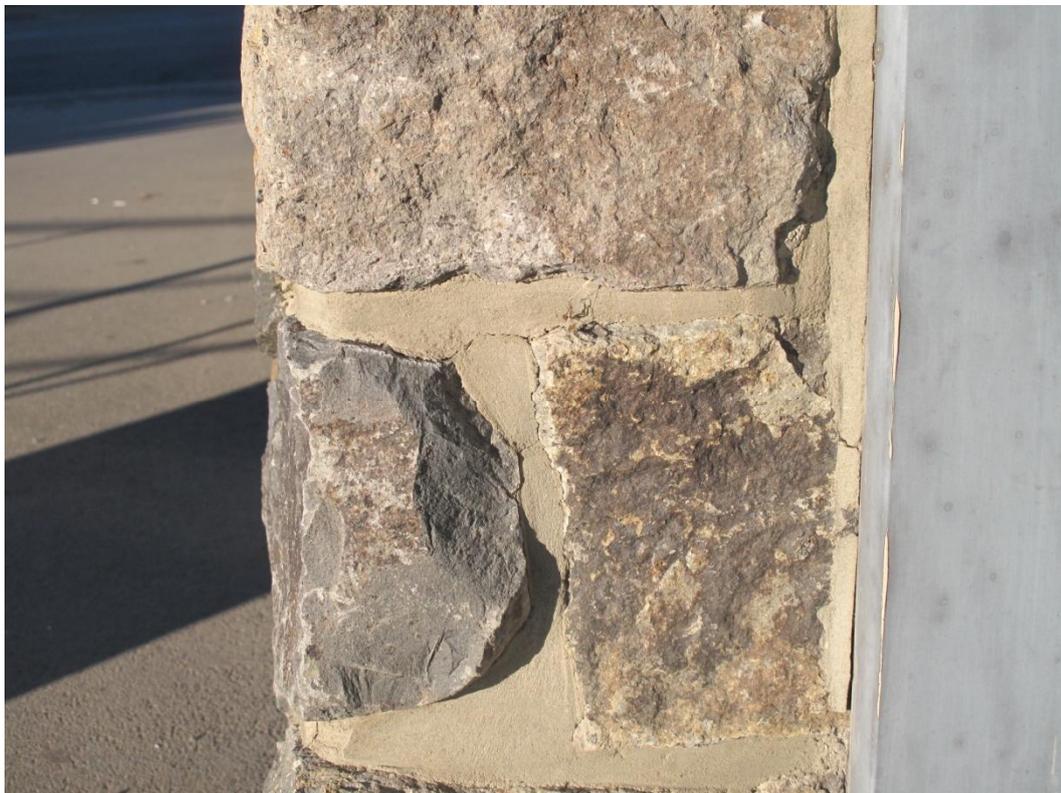
- o Minor cracking in mortar of external stone and mortar cladding in two locations.

The only visible damage to the structure was minor cracking in the stone and mortar veneer. The cracking in the mortar was located on the northern wall. See photographs 5 and 6 in Appendix A.

Photograph 4 Minor cracks in the mortar on the north side of the toilet block.

As the structure achieves only 86% NBS, it does not have any Earthquake concerns in accordance with the NZSEE guidelines. Minor damage to the stone and mortar cladding has been noted and this should be repaired. The building does not pose a risk to users and occupants. The structure can remain occupied as the building has not been classified as Earthquake Prone.

Describe:	repair crack repairs in stone cladding
Describe:	
Describe:

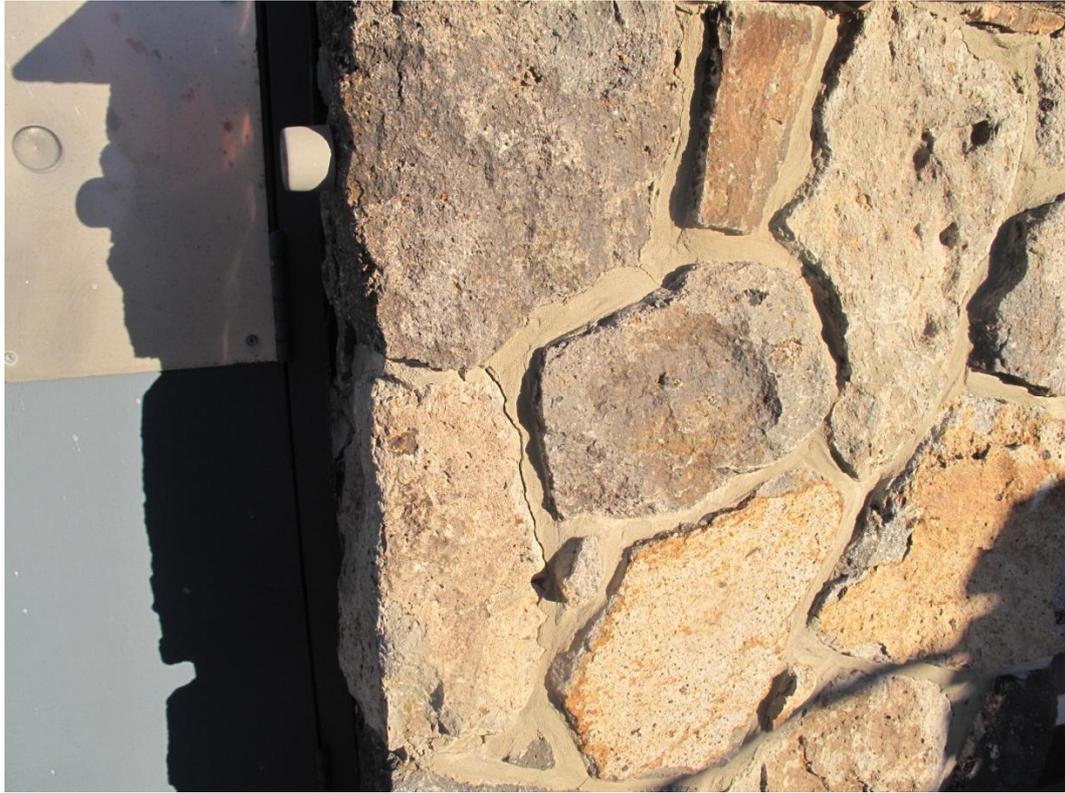
Photograph 5 Minor cracks in the mortar on the north side of the toilet block.

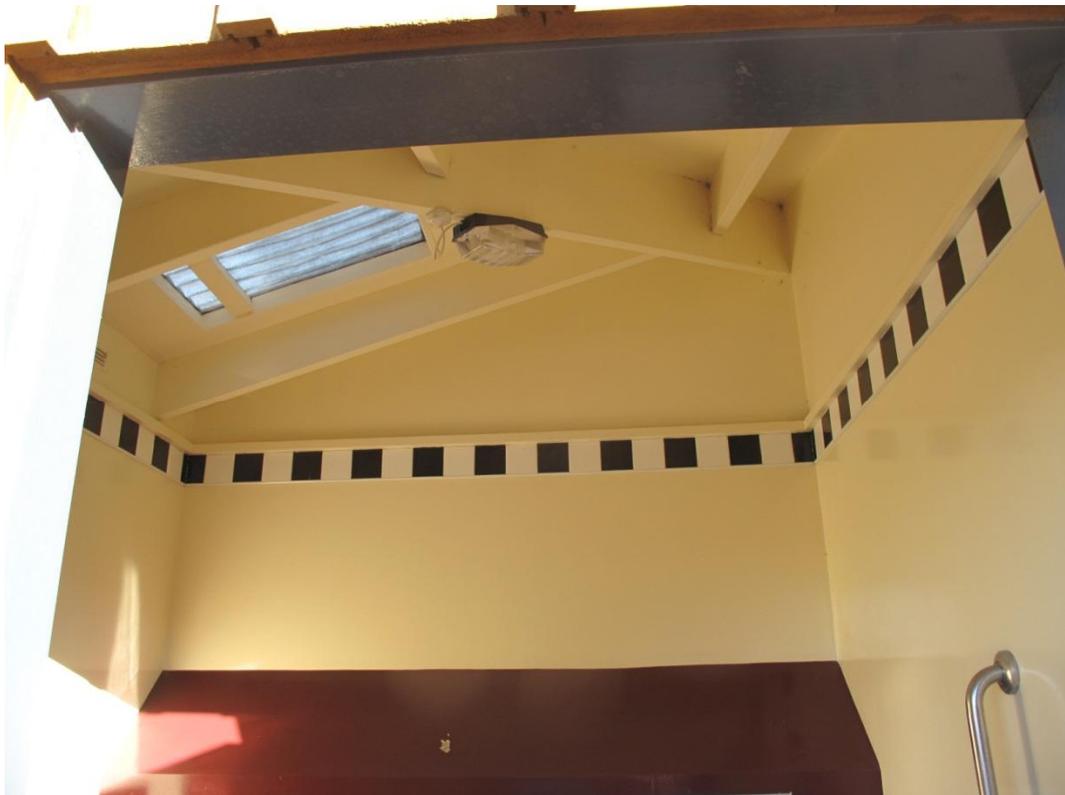
The timber roof beams were visible. The roof bracing appears to be sufficient for the lightweight roof structure. See photographs 6, 7, and 8.

Photograph 6 Roof structure with purlins and timber beam visible.

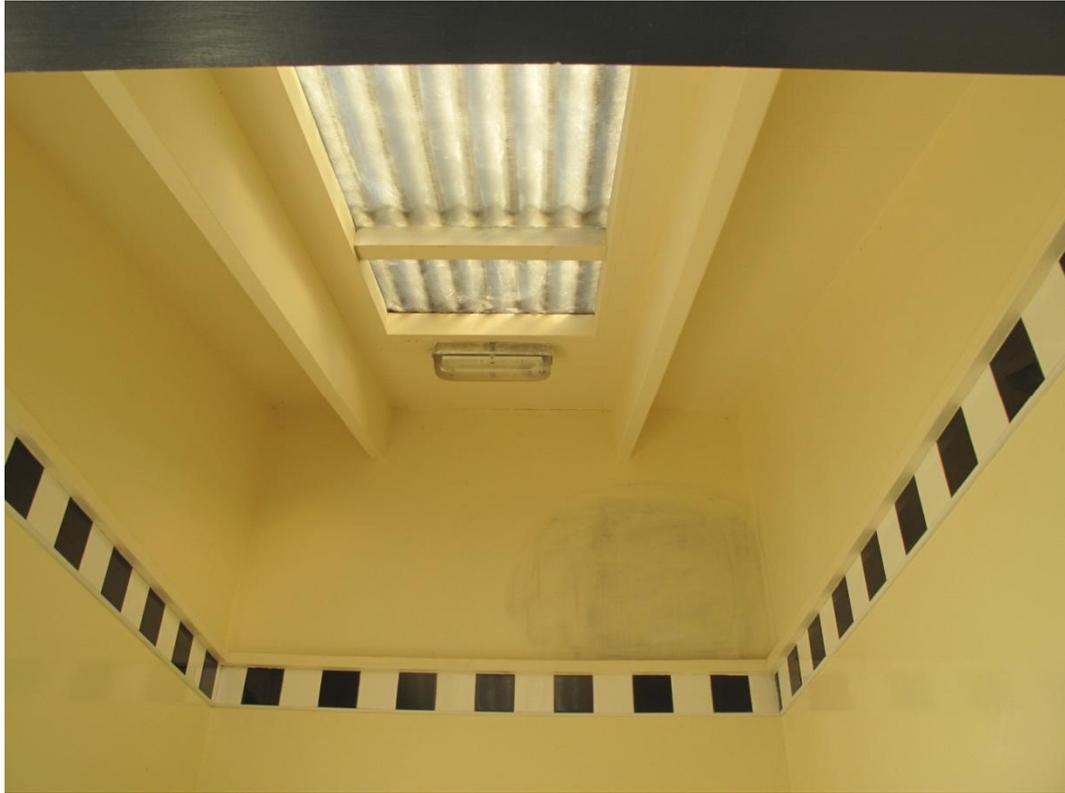
Photograph 7 Roof structure with skylight visible.

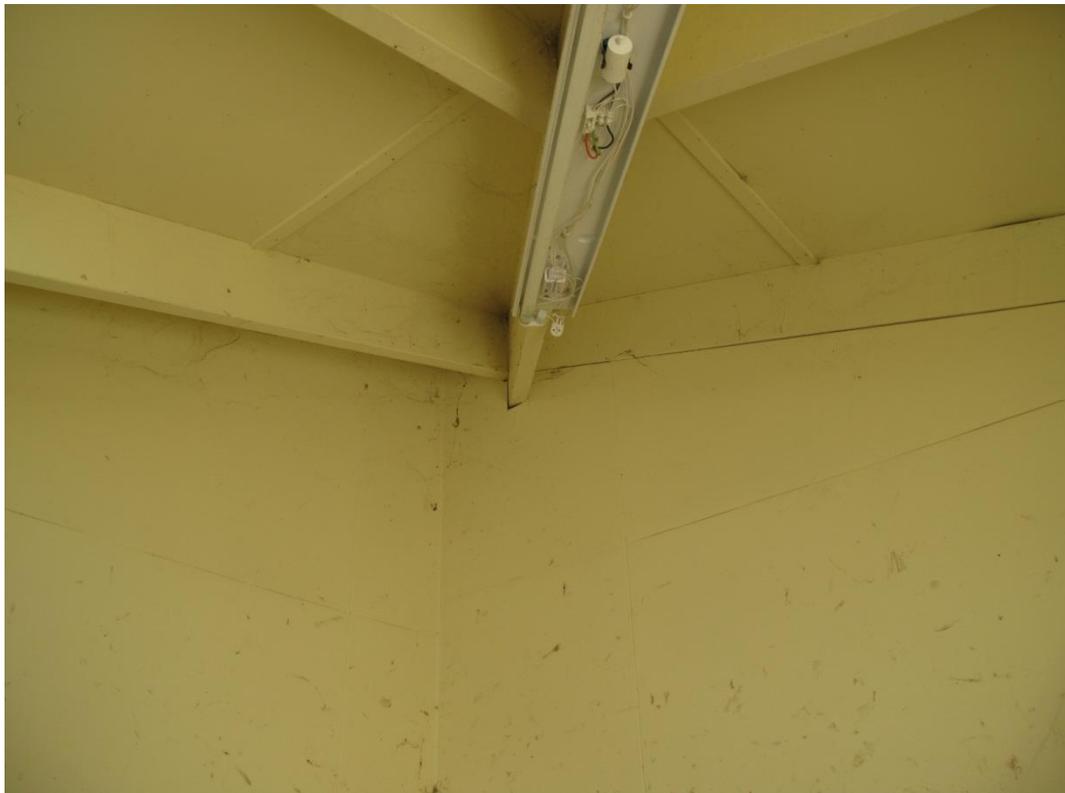
Photograph 8 Storage area with roof internal lining panels visible.
