Christchurch City Council

Crosbie Park Toilets **PRK 0201 BLDG 001 EQ2**

Detailed Engineering Evaluation

Quantitative Assessment Report

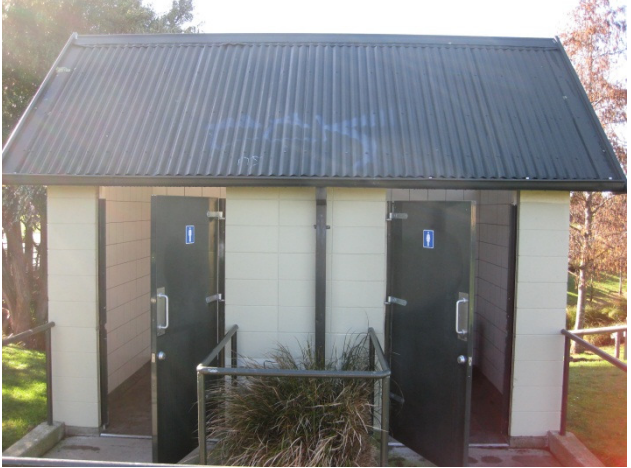
Site Name		
No.	Item description	Photo
General		
1.	Northern view of building

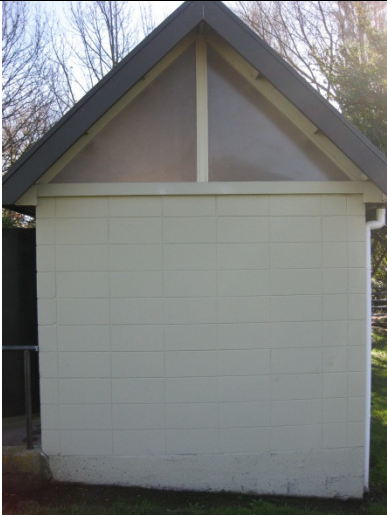
2.	Eastern view of building

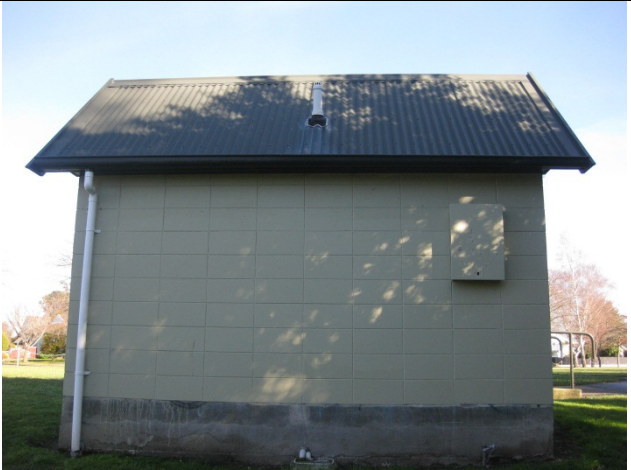
3.	Southern view of building

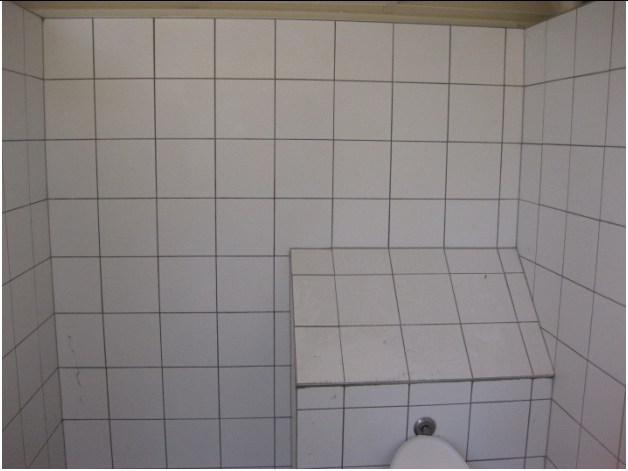
4.	Tiles lining internal walls

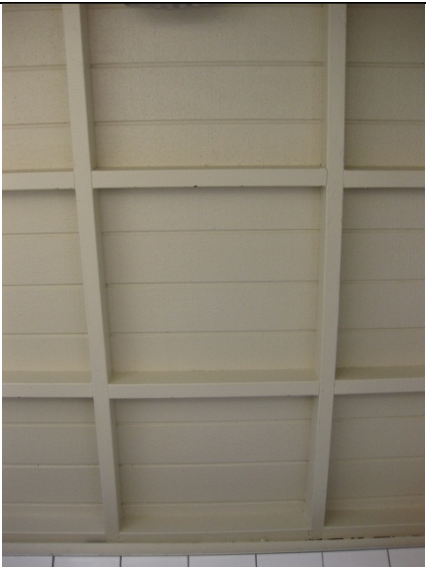
5.	Timber framed roof (sarking - no ceiling)

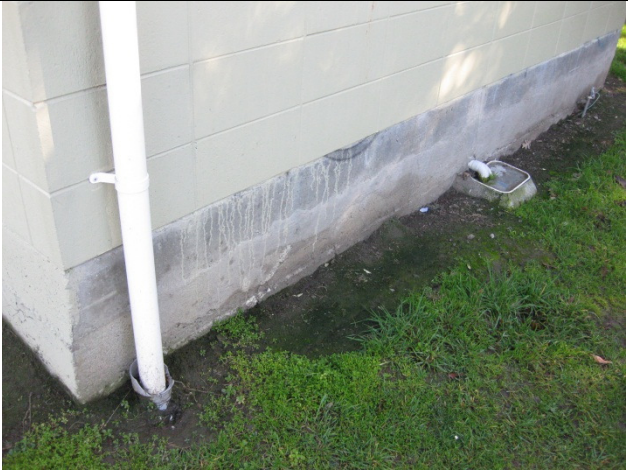
6.	Slab on ground
