Cuthberts Green – Toilet/Pavilion
PRK 0893 BLDG 008 EQ2
Detailed Engineering Evaluation
Quantitative Report
Version FINAL

220 Pages Road, Wainoni

Christchurch City Council

Date
20 March 2013

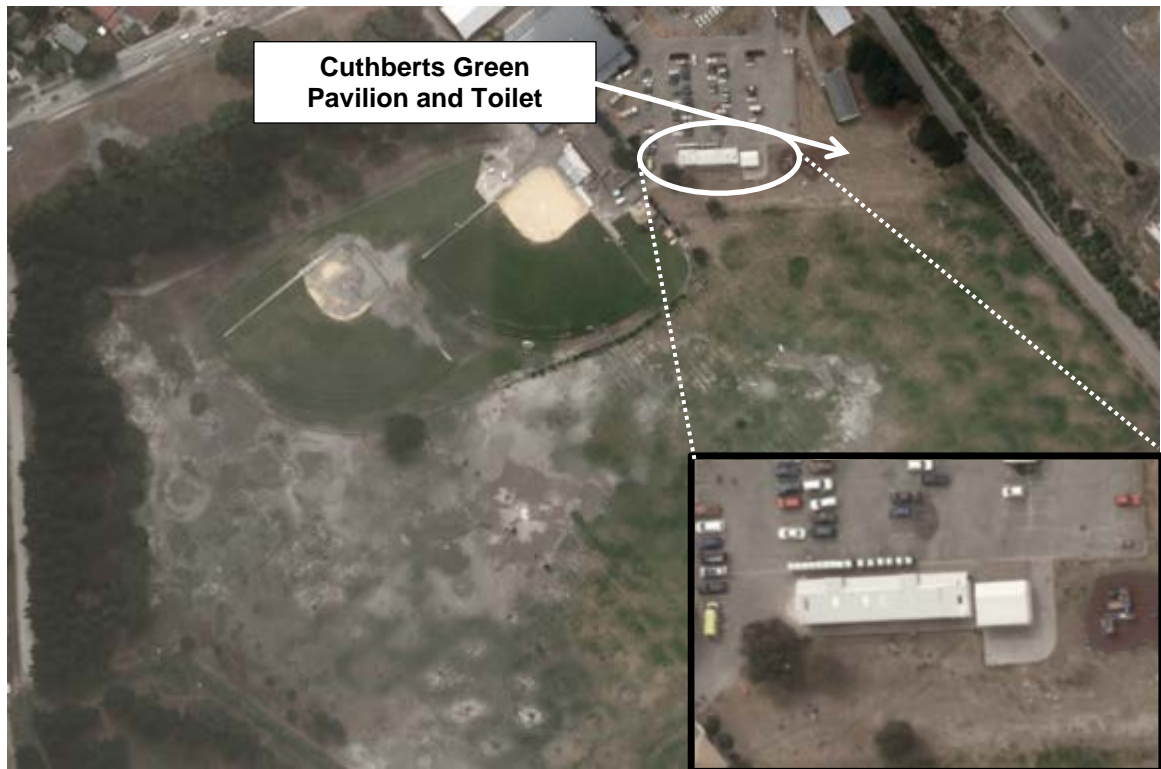
Figure 3 Post February 2011 Earthquake Aerial Photography²

Aerial photography taken following the 22 February 2011 and 4 September 2010 earthquakes shows no signs of liquefaction directly surrounding the structure. However, there are significant signs of liquefaction on the sports field adjacent to the site, as shown in Figure 3.

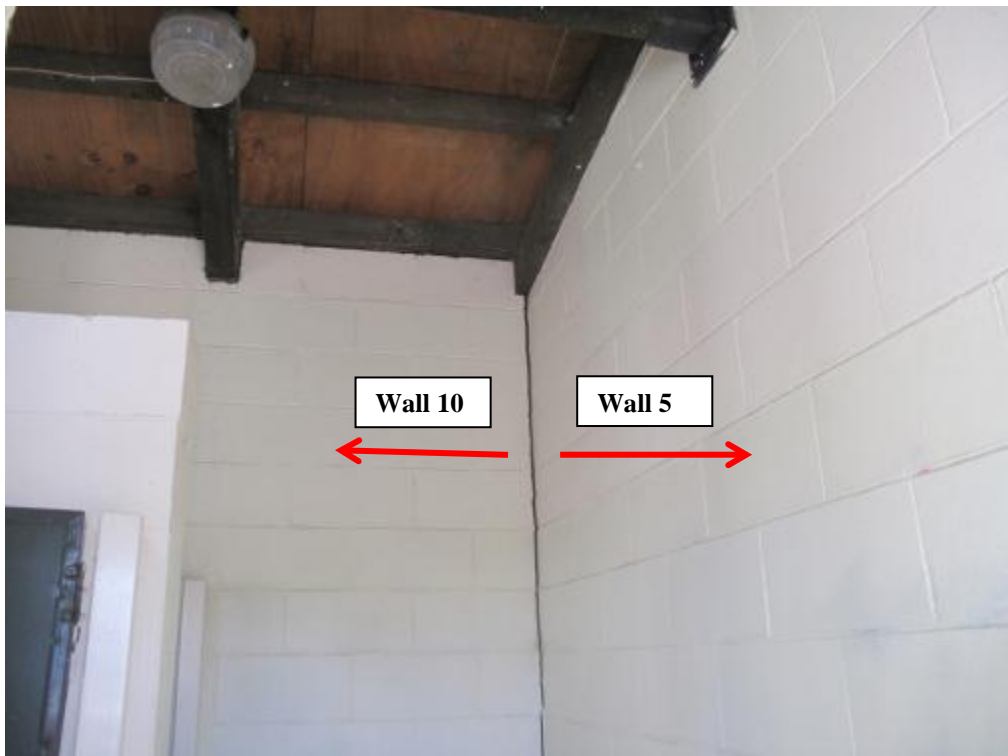
The main settlement damage to the structure was settlement of the eastern end of the block. This appears to have caused the cracking and separation of the block walls between the toilet and pavilion sections of the building. The settlement damage and separation damage is visible in Photographs 4, 5, 6 and 7 in Appendix A.

Photograph 4 Gap between Wall 10 and Wall 5, due to settlement of toilet section.

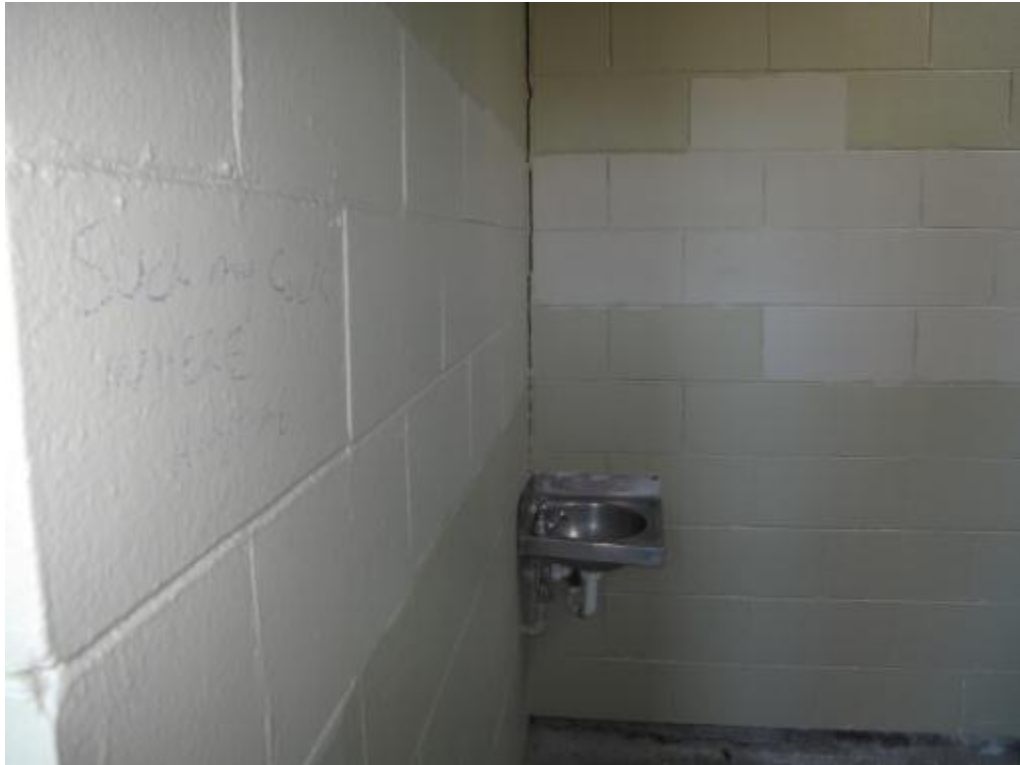
Photograph 5 Gap between Wall 10 and Wall 5, from the south side.

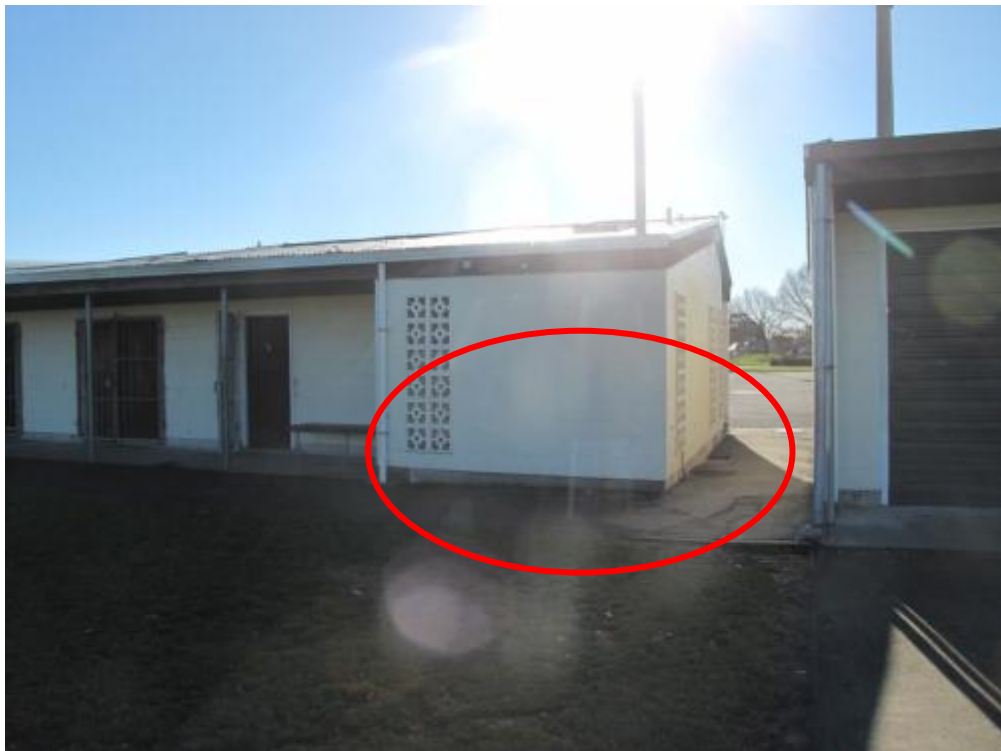
Photograph 6 Eastern end of building where settlement has occurred.

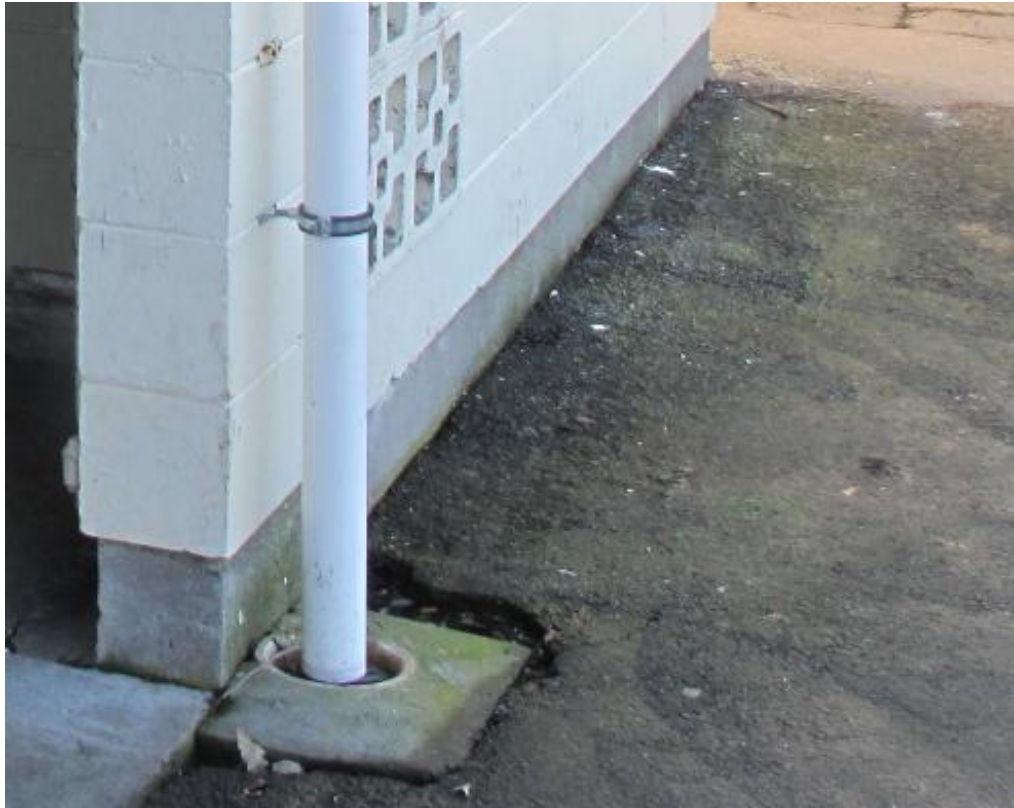
Photograph 7 Southern edge of toilet area. Note differential settlement in slab.

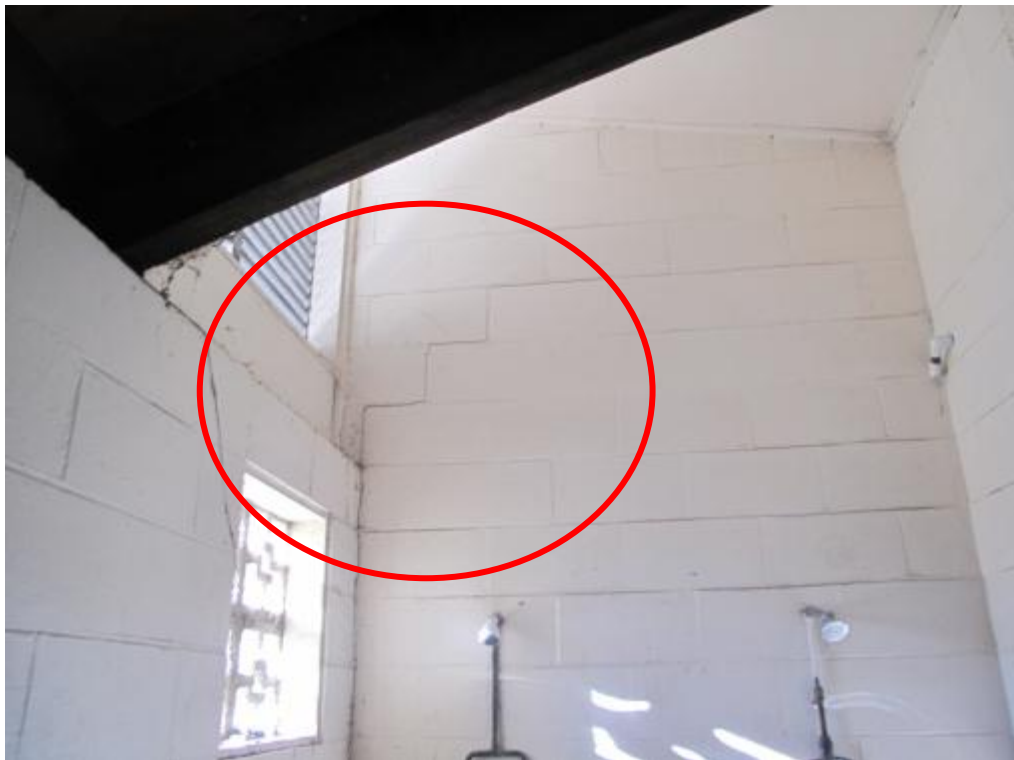
In addition to the settlement damage to the eastern end of the building a section of the north wall appears to have separated from the internal walls and started to overturn. The section of the concrete slab next to the overturning wall has significant cracking as well (See photographs 8, 9, 10, and 11)

Photograph 8 Step cracks in Wall 2 due to lean in external Wall 7.

Walls identified as a potential collapse hazard shall be temporarily secured until strengthening works are undertaken.

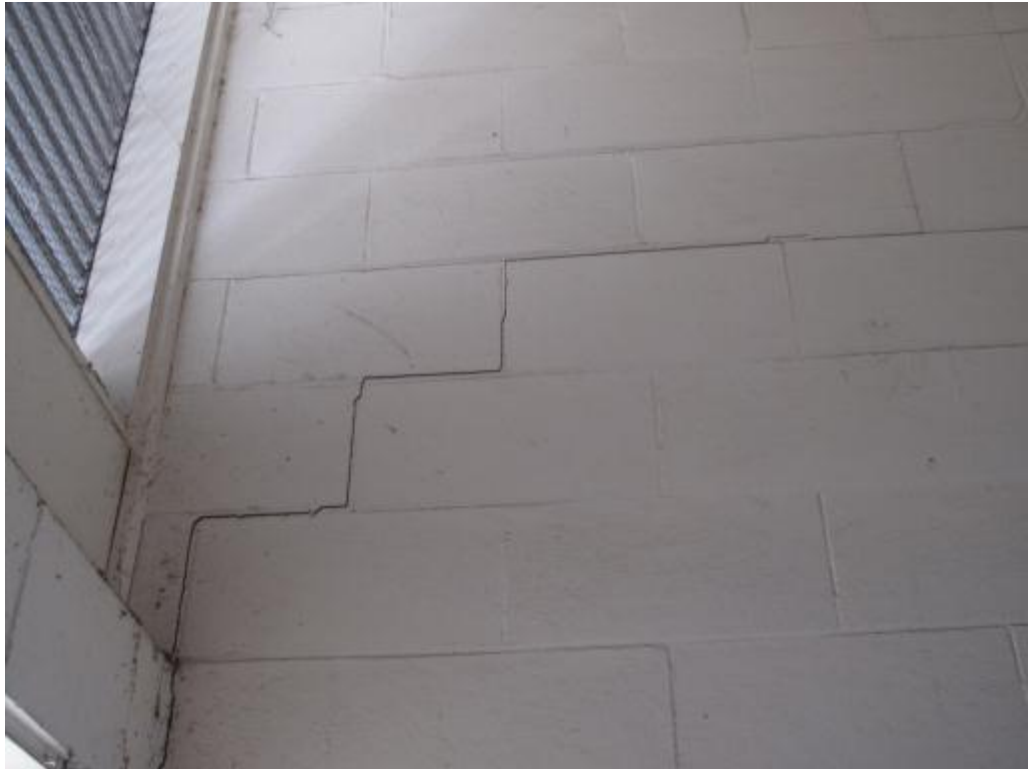
Photograph 9 Step cracking extends above the level of external wall 7.

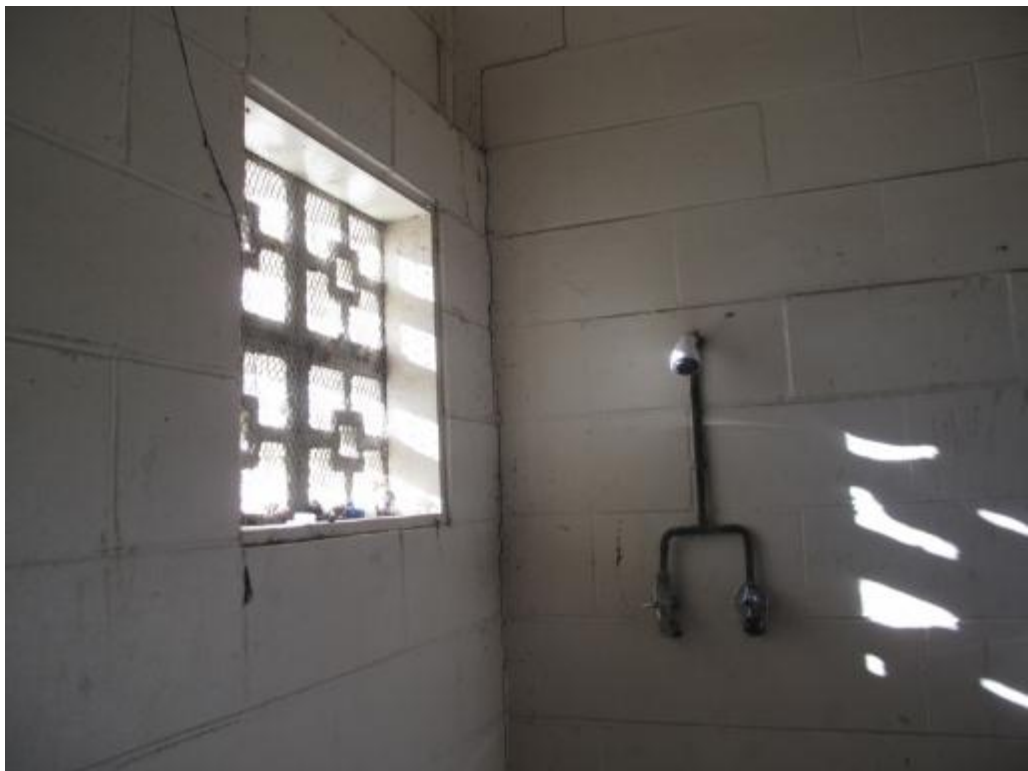
Photograph 10 Crack propagates through full height of wall.

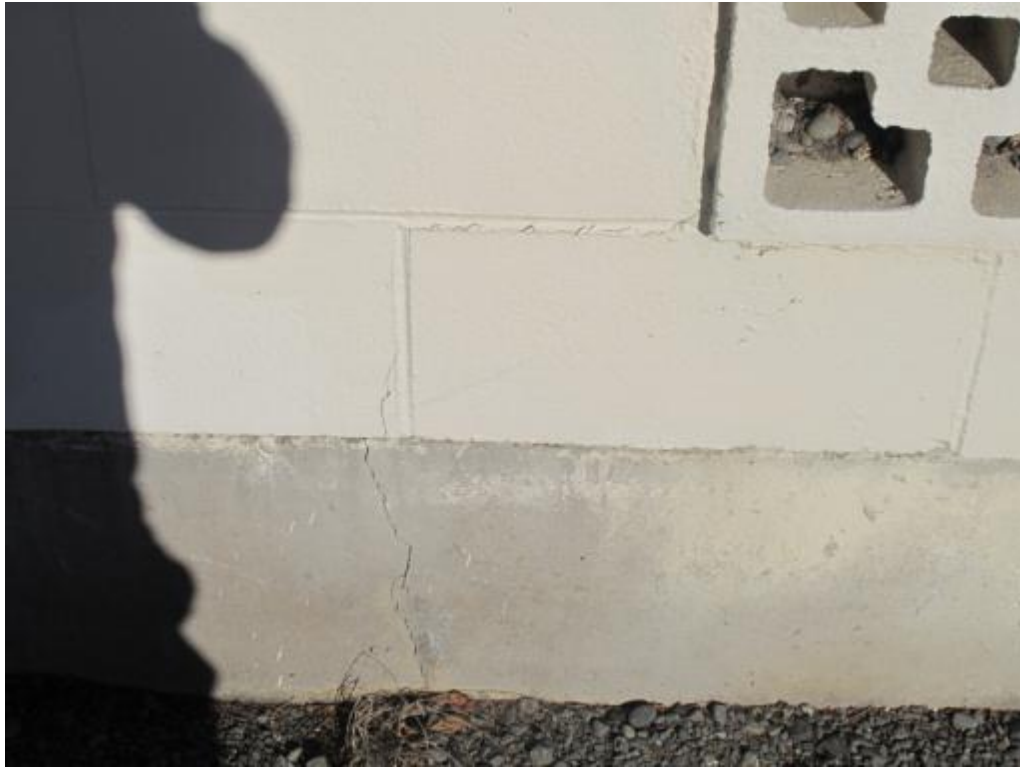
Photograph 11 Cracking in slab at base of section where Wall 2 and Wall 7 intersect.
