Denton Park Toilets
PRK 0770 BLDG 007
Detailed Engineering Evaluation
Qualitative Report
Version Final

442 Main South Road
Hornby, Christchurch

Christchurch City Council

Date
23rd of May 2013

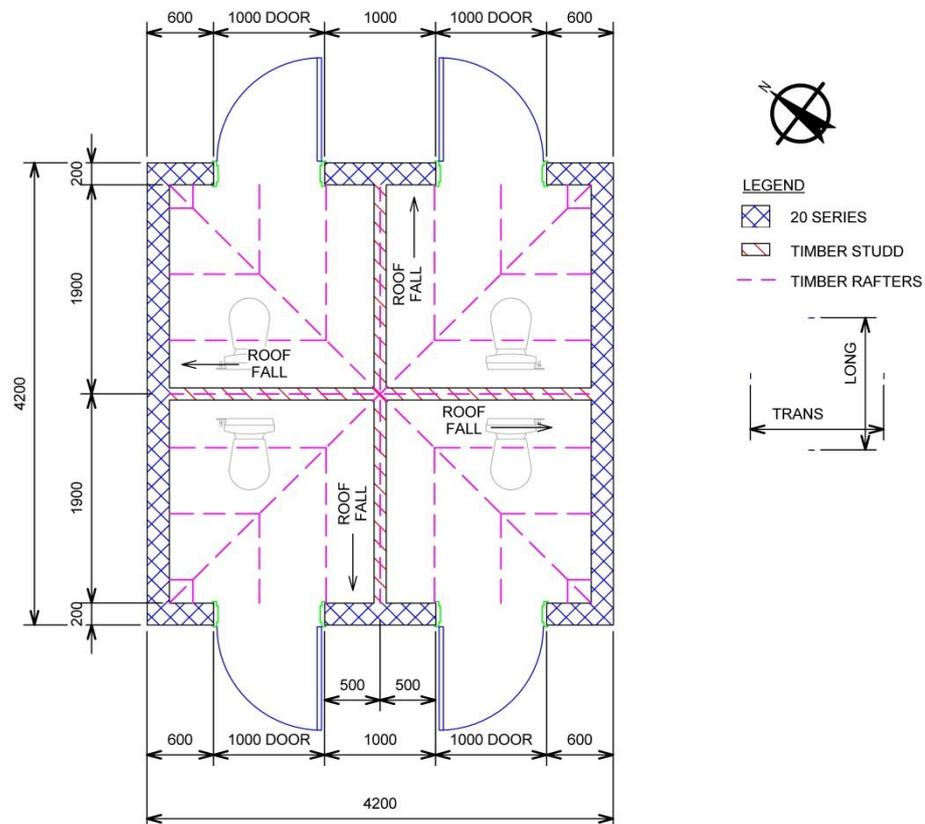
Figure 2 Plan Sketch Showing Key Structural Elements

The building resists gravity loads by load bearing concrete masonry walls. Gravity loads on the roof are transferred via rafters and the propped timber ridge beam to walls. The walls support the gravity loads and transfer them to the strip footings where they distribute into the ground. Floor gravity loads are transferred through the concrete slab to grade and the underlying ground.

Lateral loads are resisted primarily by the panel action of concrete masonry units. In both transverse and longitudinal directions, lateral roof loads are transferred to walls by the diaphragm action of roof timber boards and rafters and into the foundations.

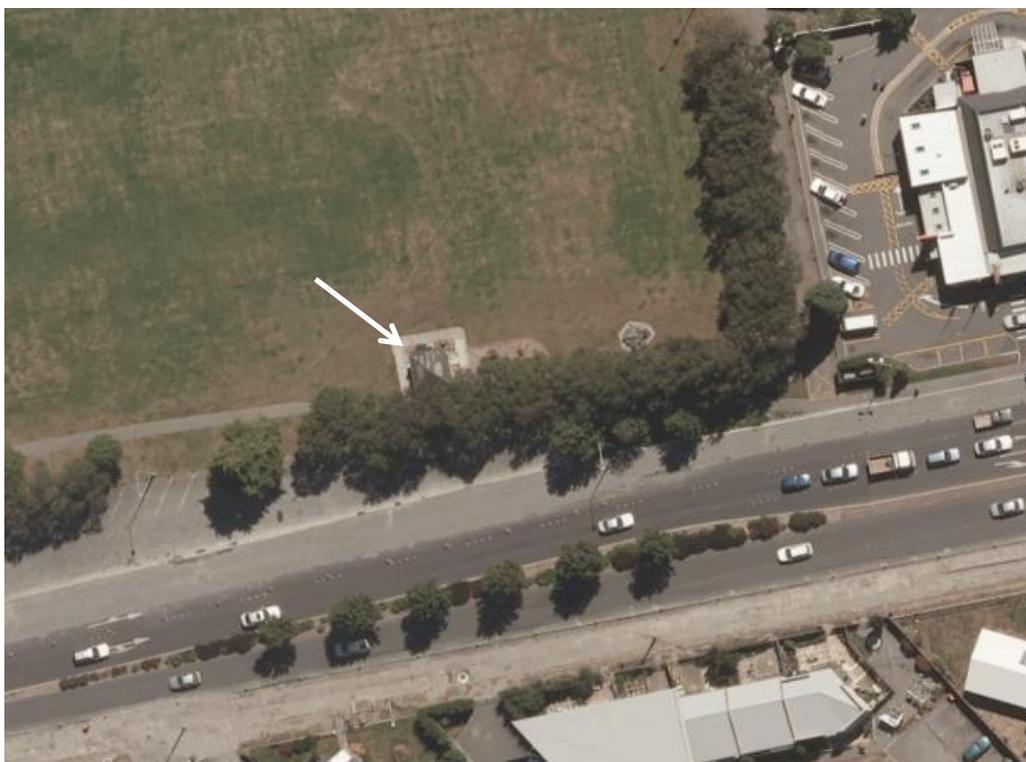
Figure 3 Post February 2011 Earthquake Aerial Photography²

Aerial photography taken following the 22 February 2011 earthquake shows no signs of liquefaction outside the building footprint or adjacent to the site, as shown in the Figure 3.

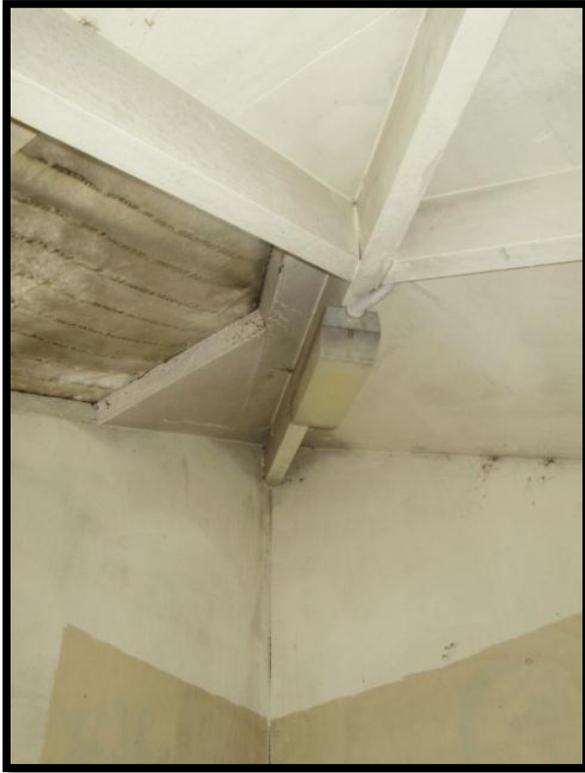
Photograph 5 Toilet exposed rafters

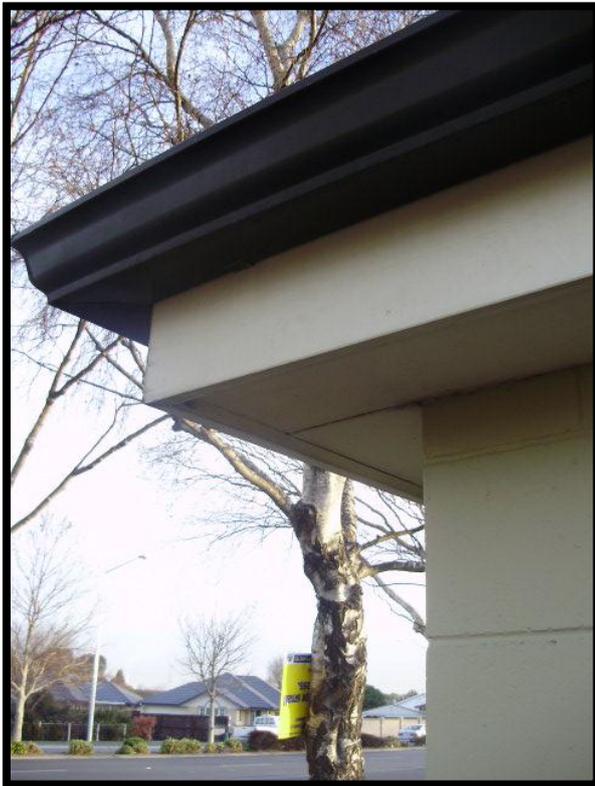
Photograph 6 Toilet eave detail

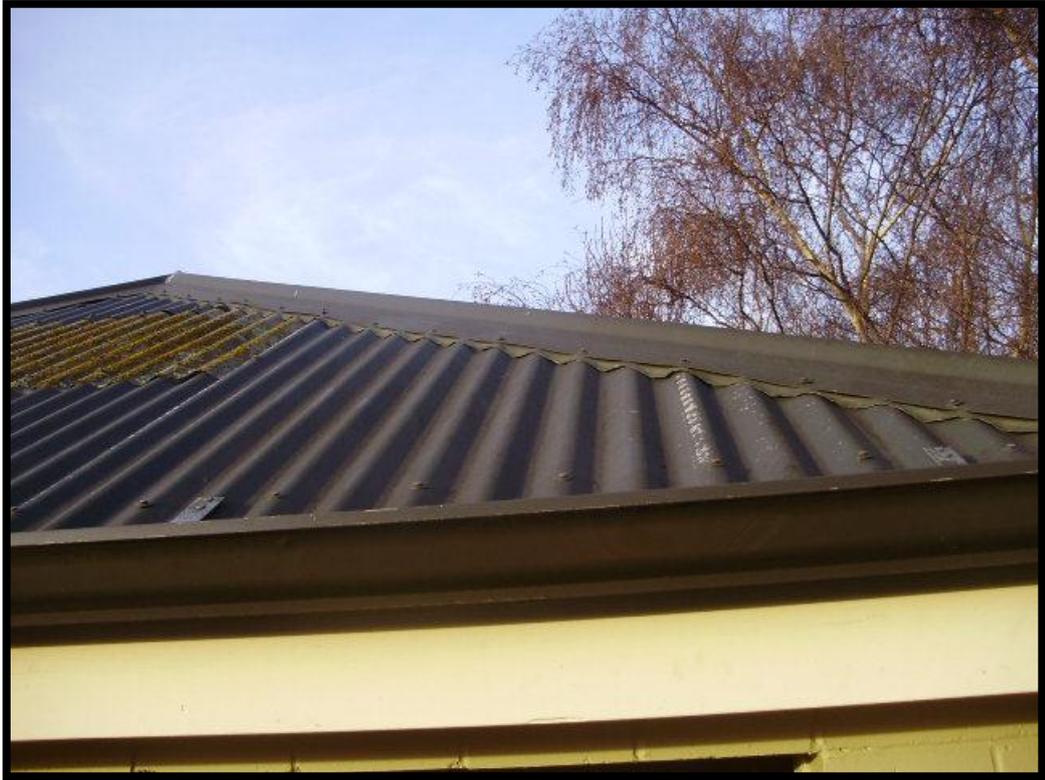
Close spacing of timber boards on rafters stiffens the structure and distribute more effectively loads to the walls in-plane. Critical structural weakness is not observed due to the diaphragm capability of the roof.

Photograph 7 Toilet roof

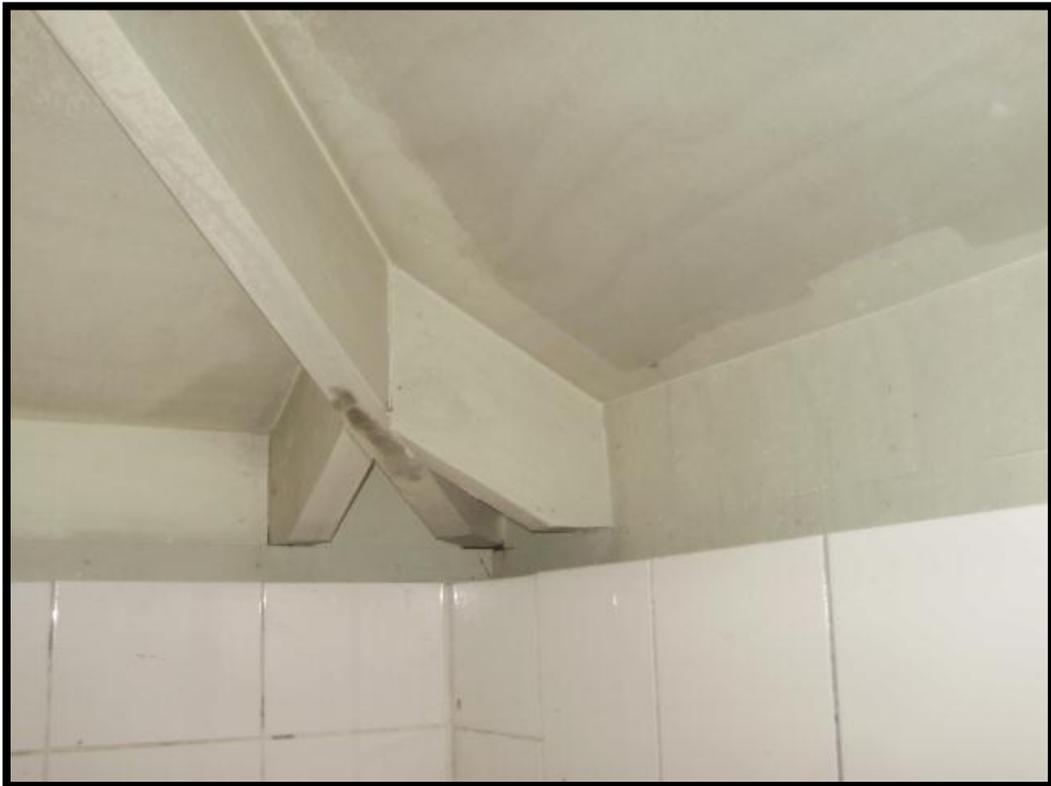
Photograph 10 Toilet exposed rafters showing the connection between rafters and block wall
