Christchurch City Council

PRK_3555_BLDG_005 EQ2

Diamond Harbour Playcentre / Scouts Den
1 J Waipapa Avenue

QUALITATIVE ASSESSMENT REPORT

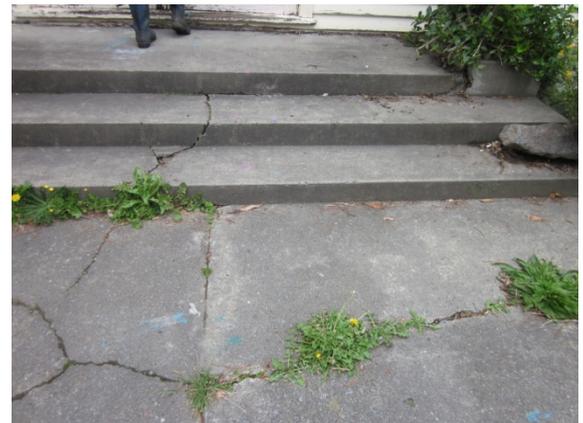
Photo 4: Cracking to the concrete steps and concrete slabs around the entry to the building

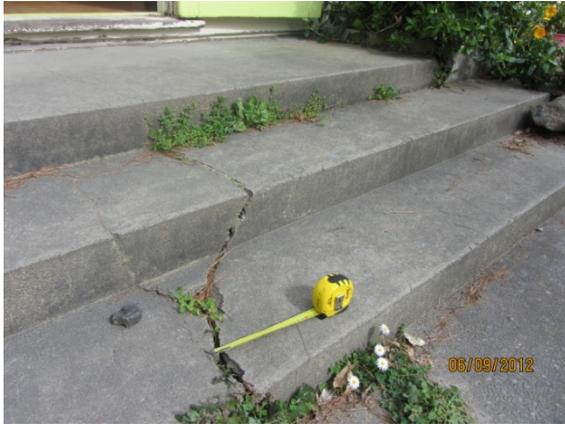
Photo 5: Cracking to the bulk concrete steps

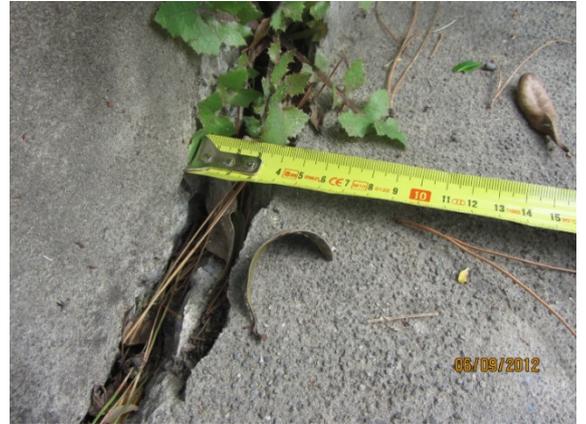
Photo 6: Cracking up to 40mm wide through steps

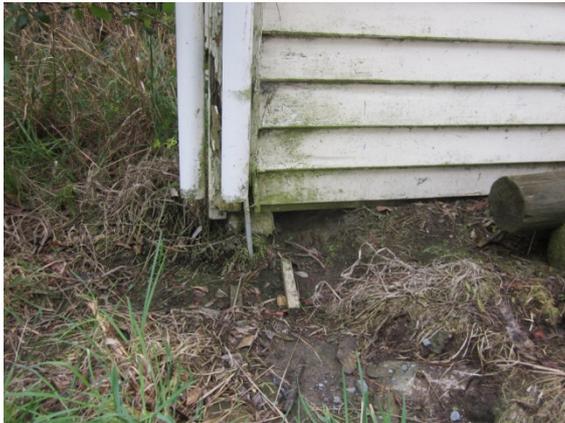
Photo 7: Eastern end of the building at the location of the sloping section

Due to the sloping section of floor in the western most room a level survey is recommended to determine if re-levelling via jacking and packing of the piles is necessary in accordance with the DBH guidelines for non-residential buildings.

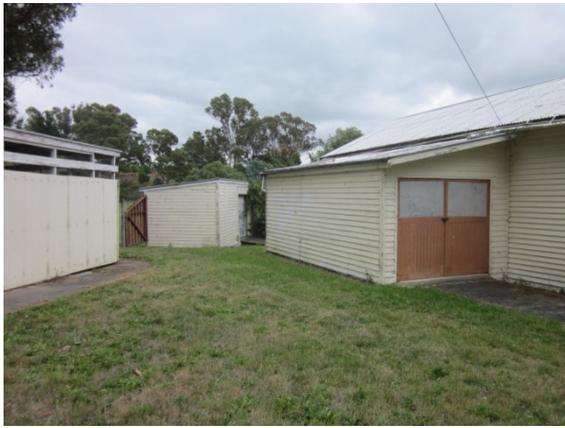
Photo 9: The buildings weather boards are becoming rotten, especially to the east.

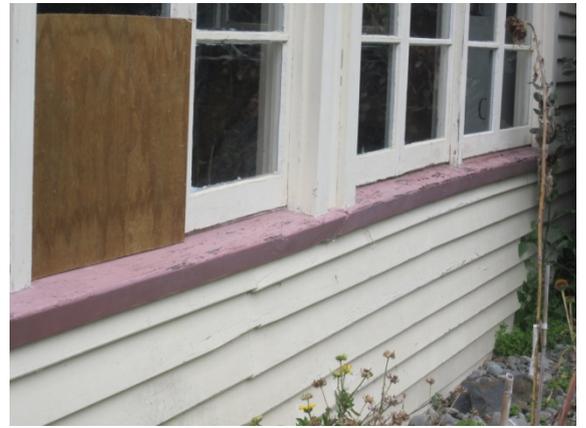
Photo 10: Rotting of the timber window framing

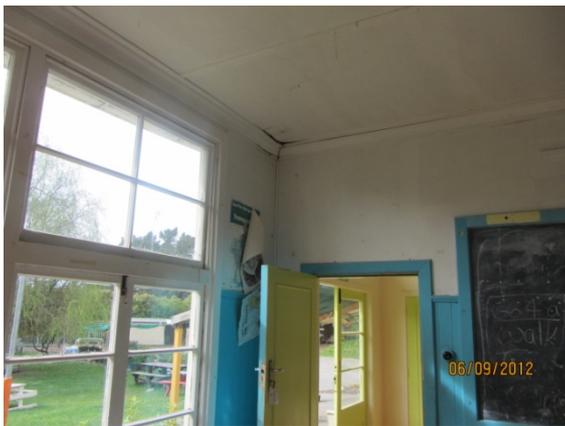
Photo 15: Roof lining damage in the NE corner of the scouts den

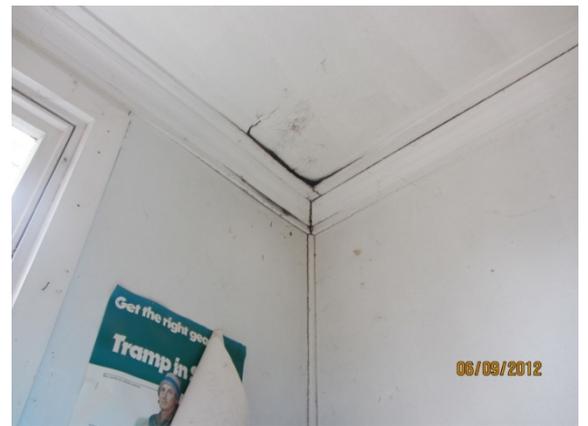
Photo 16: Close up of damage pictured photo 15

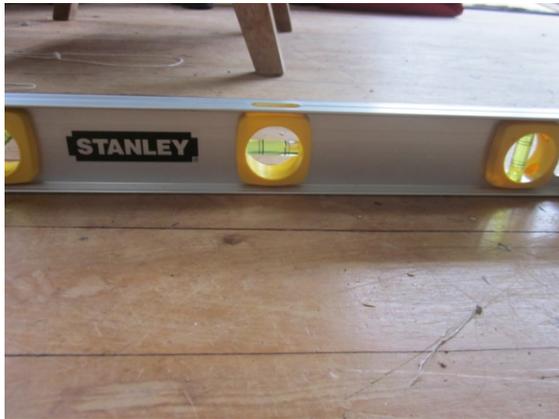
Photo 17: significant slope towards the end wall in the west of the scouts den

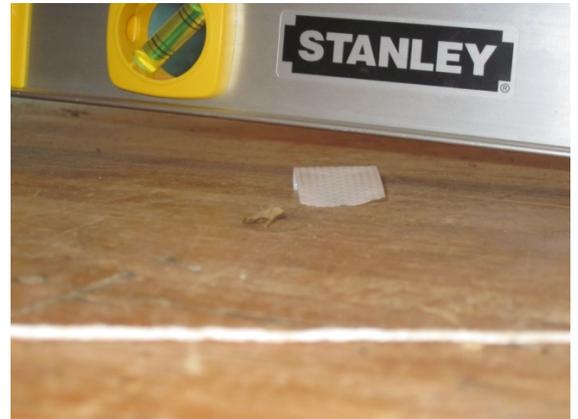
Photo 18: Slope approx 1/30

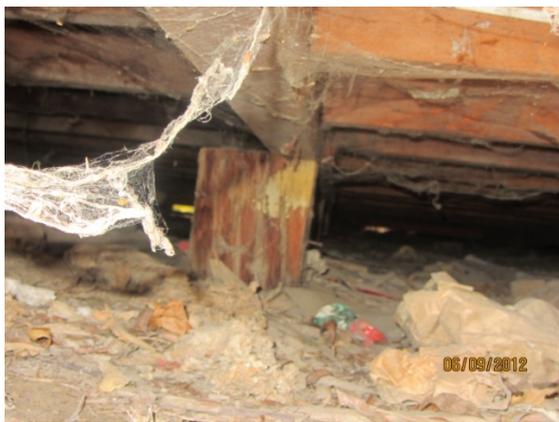
Photo 19: Bearer off centre of pile along the north side of the building

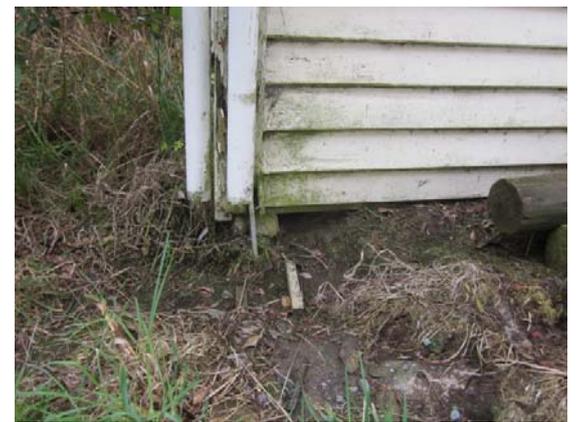
Photo 20: Settled west end of the building.

- a) The current placard status of the building of green1 remain as is.
- b) A level survey should be carried out to determine the need for releveling. If releveling is required it is recommended that pile ties are retrofitted to ensure increased compliance with current code.
- c) We consider that barriers around the building are not necessary.

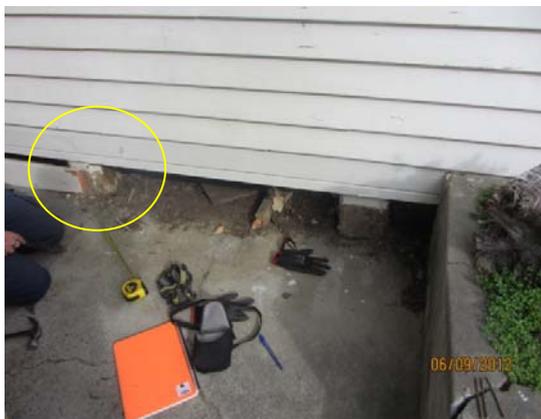
Photo 21: Pile broken approx 50mm below ground level

Adjustment as per bracing calcs 1.06 * approximated 0.85 due to broken pile (not likley EQ damage) = 1.06*0.85 ~ = 0.9

Recommendations		Level of repair/strengthening required: minor structural	Describe: Pile repair / replacement and jacking of the bearers to the west to relieve
Building Consent required: no		Interim occupancy recommendations: full occupancy	Describe: _____
			Describe: _____
Along	Assessed %NBS before: 68%	%NBS from IEP below	If IEP not used, please detail assessment methodology: GIB Ezybrace spreadsheet in conjunction with 1997 bracing calcs from renovation
	Assessed %NBS after: 68%		
Across	Assessed %NBS before: 80%	%NBS from IEP below	
	Assessed %NBS after: 80%
