Toilet – Donnell Sports Ground
PRK_2225_BLDG_001 EQ2
Detailed Engineering Evaluation
Qualitative Report
Version FINAL

Christchurch City Council

Date
5 April 2013

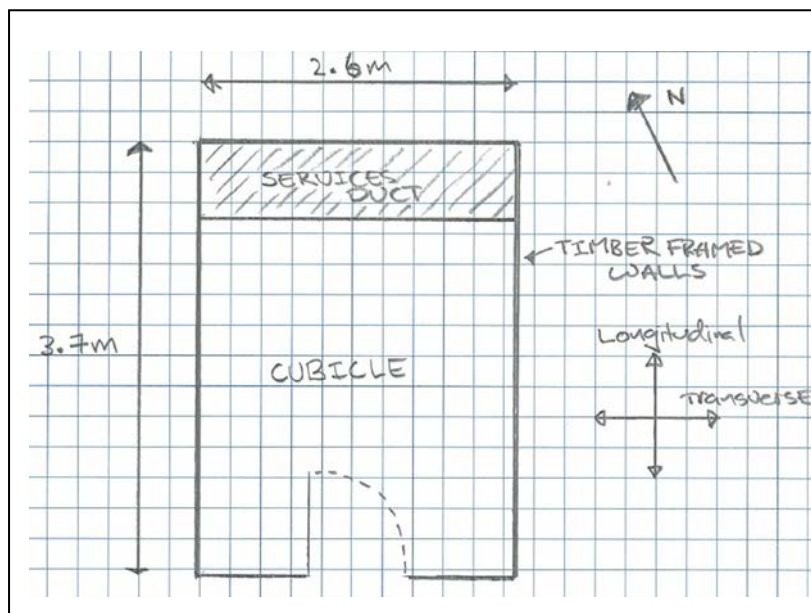
Figure 2 Plan Sketch Showing Key Structural Elements

There is a stiffness offset when considering lateral loads in the transverse direction. The north eastern wall spans the full width of the building, while the south western wall has an opening. This stiffness offset has the potential to cause torsional effects; however, given the size and nature of the structure, these effects have not been considered a critical structural weakness.

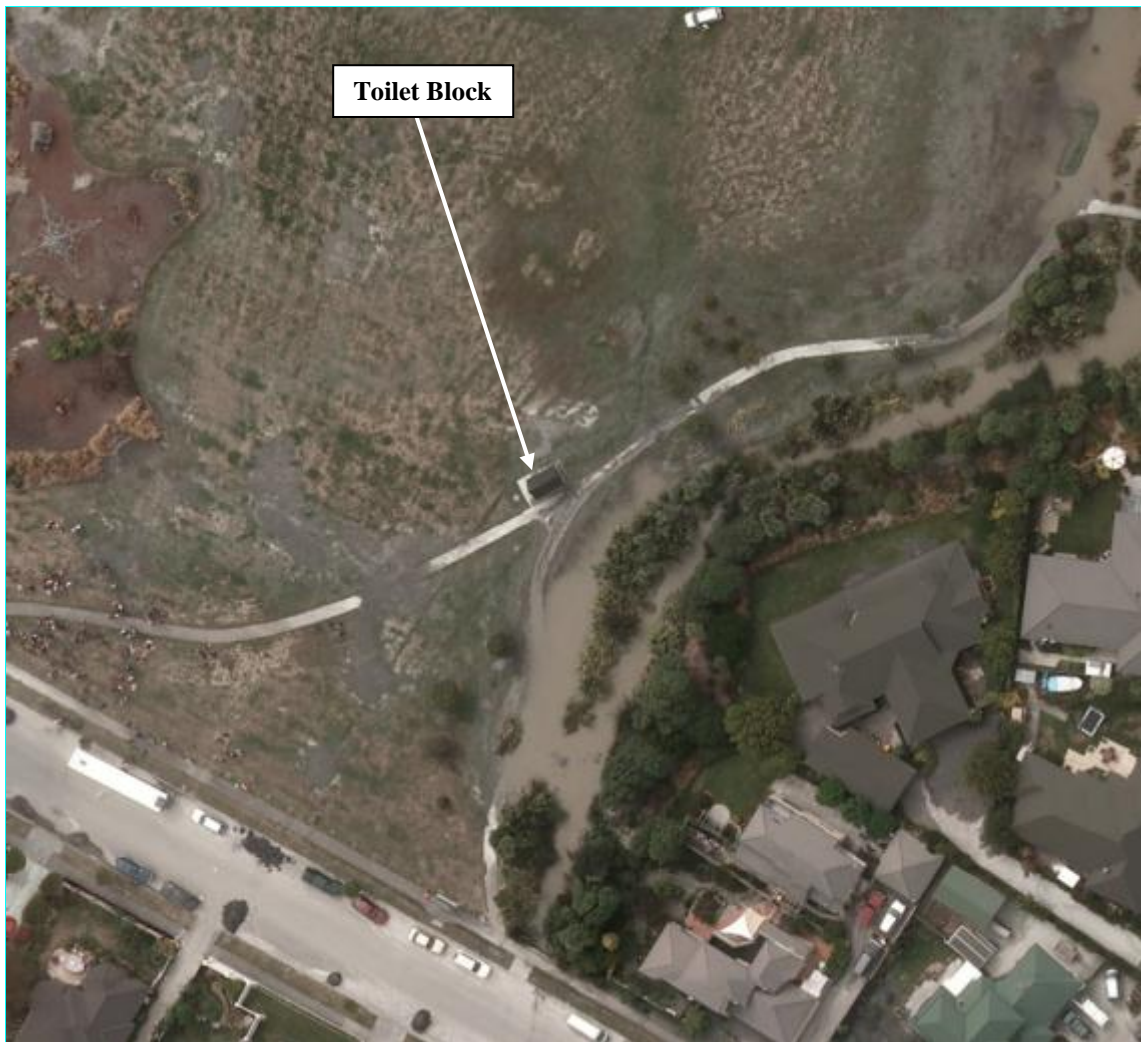
Figure 3 Post February 2011 Earthquake Aerial Photography³

Aerial photography taken following the 22 February 2011 earthquake shows signs of extensive liquefaction outside the building footprint and adjacent to the site, as shown in Figure 3.

During the site inspection, it was noted that lateral spreading had not occurred at the site, despite the proximity to the adjacent swale.

The site is anticipated to be underlain by 1~2m of fill material, overlying marine and estuarine sand and silt deposits. The site has a high liquefaction potential, as observed in the aerial photography (Figure 3).

Due to the anticipated presence of fill material overlying loose sands, and without an engineered fill certificate, it is recommended that should this structure require further detailed engineering an intrusive investigation be conducted. Further detail on testing methods can be provided following commission of the quantitative phase of assessment.

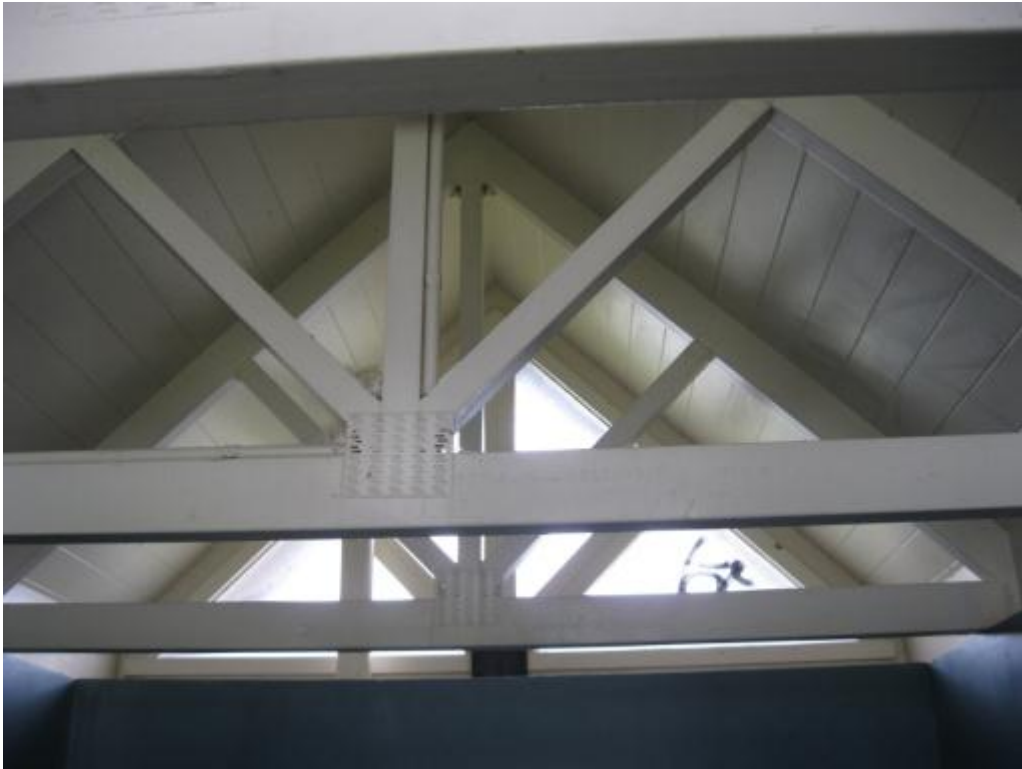
Photograph 3 Timber Truss roof structure

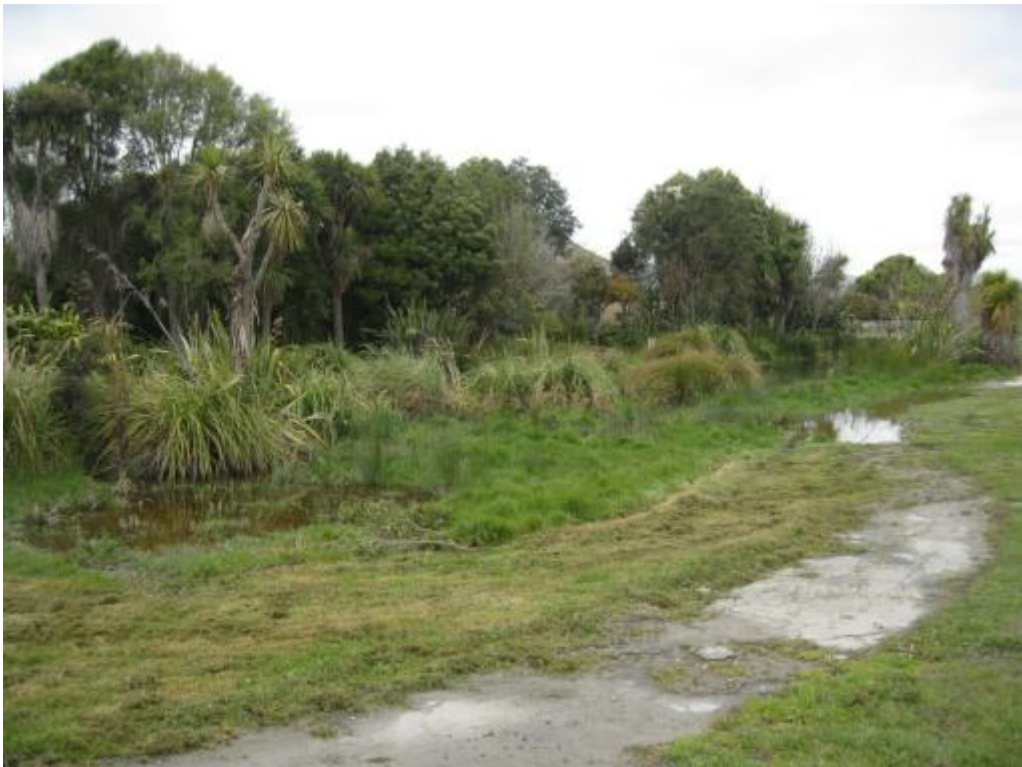
The site contained numerous areas of uplifted sand which suggests liquefaction in previous seismic events.

Photograph 4 Adjacent waterway with possible sand boils in foreground.

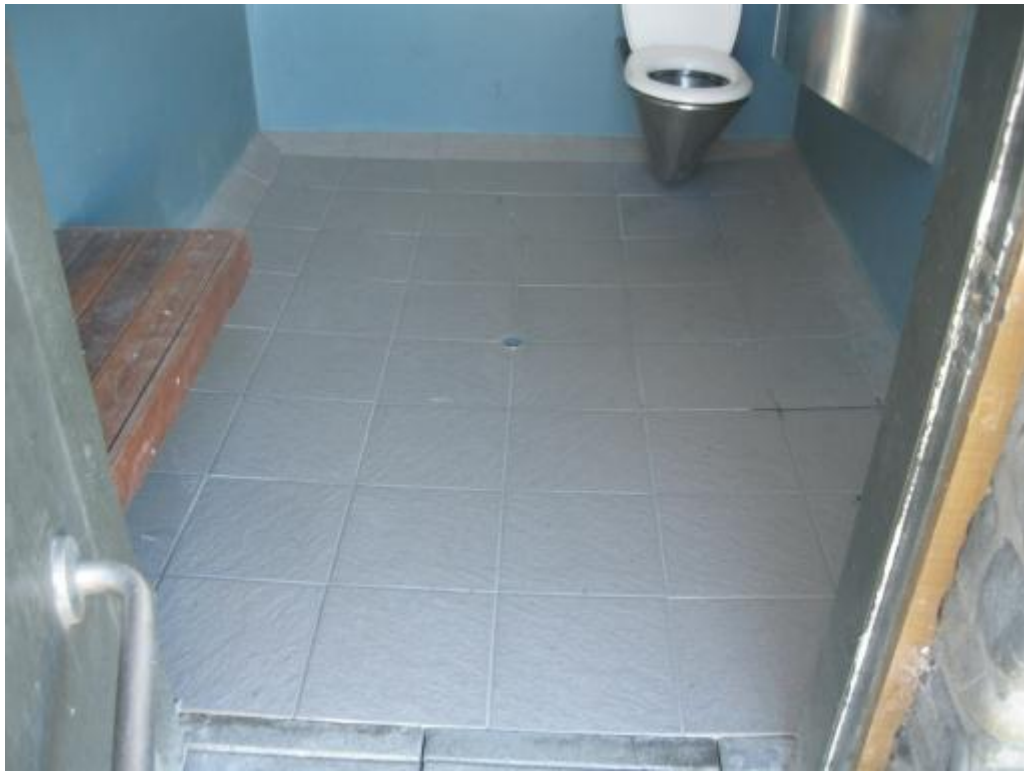
Photograph 5 Tiled concrete floor slab.
