PRK_3616_BLDG_006
Duvauchelle Reserve Tennis Club
Detailed Engineering Evaluation
Quantitative Report
Version FINAL

Seafield Road
Duvauchelle, Banks Peninsula

Date
18 June 2013

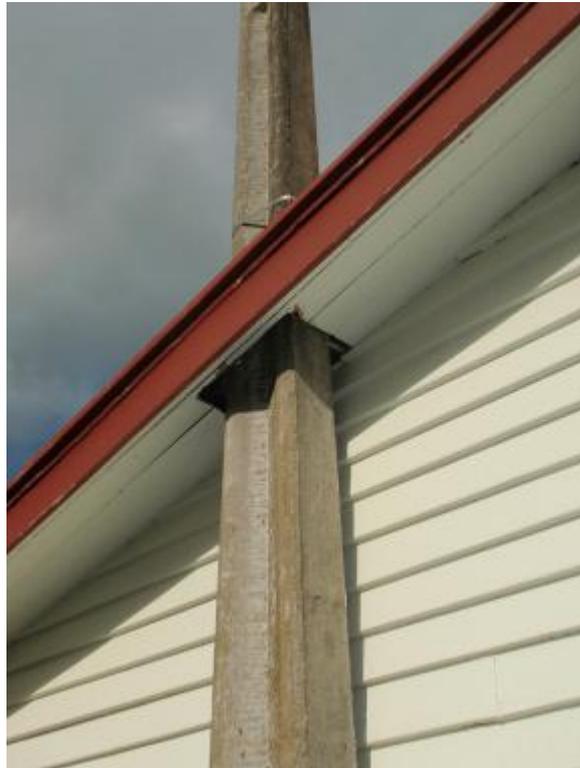
On the north elevation, a concrete light pole used as part of the tennis court's lighting system, is located directly adjacent to the building. It penetrates through the overhanging roof eaves then extends approximately 4.0 m higher than the building roof (refer to Photo 5).

Photo 5 Light Pole Adjacent to North Elevation of the Building

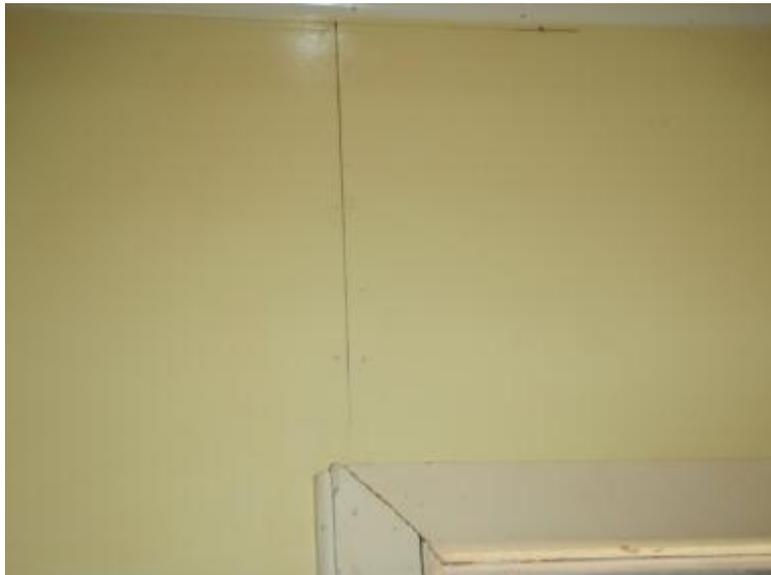
Minor cracking and joint opening were observed to the internal plywood linings in several locations throughout the building, primarily above window and door openings. The damage to the linings is due to the movement of the building during an earthquake. Ductile timber wall frames are able to accommodate movement during an earthquake; however, the plywood linings behave in a more brittle manner and crack as a result of lateral movement.

Photo 8 Opening to Joint of Interior Linings

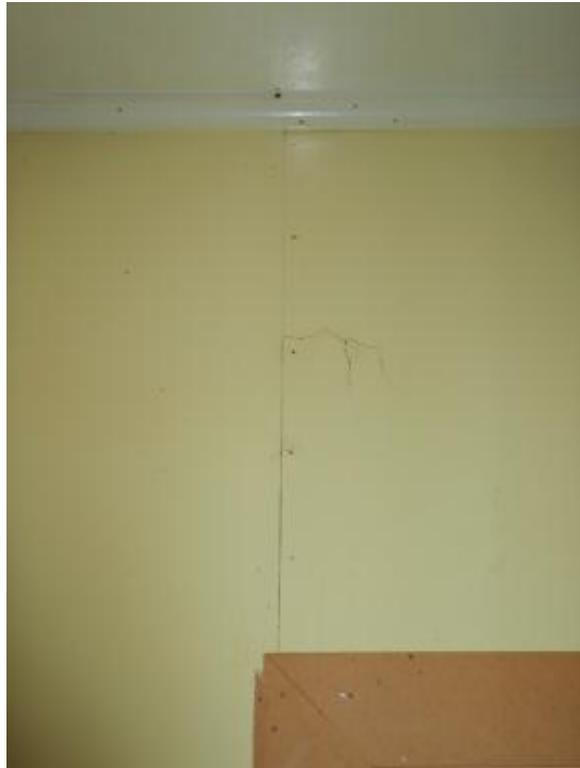
Photo 9 Cracking to Interior Linings

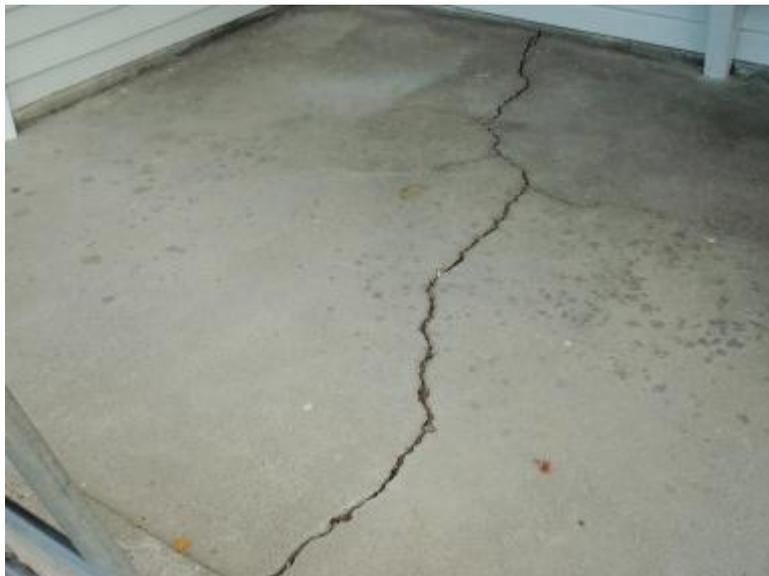
Cracking to the concrete slab floor in the veranda on the east side of building was observed. Some of these appear to be existing shrinkage cracks that have opened up during the recent seismic activity.

Photo 10 Cracking on Veranda Concrete Slab On-Grade

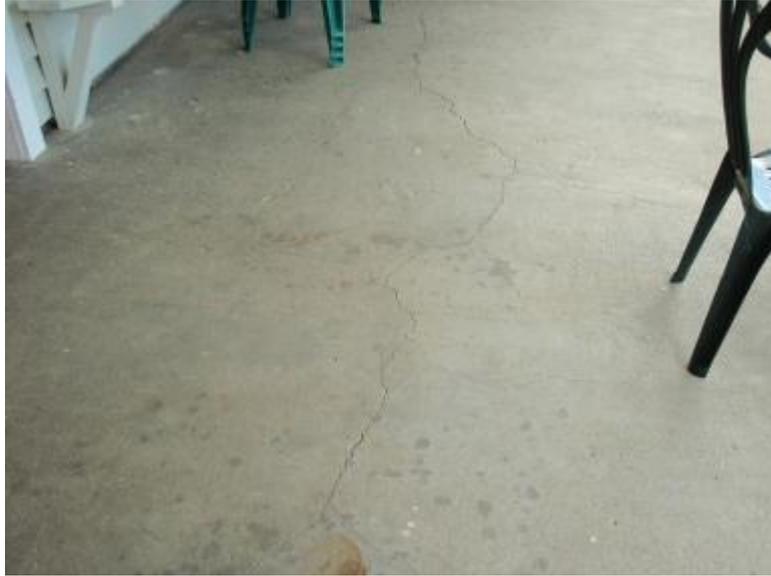
Photo 11 Cracking on Veranda Concrete Slab On-Grade
