CHRISTCHURCH CITY COUNCIL
PRK_3616_BLDG_005 EQ2
Duvauchelle Reserve – Toilet Block 1 &
Changing Rooms
Seafield Rd, Duvauchelle

QUALITATIVE ASSESSMENT REPORT
FINAL

- Rev C
- 23 May 2013

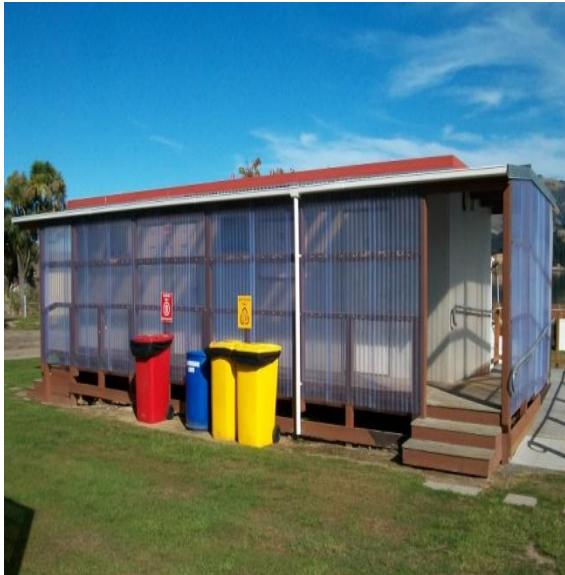
Photo 1: The east elevation of the toilet block

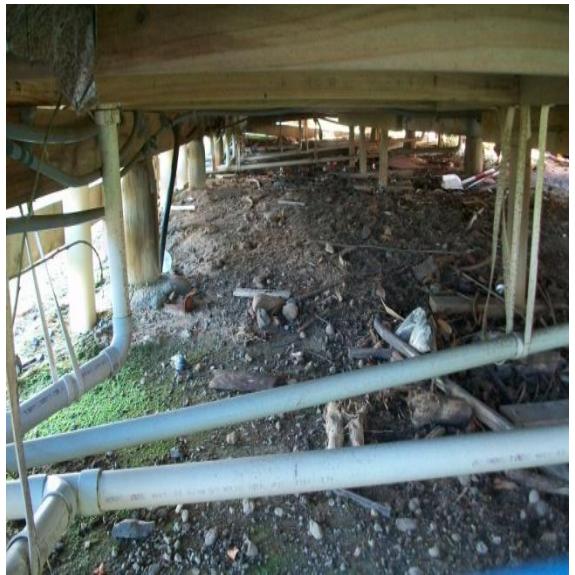
Photo 2: The sub floor structure showing the short timber poles

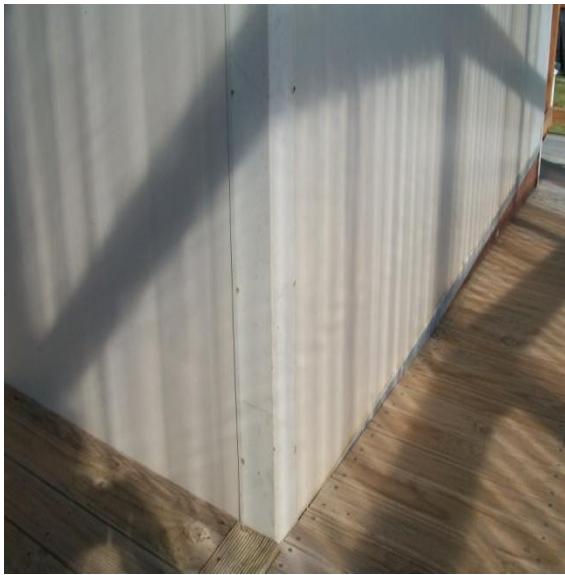
- 1) Some rivet heads had sheared off at the base of the angle in the north east corner of the structure. The angle appears to be responsible for tying the wall panels together. No permanent deformation was noted. (see Photo 3 and Photo 4)
- 2) Some of the heads of the rivets holding the window and door framing in place had sheared off. (see Photo 5 and Photo 6)
- 3) Nails between the angles at the corners of the structure and the timber beams supporting the structure had popped. (see Photo 7)

Photo 3: The north east corner of the structure where rivets have sheared

Recommendations	Level of repair/strengthening required: <input type="text" value="minor structural"/>	Some riveted and nailed fixings are to be replaced
	Building Consent required: <input type="text" value="no"/>	Describe: <input type="text"/>
	Interim occupancy recommendations: <input type="text" value="full occupancy"/>	Describe: <input type="text"/>
Along	Assessed %NBS before: <input type="text" value="70%"/>	%NBS from IEP below
	Assessed %NBS after: <input type="text" value="70%"/>	
Across	Assessed %NBS before: <input type="text" value="70%"/>	%NBS from IEP below
	Assessed %NBS after: <input type="text" value="70%"/>	
		If IEP not used, please detail assessment methodology: <input type="text" value="Qualitative Assessment carried out includes NZSEE IEP (refer to SKM report)"/>

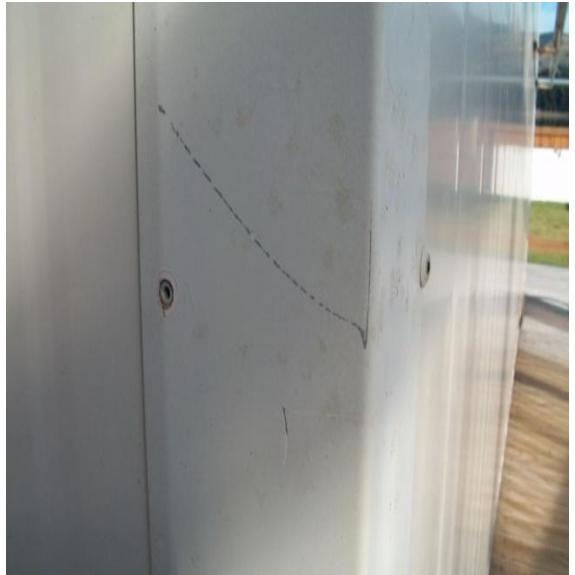
Photo 4: Detail of sheared rivets in the north east corner of the building

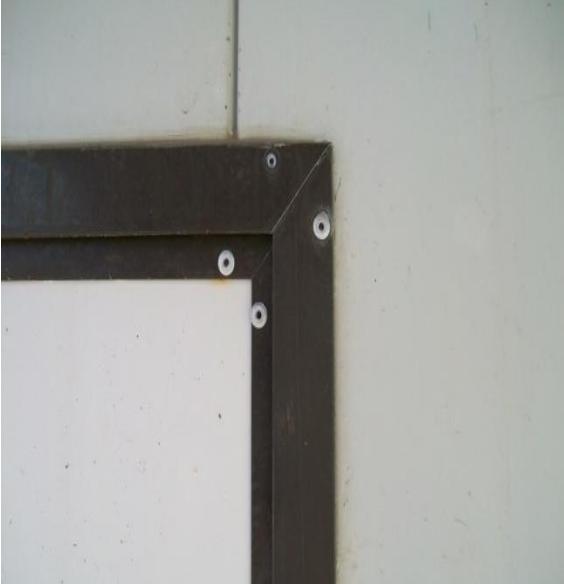
<p>Photo 5: Example of sheared rivets on the door trim</p>	<p>Photo 6: Example of sheared rivets on the window framing</p>

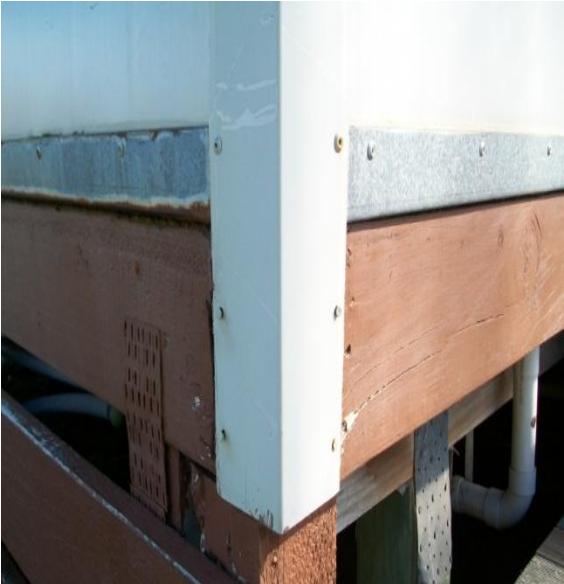
<p>Photo 7: Typical corner angle showing popped nails where it is fixed to the supporting timber framing</p>
