Duvauchelle Works Yard Workshop
PRO 3612 B002
Detailed Engineering Evaluation
Qualitative Report
Version FINAL

Pawsons Valley Road, Duvauchelle

Christchurch City Council

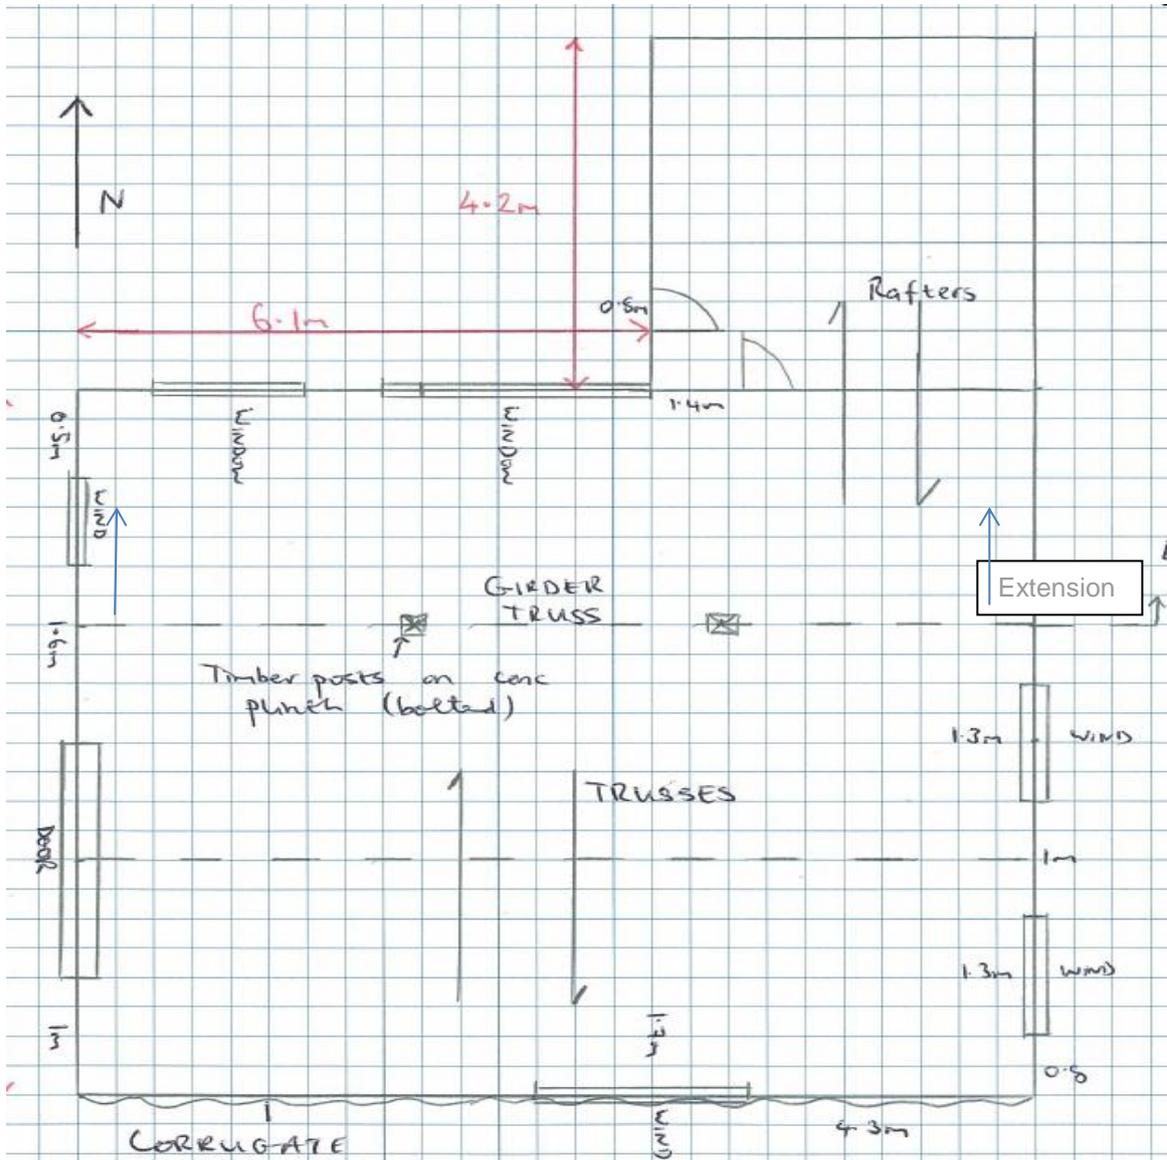
Figure 2 Plan Sketch Showing Key Structural Elements

The seismic load is resisted in both the transverse and longitudinal directions by the timber Sark board lining and weather board panelling on three sides of the structure. In addition the corrugated exterior will offer some lateral load resistance and there is a likelihood of timber diagonal braces existing inside the walls, this however could not be observed. The lack of diagonal bracing in the roof will result in seismic load not being efficiently transferred to the load resisting walls. The timber Sark boarding in the roof acts as a diaphragm and allows the transfer of the load to the supporting walls.

There is seismic bracing in only three of the four sides of this structure, causing torsional effects. The front of the building is open-sided and lacking bracing, so consequently bracing this side must be achieved via roof diaphragm action from the timber sarking. This will allow the transfer of the seismic load to the rear wall. Due to the lightweight nature of the building it is unlikely that it will prematurely collapse as a result of plan irregularity during a seismic event. As such, plan irregularity is considered to be "insignificant".

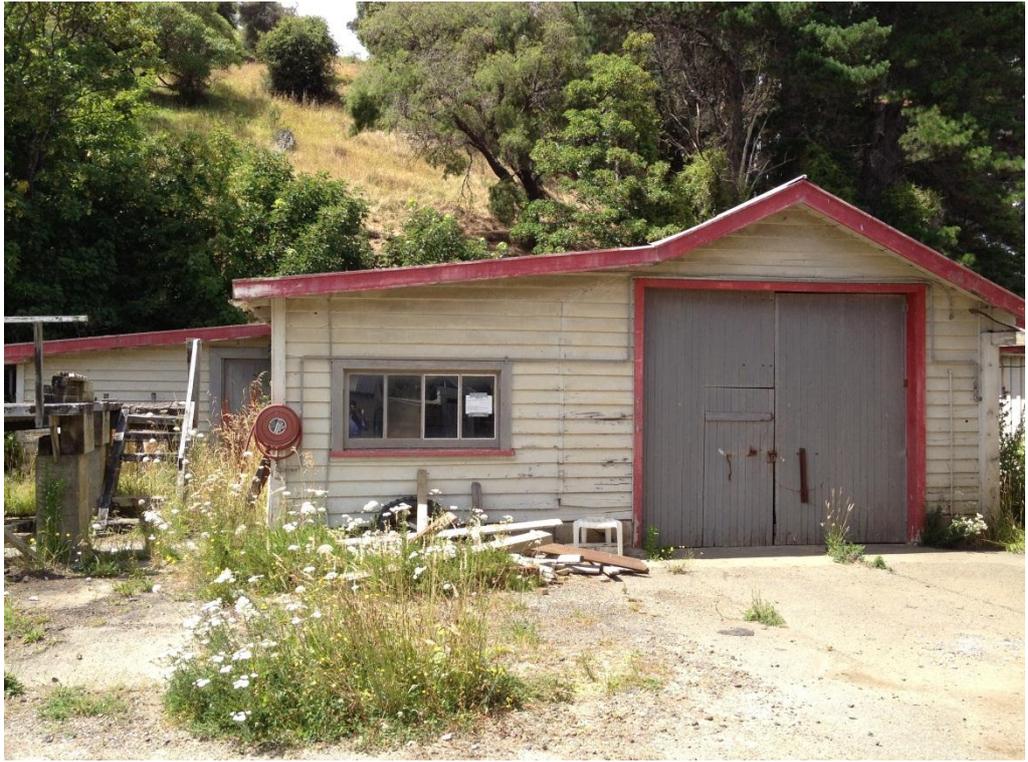
No diagonal roof bracing exists consequently load transfer from the front west open side will not be effective.

Photograph 1: West (front) Elevation

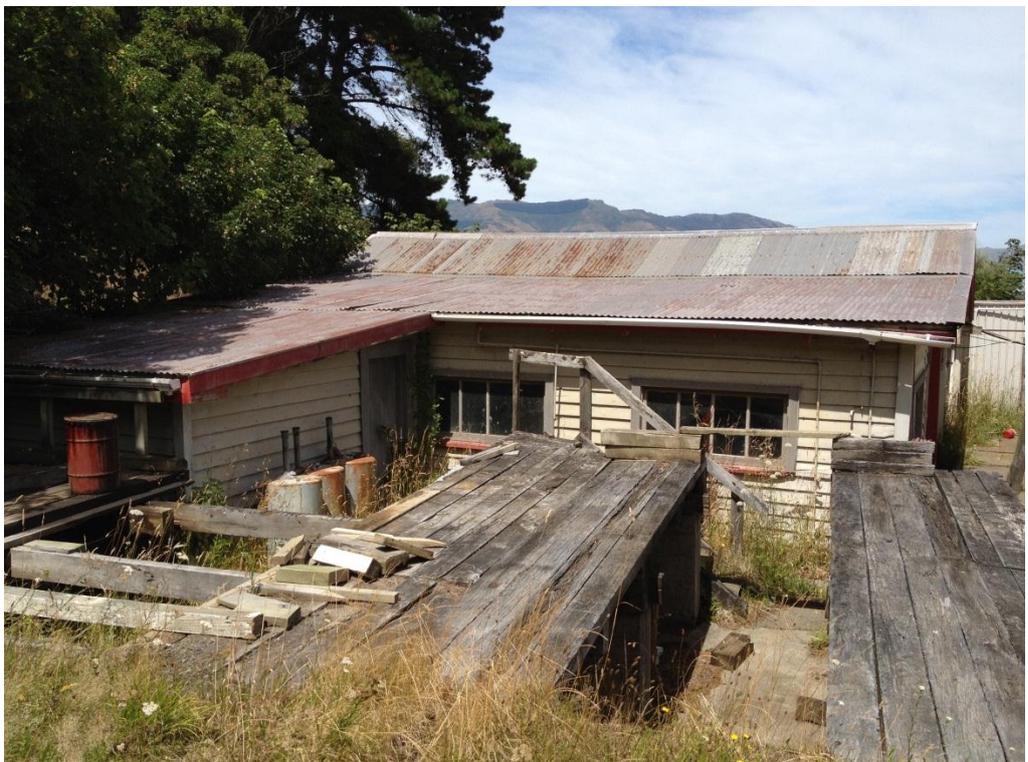
Photograph 2: North Elevation

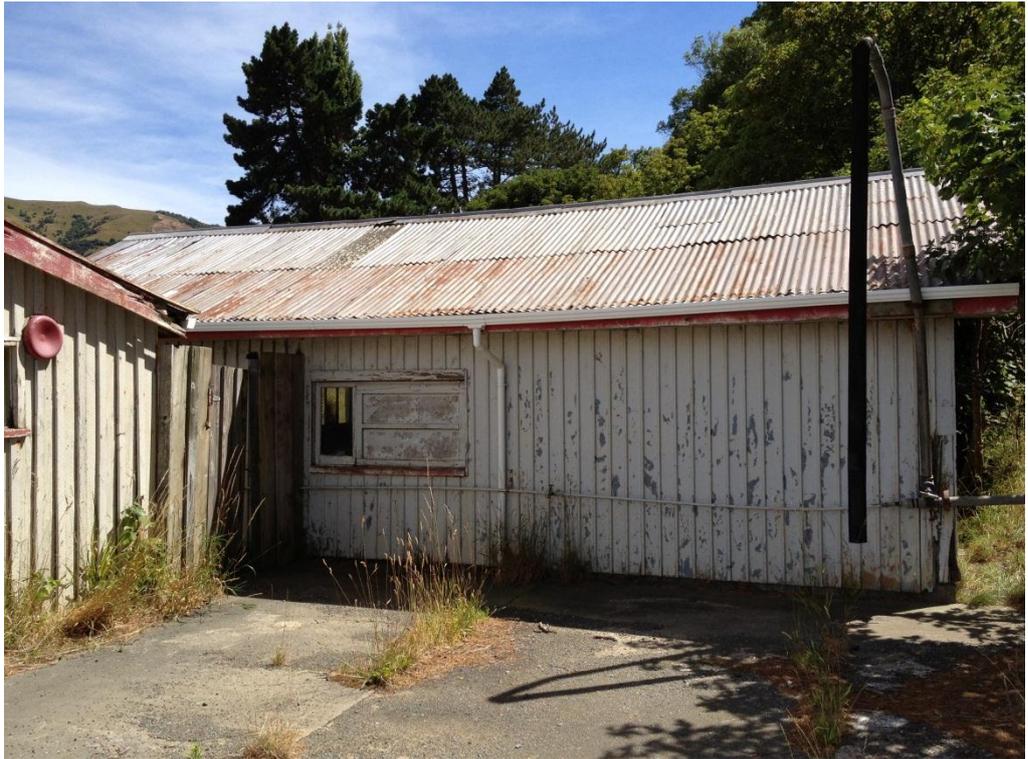
Photograph 3: South roadside Elevation with metal cladding

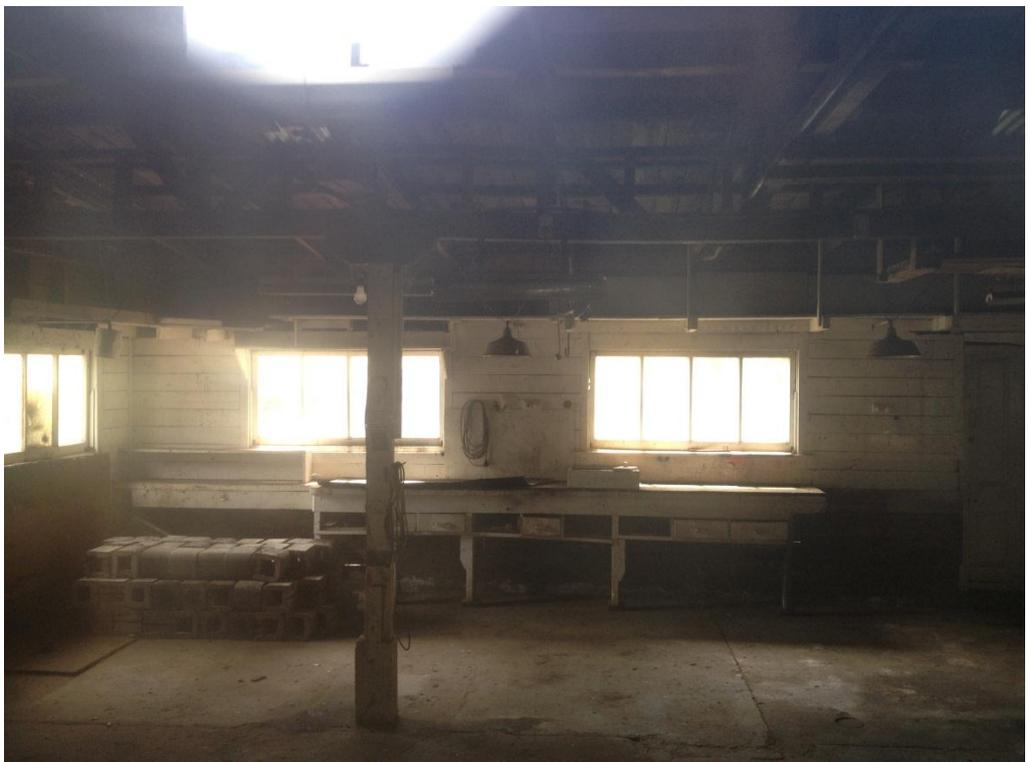
The timber framed load bearing walls act as the gravity load resisting system for the building. The timber trusses are connected directly into the supporting timber posts and internal column, these deliver the load to the external walls and in turn into the foundations through the concrete plinths. The timber column and concrete plinth can be observed in Photograph 4 in Appendix A.

Photograph 4: Interior timber panelling/ Timber column with concrete plinth

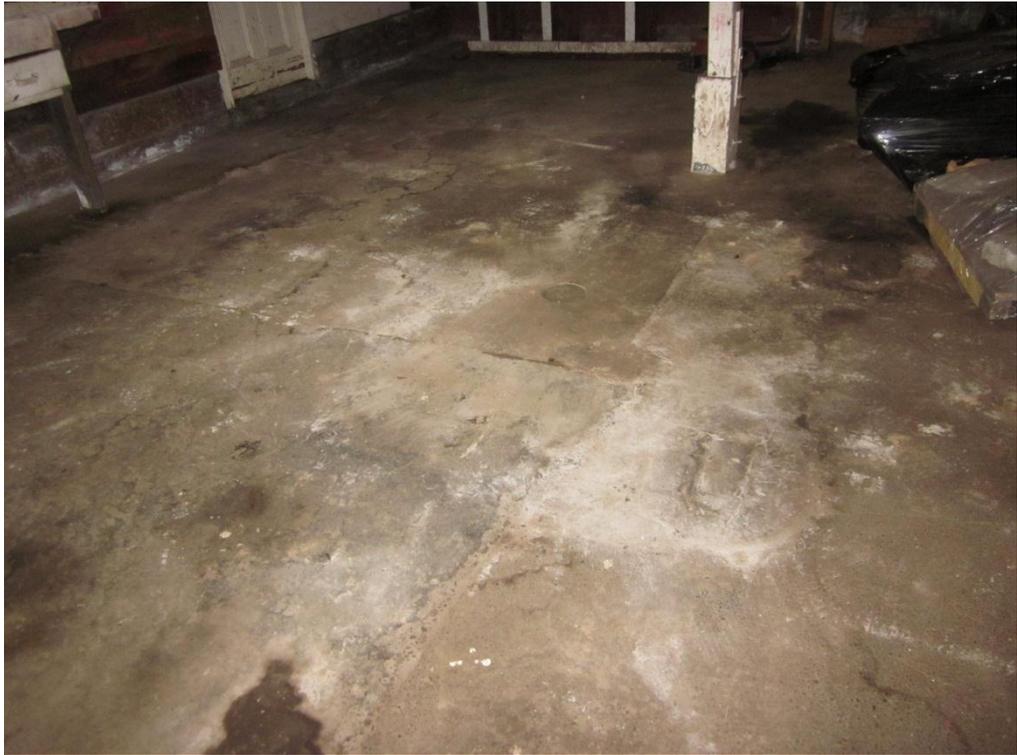
Photograph 5: Slab on grade interior floor

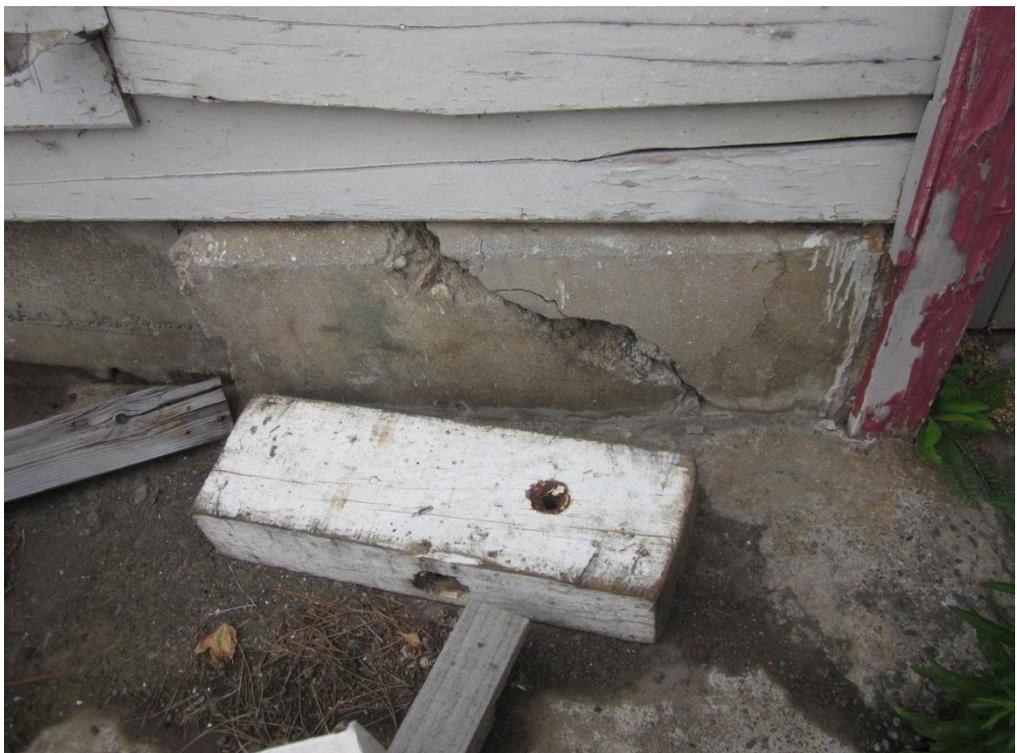
Cracking to the perimeter strip footing was noted and can be observed in Photograph 6 in Appendix A. Existing shrinkage cracks to the concrete floor slab and perimeter wall were observed, these may have opened up slightly during the recent seismic activity.

Photograph 6: Existing cracking to the perimeter strip footing may have opened up further in recent seismic activity

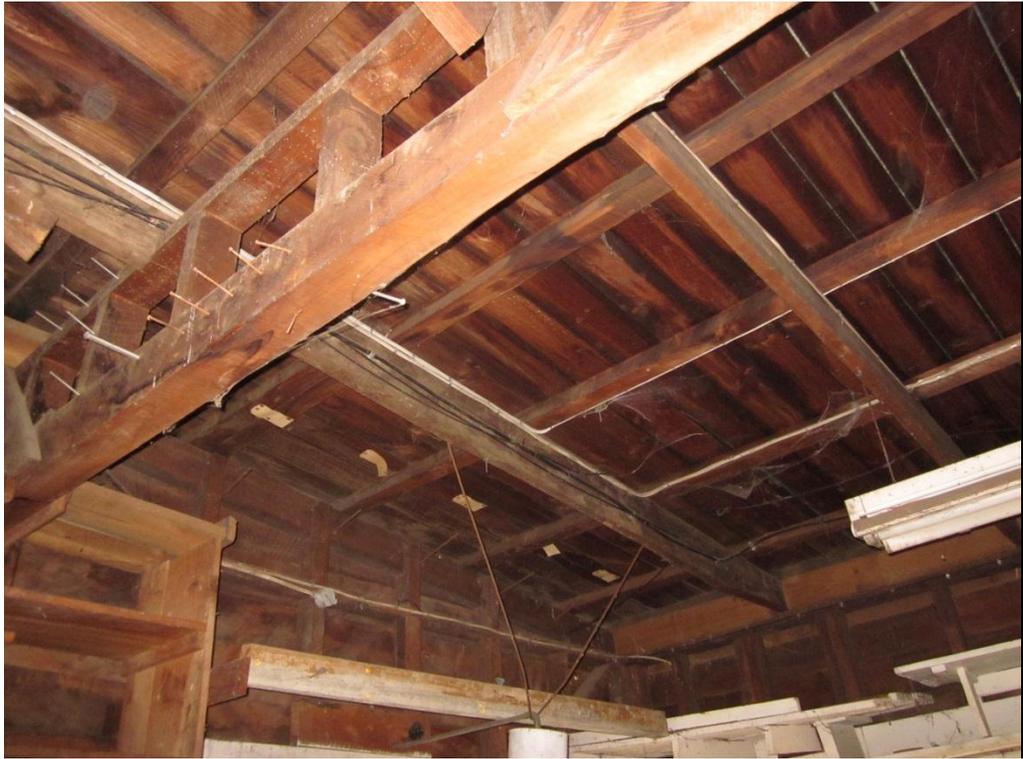
Photograph 7: Timber framed roof with timber gurder truss

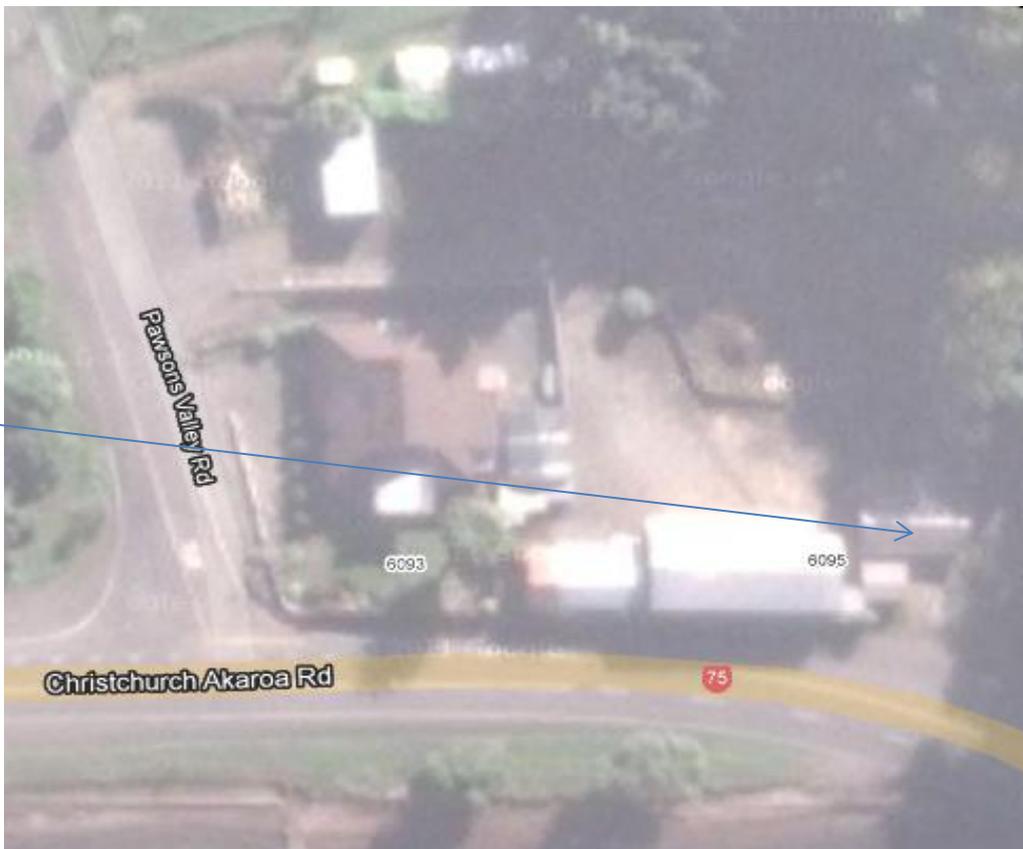
The workshop is located in the Duvauchelle works yard, Pawsons Valley Road, Akaroa. The original construction date of the workshop is unknown but based on site observation is estimated to be in the 1940's. The structure can be observed aerially in Photograph 8 in Appendix A.

Photograph 8: Aerial Plan with Arrow pointing to Workshop Structure
