**Elm Grove Block A**  
**BU 0782 -001 EQ2**  
Detailed Engineering Evaluation  
Quantitative Report  
Version FINAL

8-14 Elm Grove  
Linwood  
Christchurch

Christchurch City Council

**Date**  
07 December 2012

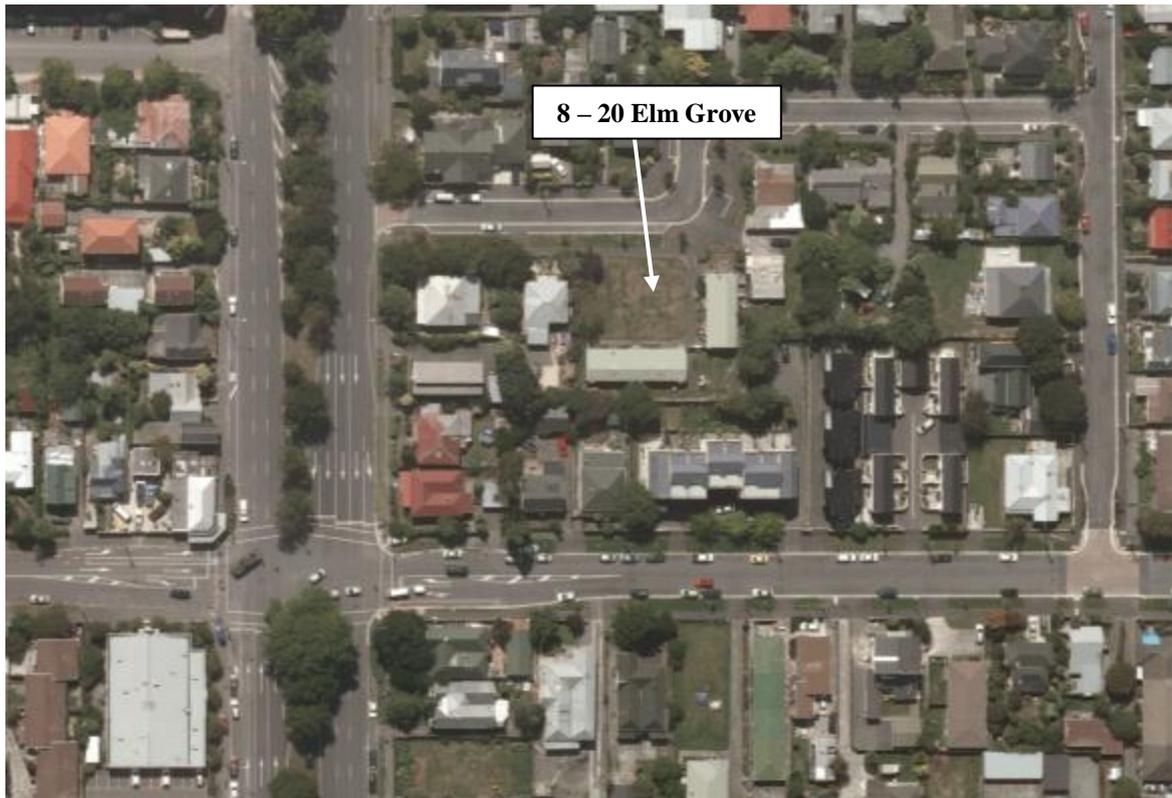
**Figure 3 Post February 2011 Earthquake Aerial Photography**

Aerial photography<sup>5</sup> taken following the significant earthquakes of the Canterbury earthquake sequence show no signs of liquefaction outside the building footprint or adjacent to the site, aerial photography taken 22 February 2011 earthquake is shown in Figure 3.

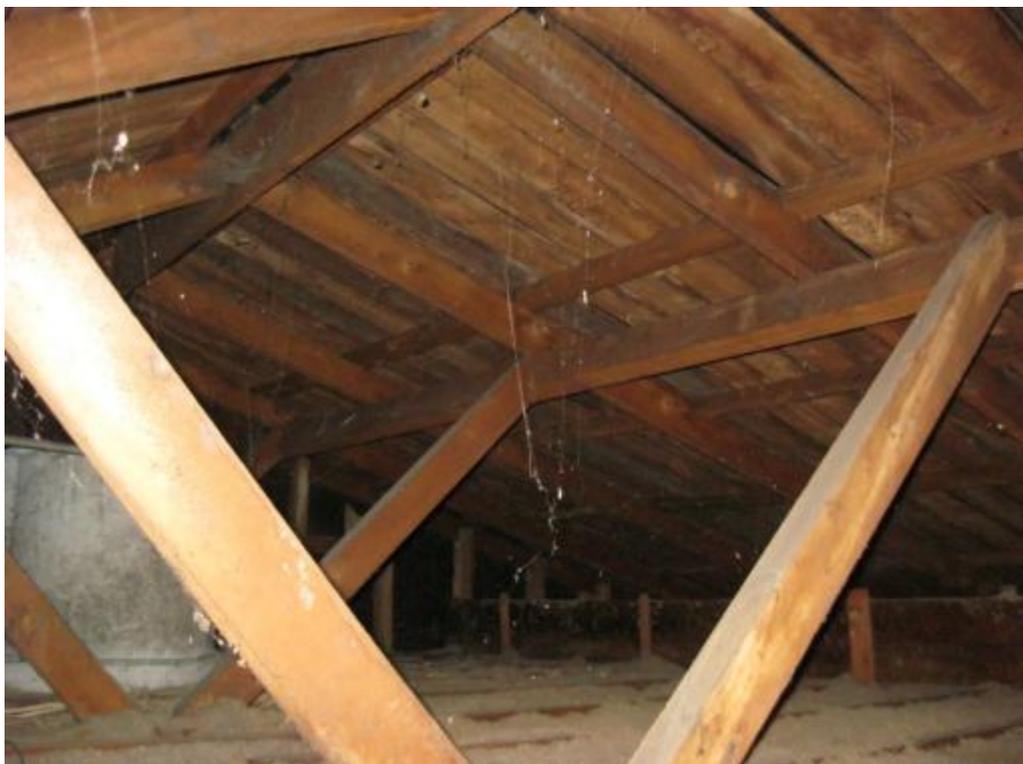
No damage was evident to the roof structure.

**Photograph 4 Roof structure.**

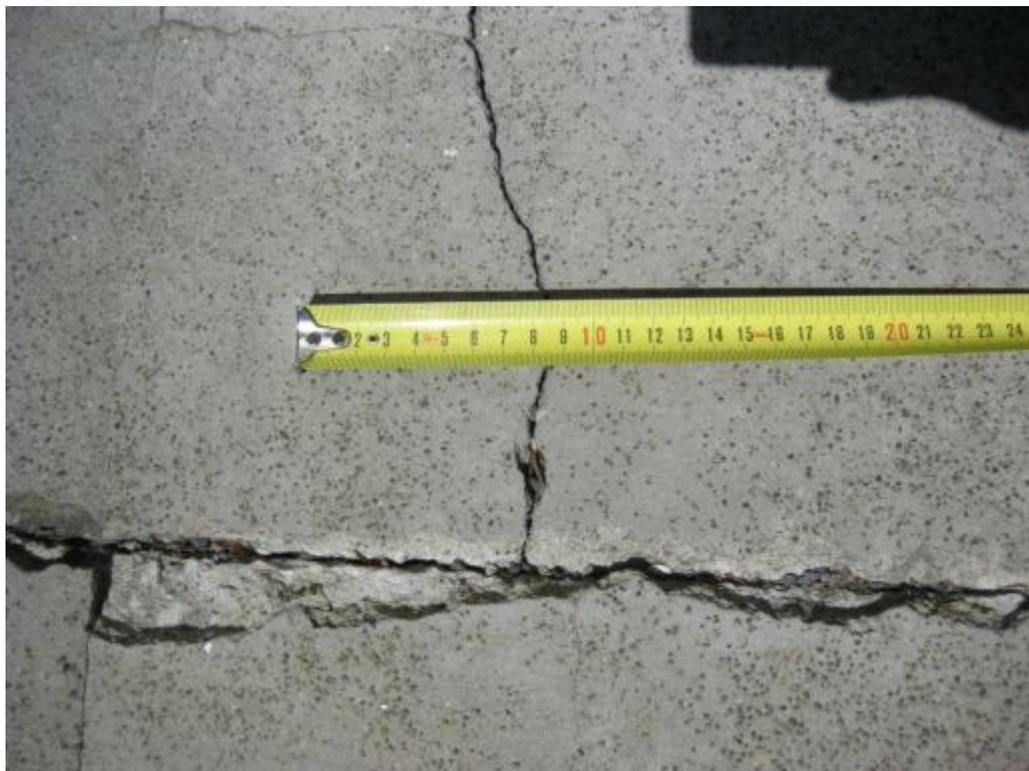
Minor damage to surrounding buildings was observed during our inspection of the site. This was mainly in the form of cracking to plasterboard linings, and cracking to external paved areas.

**Photograph 5 Cracking to external paving.**

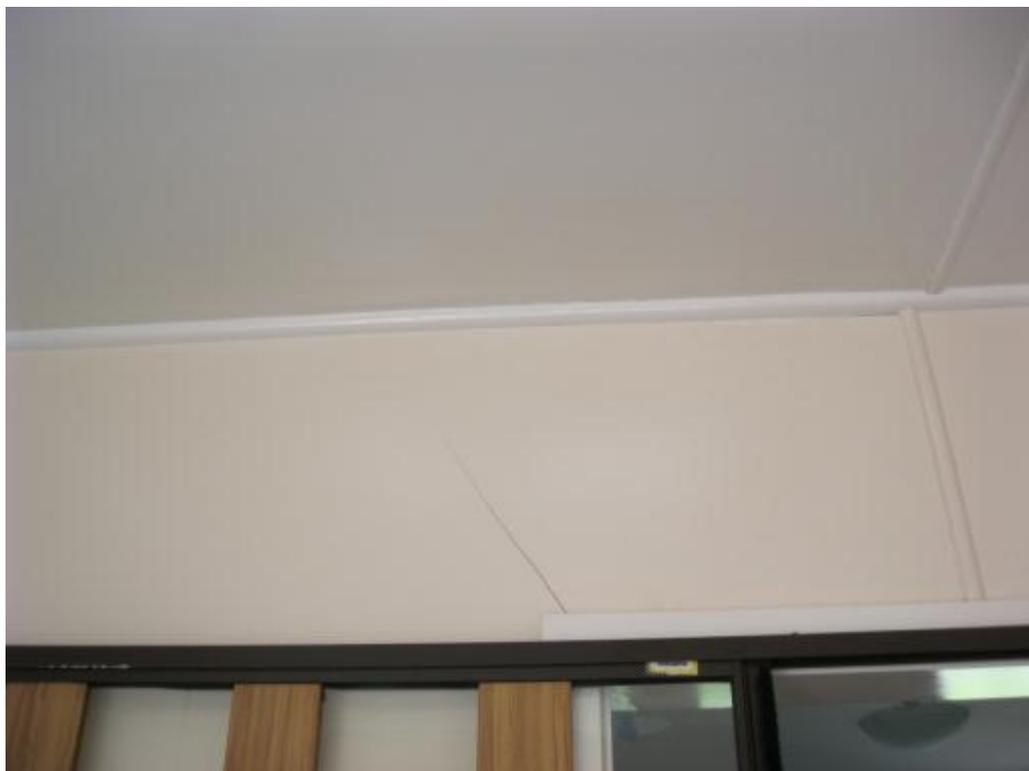
Minor cracking was noted to plasterboard linings in several locations throughout the building however this is not deemed to affect the load carrying capacity of the structural systems.

**Photograph 6 Cracking to plasterboard linings.**
