Feast Place Housing Complex PRO 1107

**Detailed Engineering Evaluation
Quantitative Assessment Report**

**56 Poulson Street, Addington,
Christchurch 8024**

Date: August 2013
Reference: 6-QC339.00
Status: Final

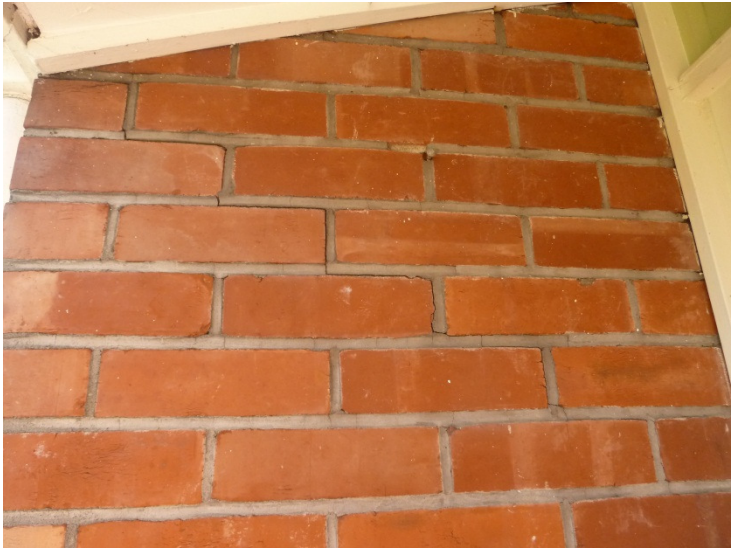
Minor step cracking of the brick veneer mortar joints was observed (photo 8). This damage was not widespread throughout the units.

8.	Step cracking in the firewall between units 5 and 7

It is recommended that remedial repair works be carried out to cracks in walls and foundations.

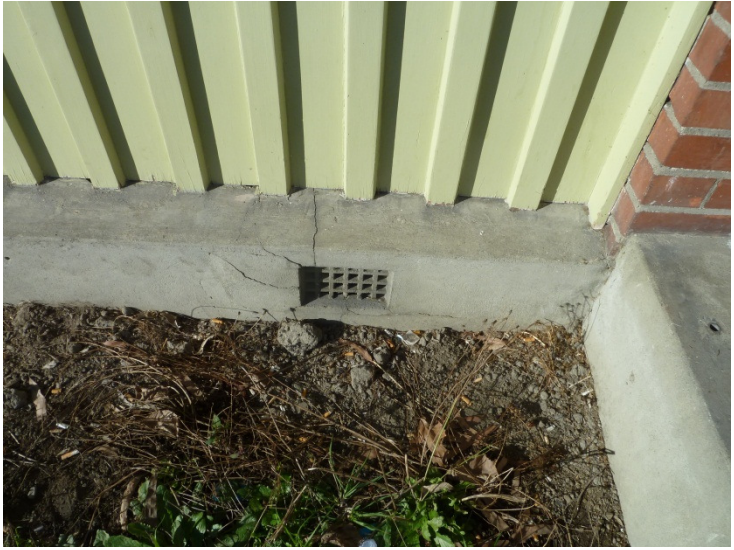
Minor cracking was observed around the vents in the concrete perimeter foundations (photo 9).

9.	Typical cracking around the vents in the perimeter foundations of the units

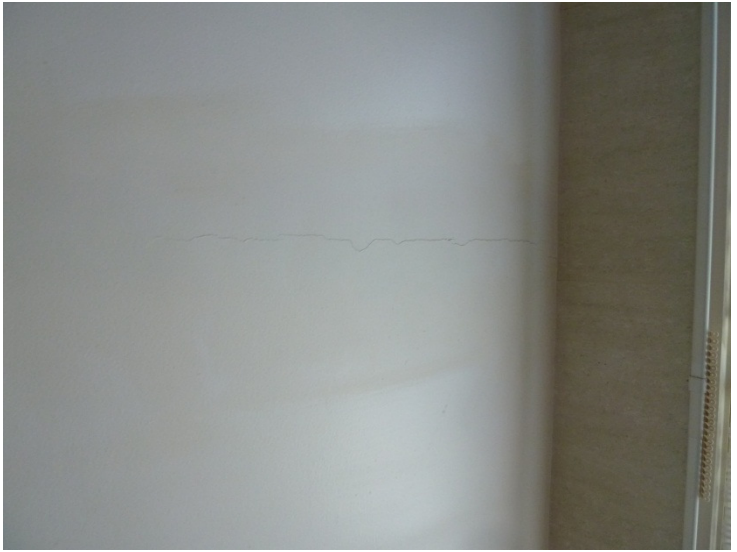
Some minor cracking of the GIB-lined walls was observed in the majority of units that were inspected (photos 10 and 11).

10.	Typical cracking in the GIB lined walls

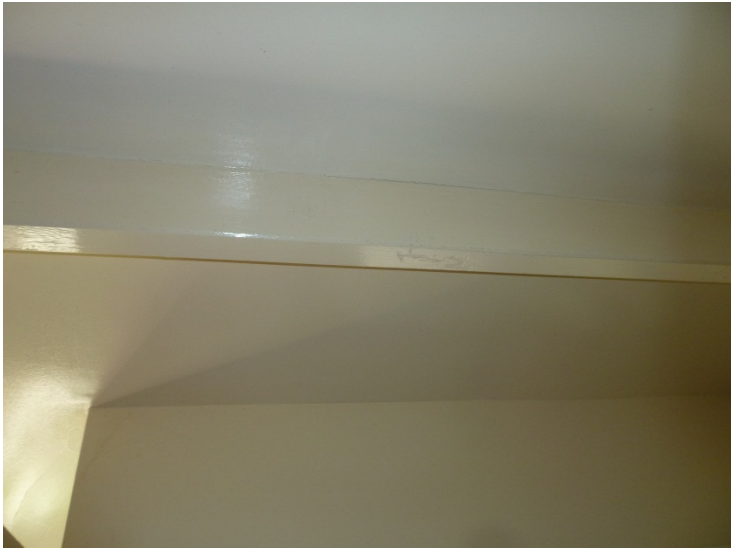
11.	Typical cracking along the beams in the lounge
