Fencing Centre
Qualitative Engineering Evaluation

Reference: 228602
Prepared for:
Christchurch City Council

Functional Location ID: PRO 2394 B003

Address: 95 Jack Hinton Drive, Addington

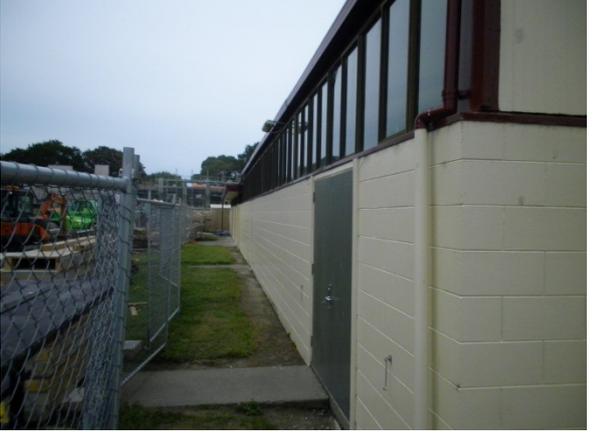
| <p>Building northern elevation</p> | <p>A photograph showing the northern elevation of a building. The building has a light-colored, possibly concrete or stone, facade. A dark green door is visible. To the left of the building is a chain-link fence. The sky is overcast.</p> |

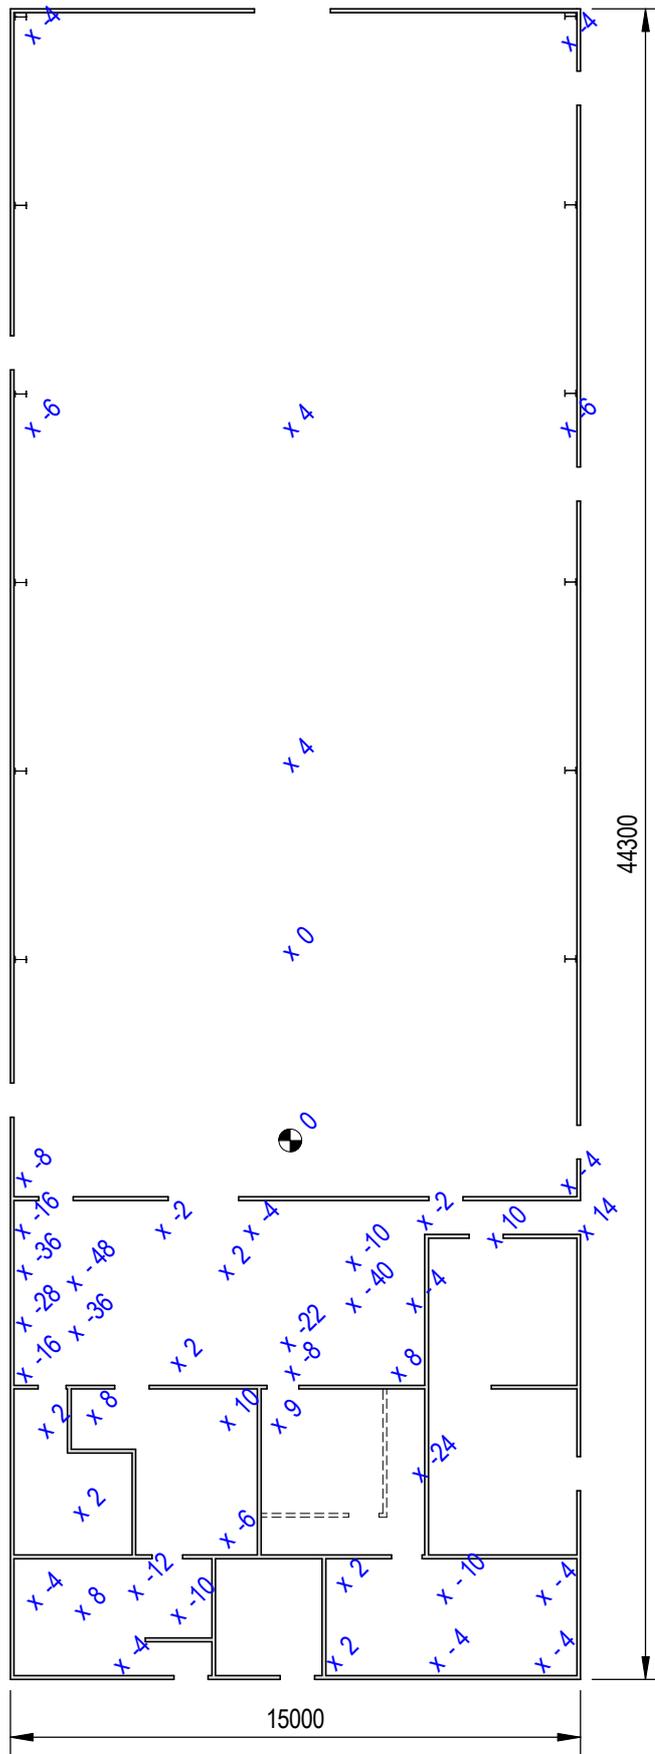
PLAN - LEVELS

| Levels Survey Results | Y | Variations in floor levels were not within the DBH's Guidelines, with falls greater than 1:200 or 0.5% | | | |

The floor levels for the Fencing Centre were found to be within the recommended tolerances excluding the floor area between the hall and the toilets. The large slopes that are shown on the level survey are around cracks in the slab.

There is no clear evidence of any liquefaction or ground movement in the vicinity of the Fencing Centre although there is damage to one portion of the floor slab therefore **a geotechnical investigation is currently considered necessary**. It is also recommended to perform an intrusive investigation on that section of the floor slab to determine the extent of the damage.
